| <b>Type of Services</b> | <b>Phase I Environmental Site Assessment</b> |
| <b>Location</b> | <b>941, 943, 945 and 949 Moraga Road<br/>Lafayette, California</b> |
| <b>Client</b> | <b>City of Lafayette</b> |
| <b>Date</b> | <b>June 8, 2010</b> |

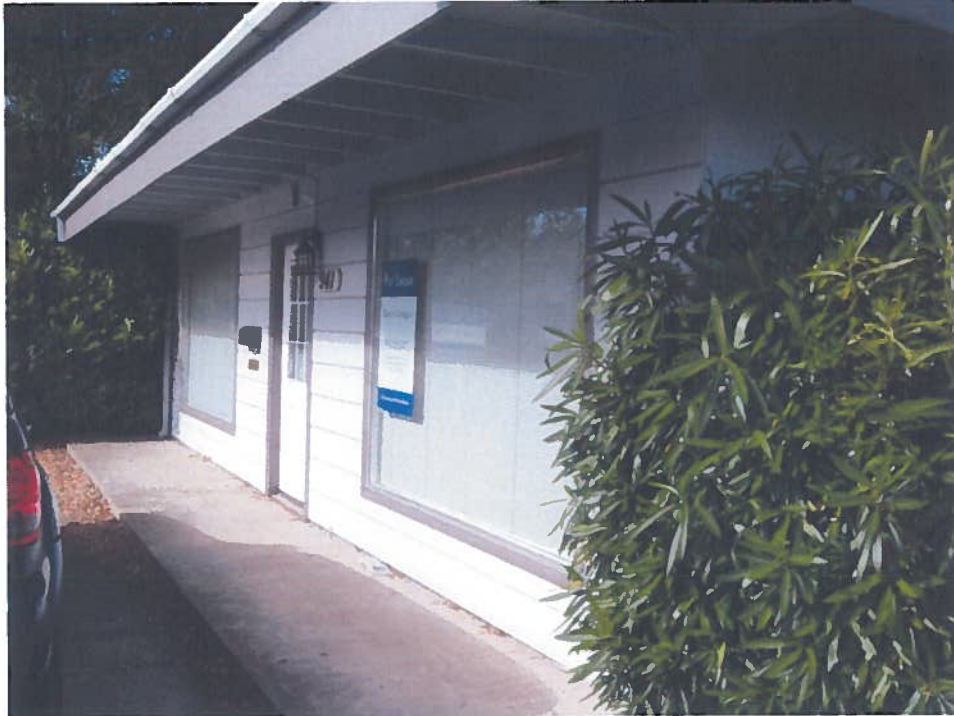
Photograph 1. Front of vacant office building at 941 Moraga Road.

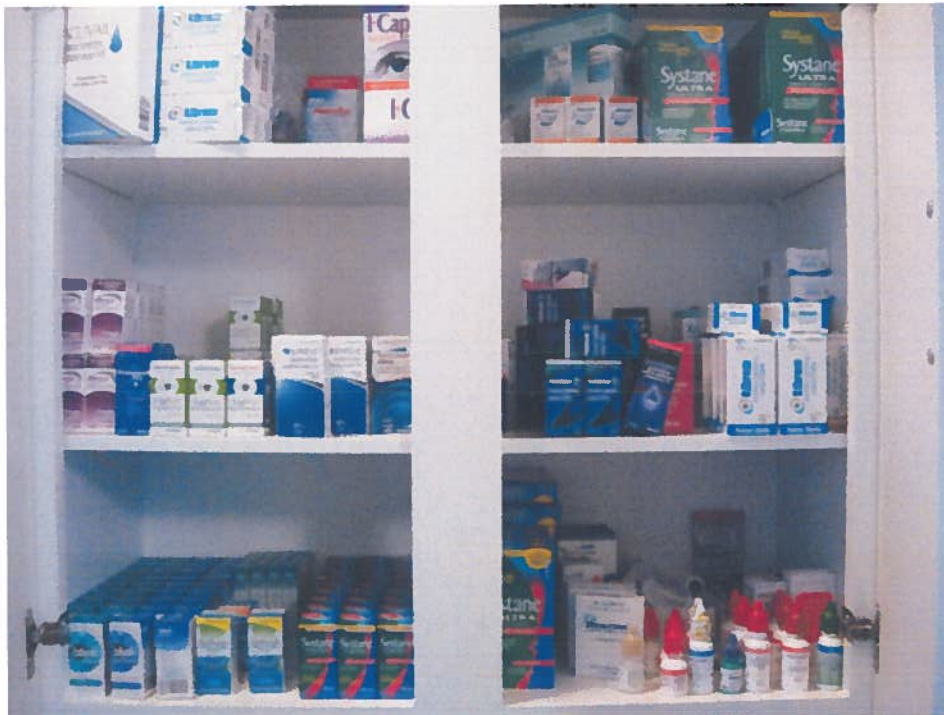
Photograph 2. Medical supply cabinet in optometrist office at 949 Moraga Road

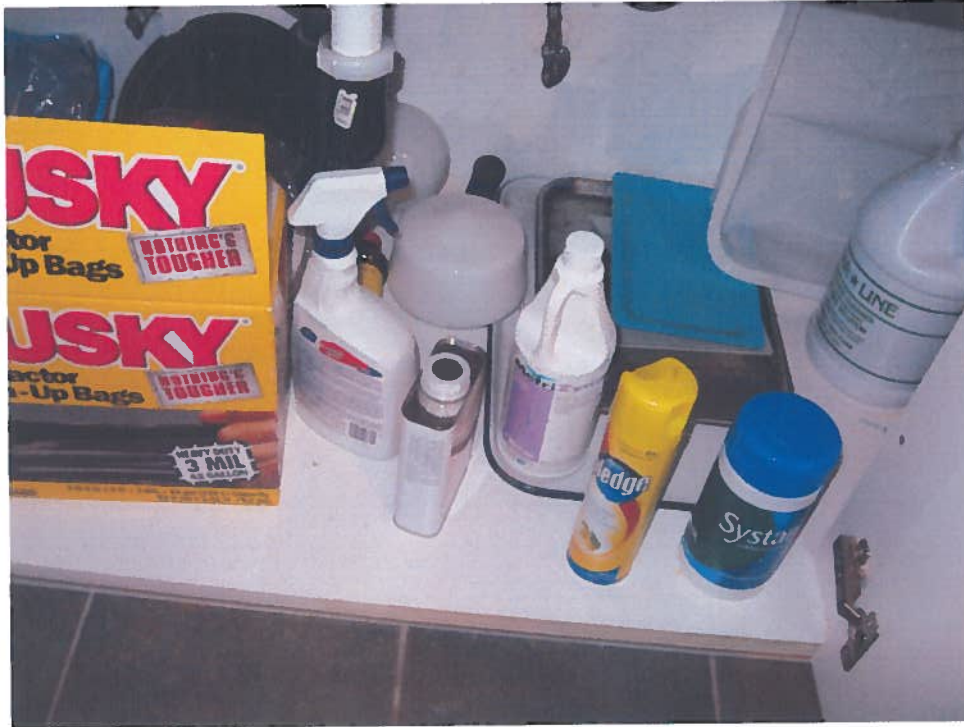
Photograph 3. Janitorial supply from optometrist office at 949 Moraga Road.

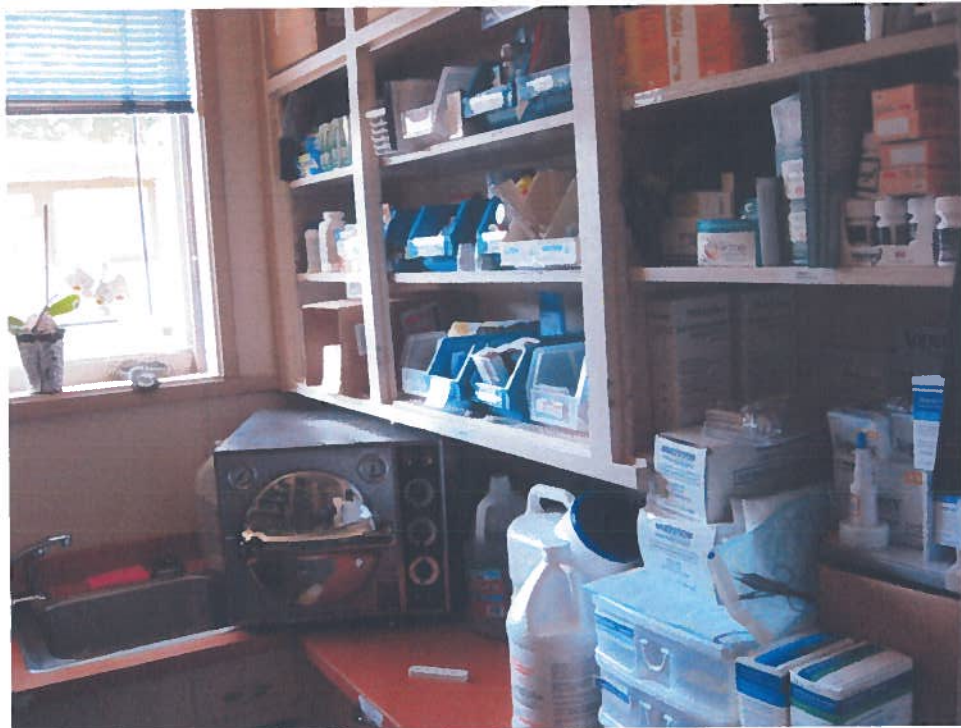
Photograph 4. Medical supply room at doctor's office at 949 Moraga Road.

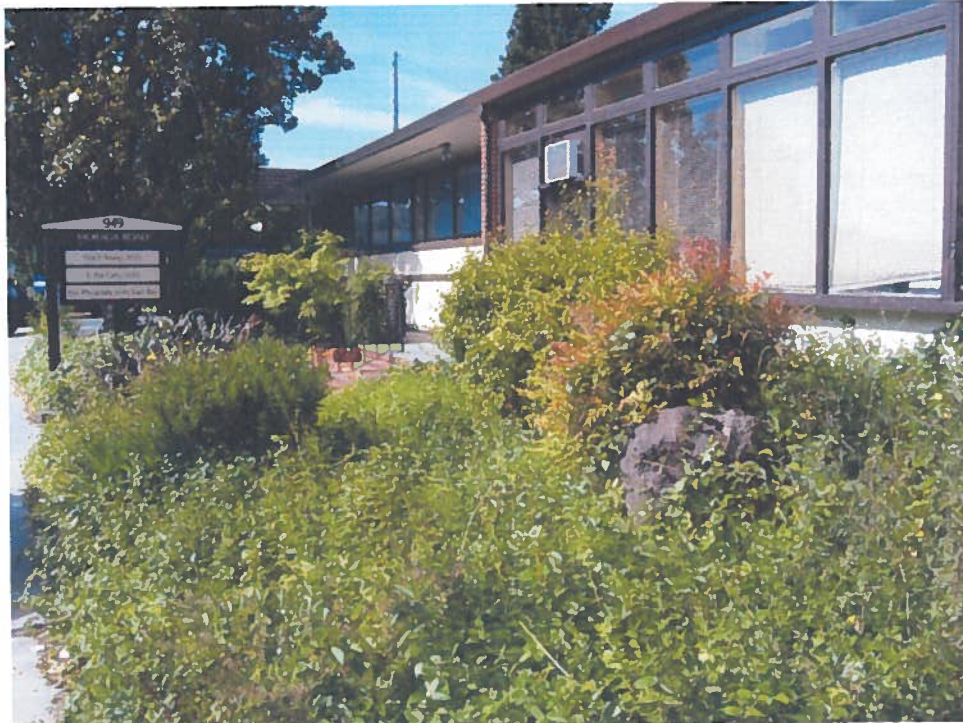
Photograph 5. View looking west of office building at 949 Moraga Road.

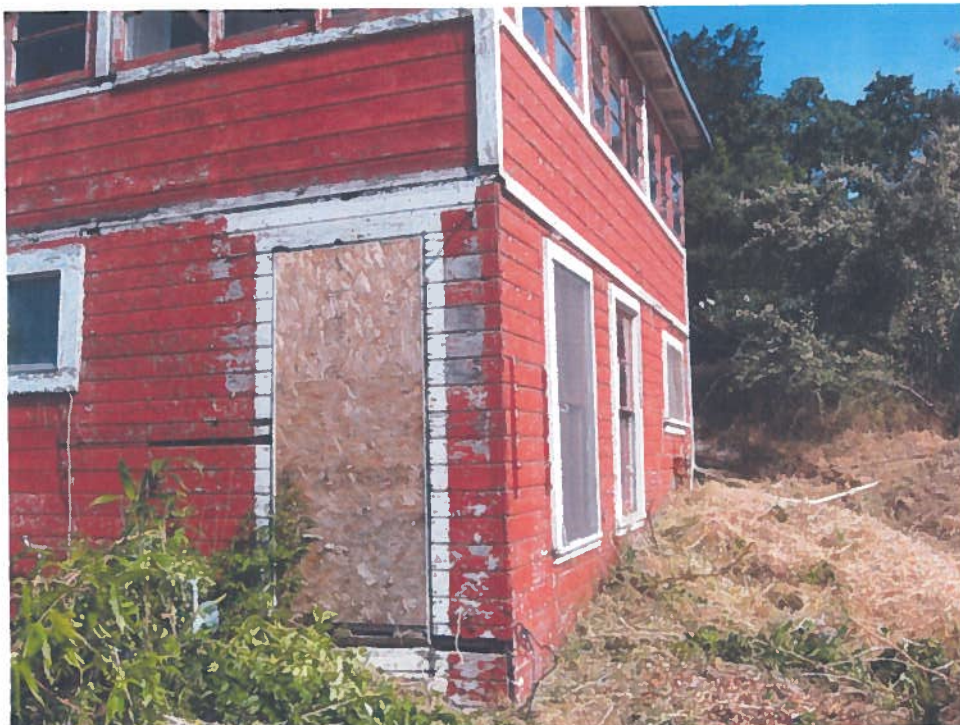
Photograph 6. View looking west of vacant residence at 943 Moraga Road.

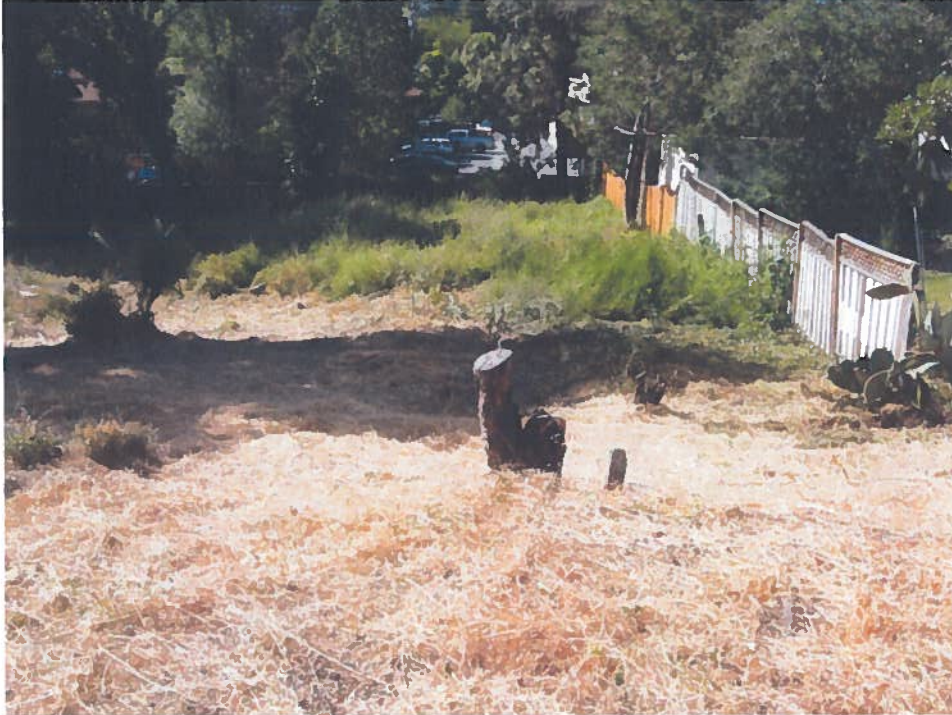
Photograph 7. View looking south from northwest end of property behind the vacant residence at 943 Moraga Road.

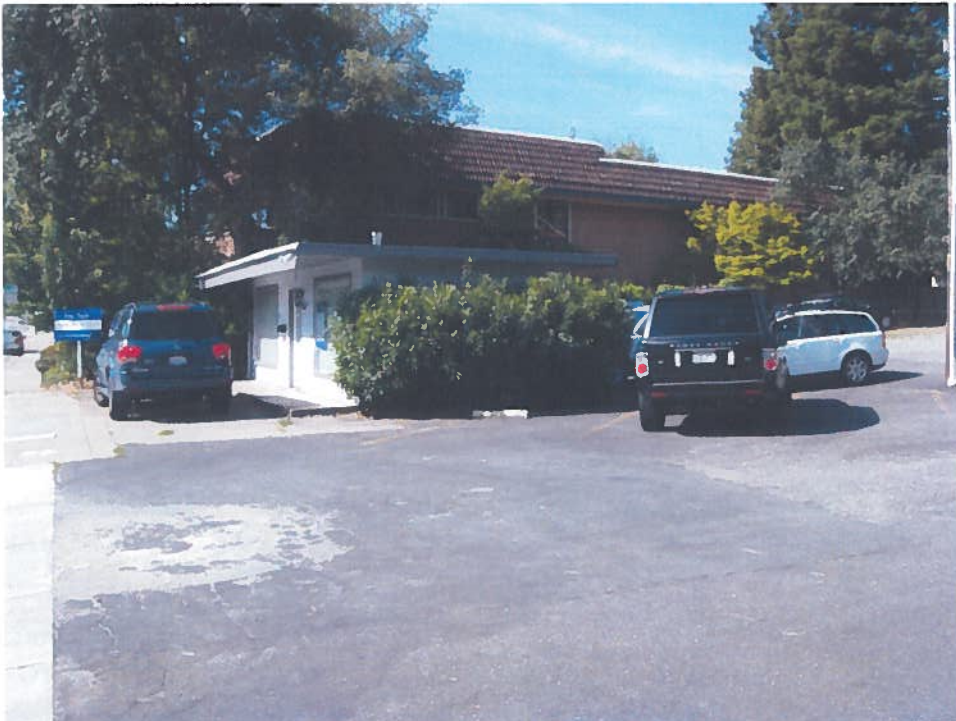
Photograph 8. View looking south from 949 Moraga Road toward vacant office building (941 Moraga Road) and asphalt parking area (945 Moraga Road)
