HISTORICAL RESOURCE  
ASSESSMENT REPORT

## Memorandum

Project Lennar Homes

Topic Historical Resource Assessment

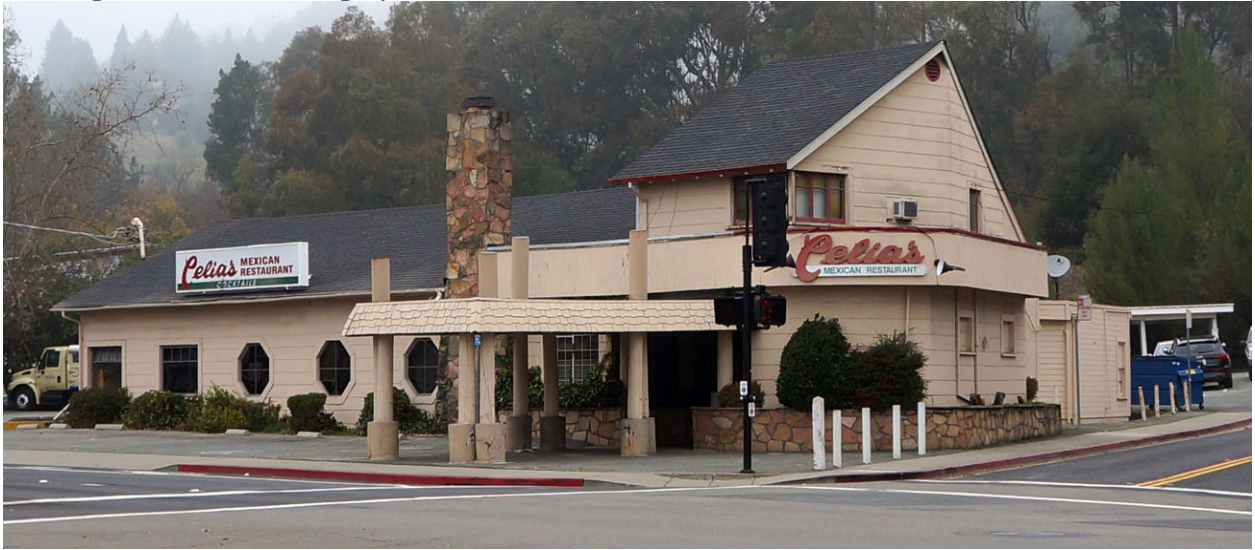
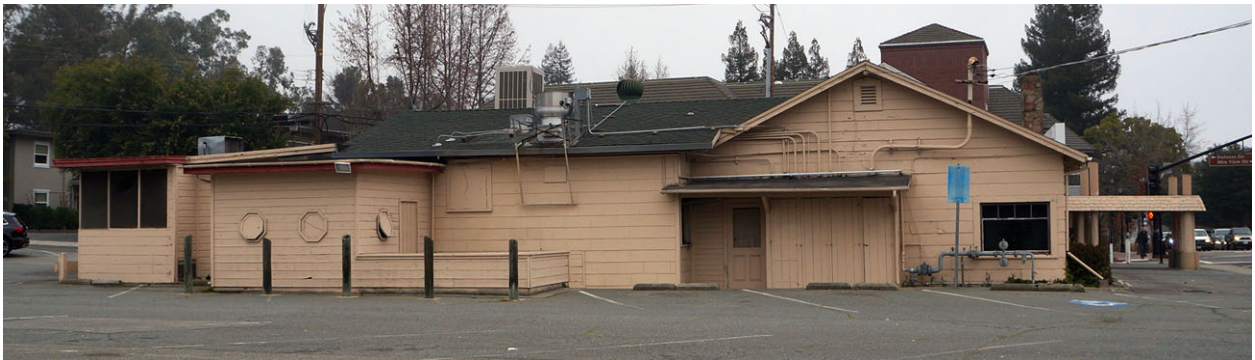
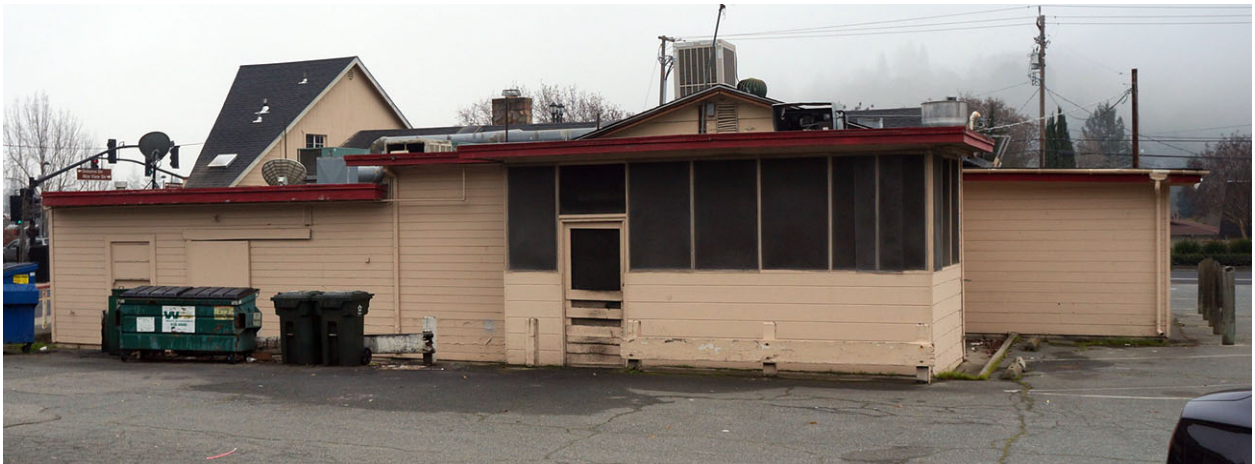
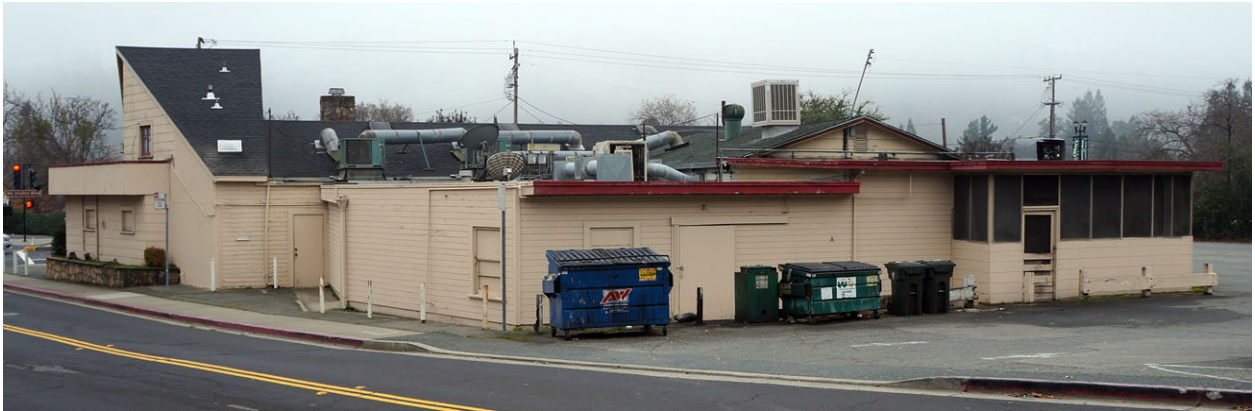
View of the east (right) and south (left) exterior walls of 3666 Mt. Diablo Boulevard, looking northwest.

View of the west exterior wall of 3666 Mt. Diablo Boulevard, looking east.

View of the north exterior wall of 3666 Mt. Diablo Boulevard, looking south.

View of the north (right) and west (left) exterior walls of 3666 Mt. Diablo Boulevard, looking southeast.

The physical condition of Structure 1 is good. There is minor exterior wood deterioration at the base of the rear additions and exterior side of windows. The interior appears intact with some patching of ceilings with plywood at the bar/dining area.

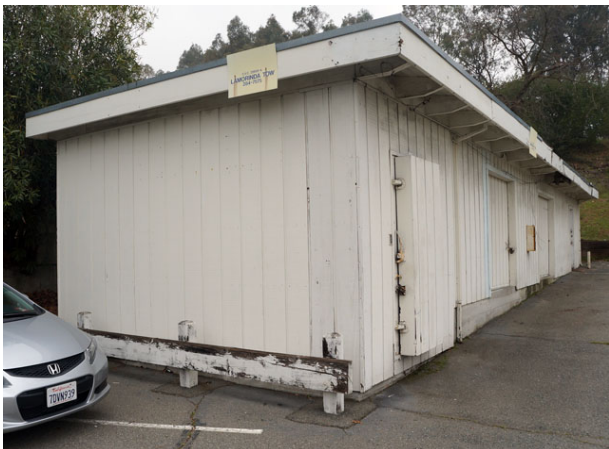
View showing the south (left) and east (right) walls of the storage building (Structure 2).

The storage building is a simple one-story, wood frame structure, measuring overall about 52 feet long by 30 feet in depth. It has a sloped roof, exposed rafter tails at the eaves, vertical board siding and doors made up of vertical boards. There is a locker and toilet room at the north end of the structure and a cold storage room, added in 1967, at the south end. The interior was not observed. The condition is fair with wood deterioration at the base of siding and eave, and poor roof drainage.

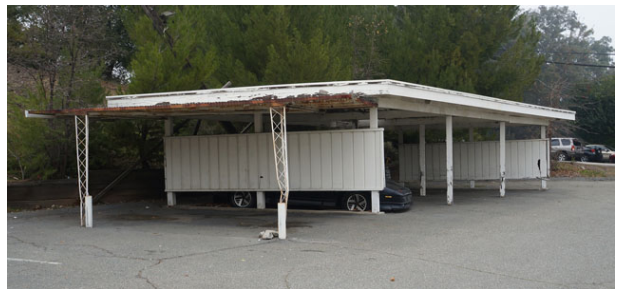
View of the south side of the carport (Structure 3), looking northeast.

The carport is composed of two sections; one is trapezoidal, measuring 33 by 18 feet, and the other is rectilinear mass, measuring 10 by 20 feet. The main body of the carport was built from wood posts supporting a flat wood-frame roof. Two panels composed of vertical wood boards over wood framing provide some shear strength to two of the column lines. The bay at the west is covered by a lower roof, attached to the main roof framing, and supported by metal filigree posts. The condition is fair to poor; it appears unstable with some wood deterioration.

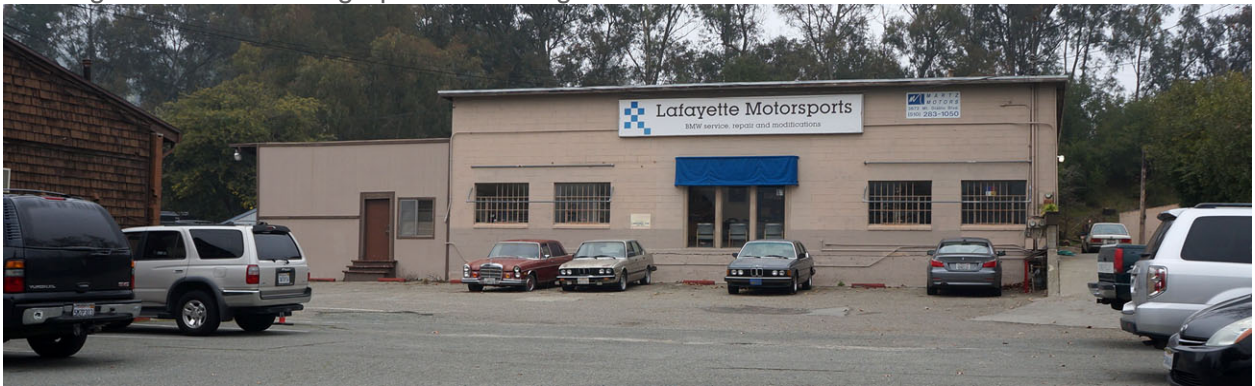
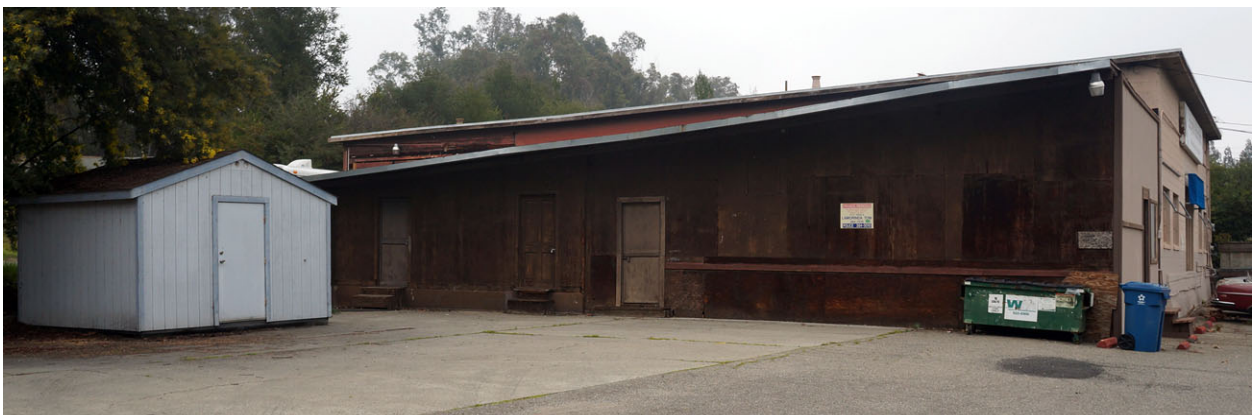
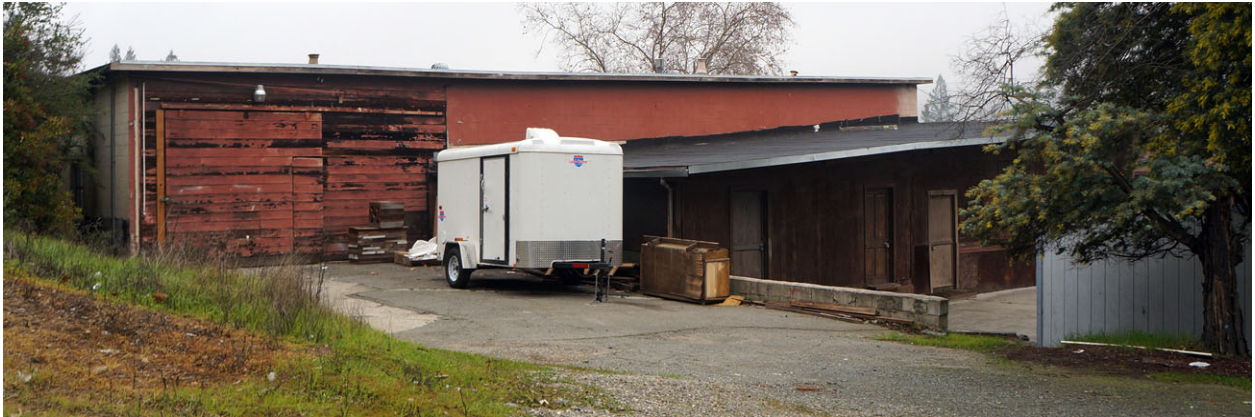
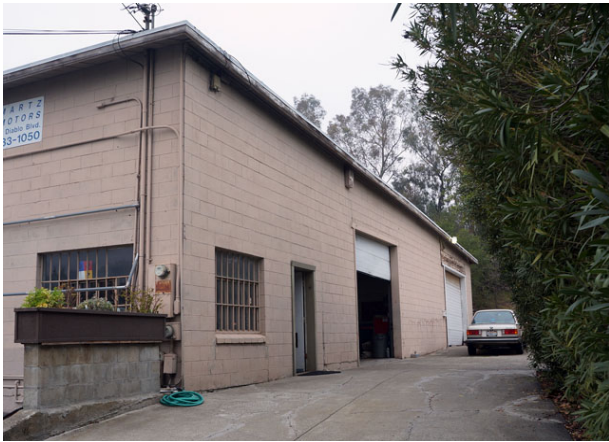
View of the south exterior wall of Building 1, looking north.

View of the south side of the west exterior wall of Building 1, looking northeast.

View of the north side of the west exterior wall of Building 1, looking east.

View of the of the east exterior wall of Building 1, looking north.

The physical condition of Building 1 is fair to good. The condition of the concrete warehouse is good while the wooden shed section is fair with peeling painted and wood deterioration.

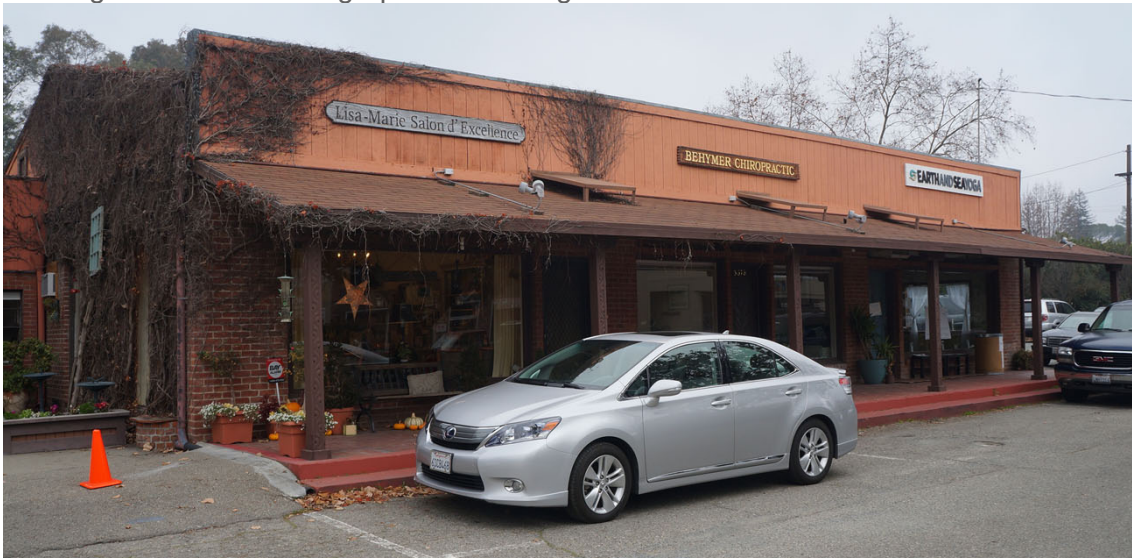
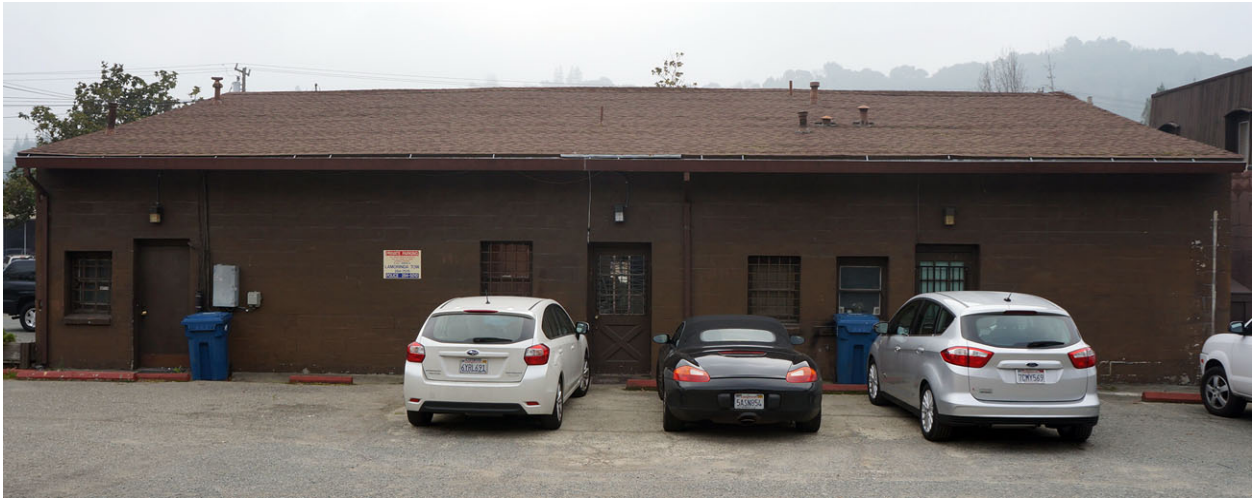
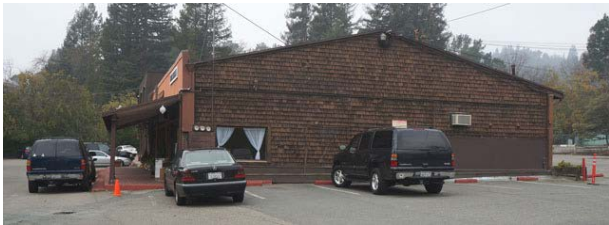
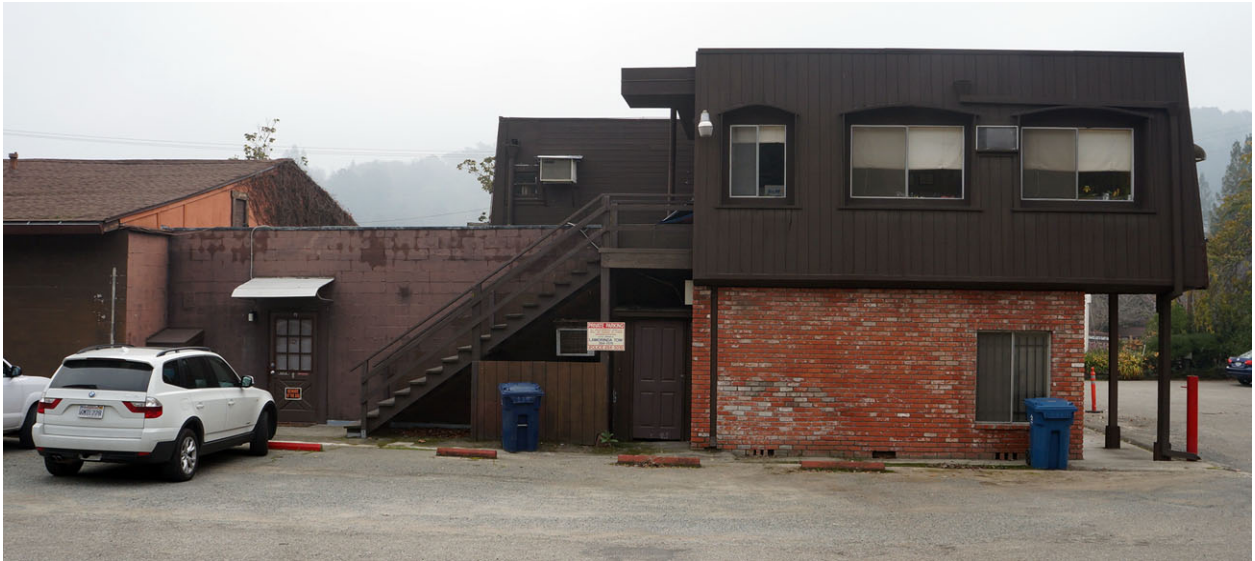
View of the south wall of the east side of Building 2, the first section at 3674-78 Mt. Diablo Boulevard.

View of the north or rear exterior wall of the first section of Building 1 at 3674-78 Mt. Diablo Boulevard.

View of the shingled east exterior wall of 3674-78 Mt. Diablo Boulevard, the first section of Building 1.

View of the north or rear wall of 3680 (right) and 3678a Mt. Diablo Boulevard (left), with a portion of 3674-3678 Mt. Diablo Boulevard at far left.

The condition of Building 2 is good. The ivy growing on the first and second section of the building is likely bringing moisture to the surface and deteriorating the face of the brick and upper wood siding. The upper section of the rear concrete block wall at the second section appears to suffer from water infiltration. This might indicate a roof leak. According to tenants, Building 2 has experienced flooding in the past from the rear hillside and may not have adequate drainage surrounding the building.

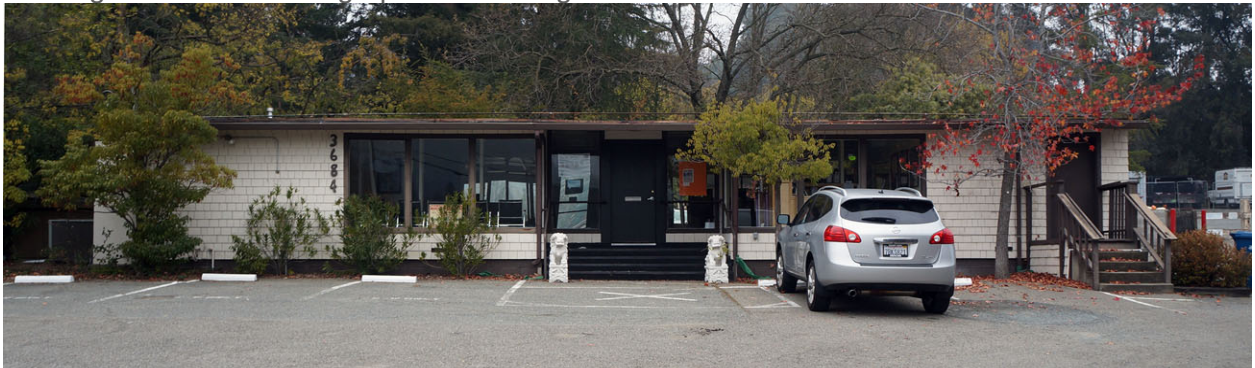
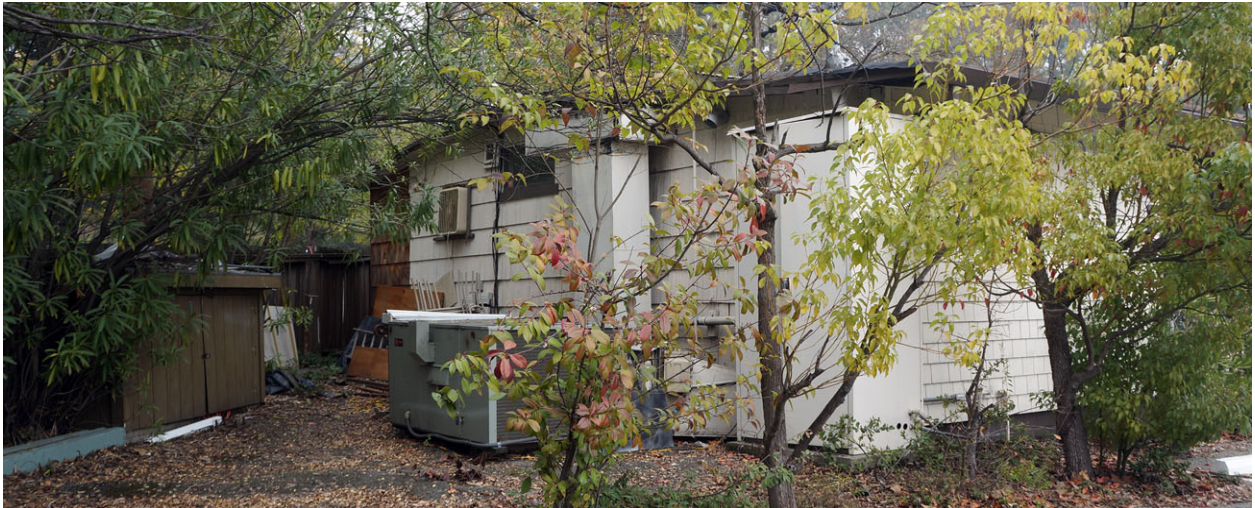
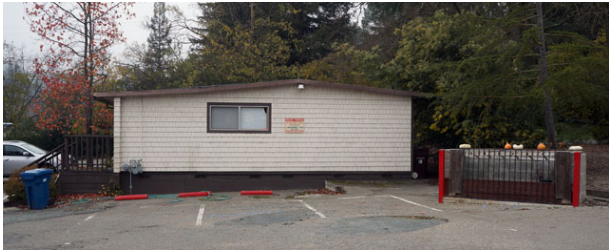
View of the south wall of Building 3, looking north.

View of the north wall of Building 3, looking southeast.

View of the east exterior wall of Building 3.

The physical condition of Building 3 is good. Deterioration of roofing and gutters is visible at the north side. Shingles have been replaced at the northwest corner of the building.

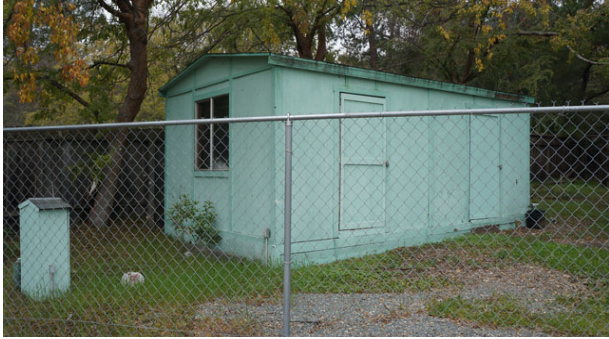
Because this structure does not appear to have a foundation, it appears to be temporary,
