APPENDIX C:  
TREE REPORTS

**RE: Tree Inventory & Assessment at Leigh Creekside Park Improvement Plan**

**Tree Inventory & Preliminary Park Improvement Plan**  
**Leigh Creekside Park**  
LAFAYETTE CA

**Re: Leigh Creekside Park Improvement Plan**

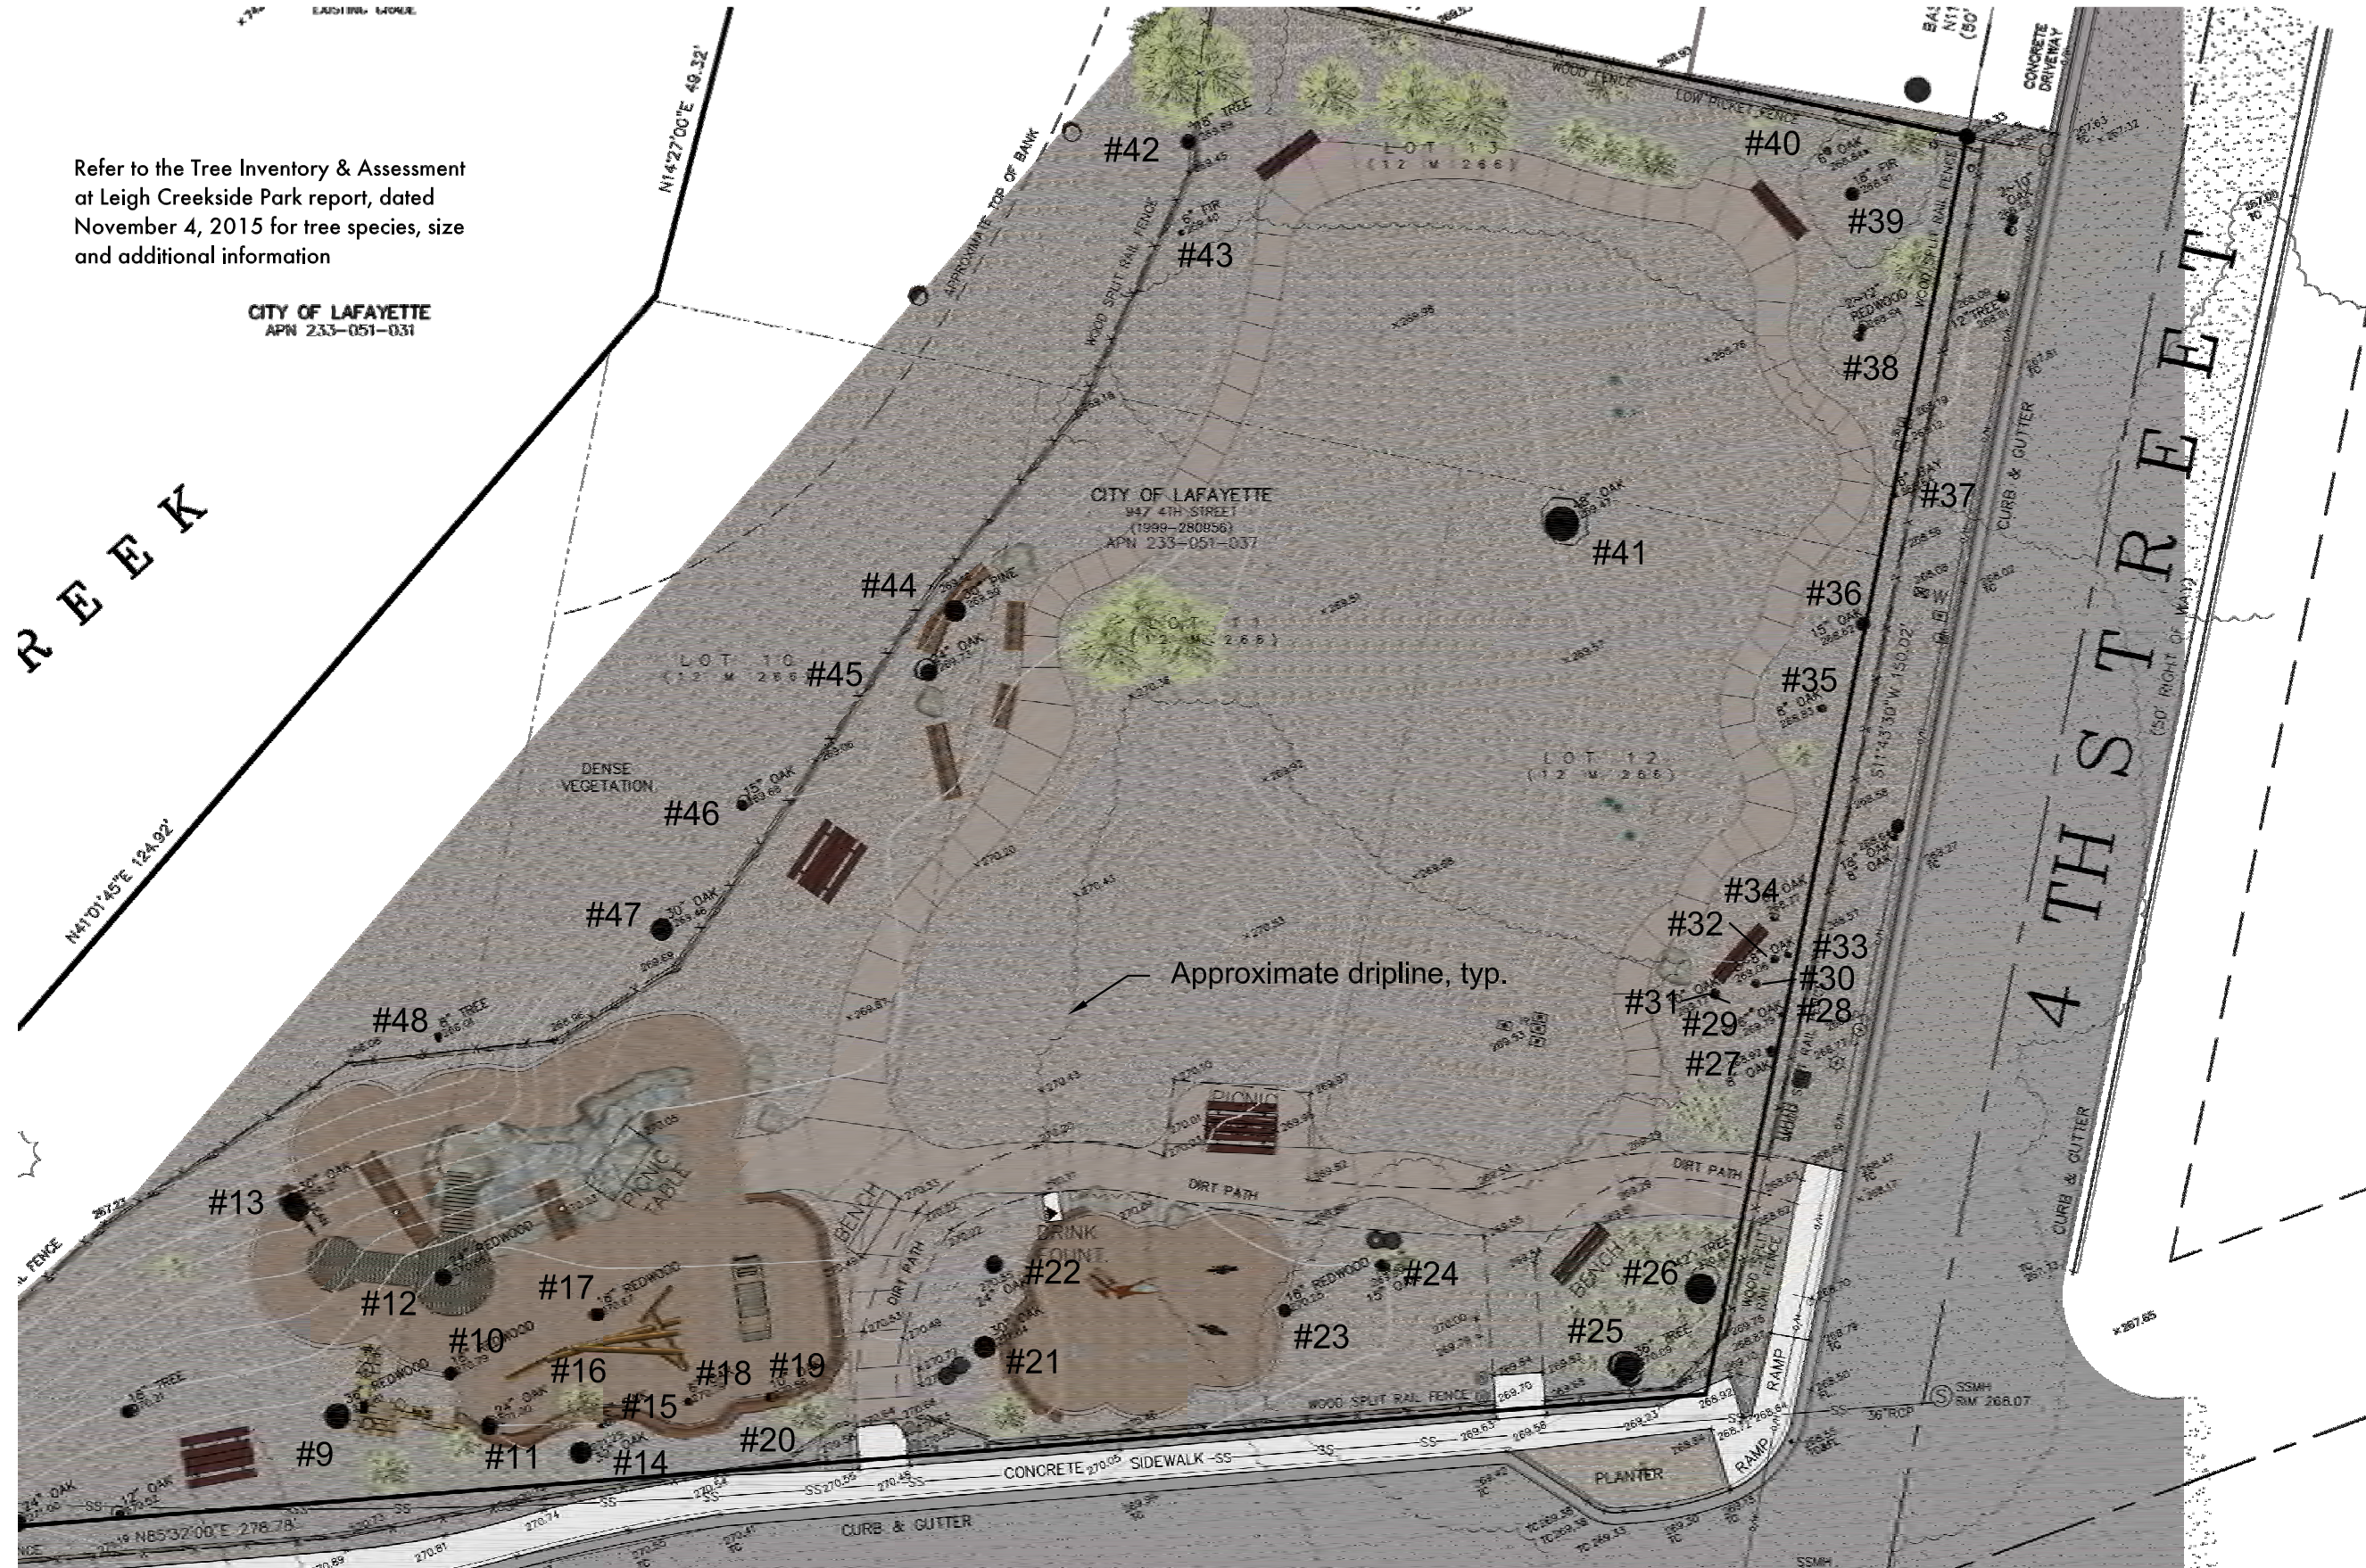
Refer to the Tree Inventory & Assessment at Leigh Creekside Park report, dated November 4, 2015 for tree species, size and additional information
