FINAL REPORT

Pacific Gas and Electric Company

Tree Root Interference Assessment

January 17, 2014

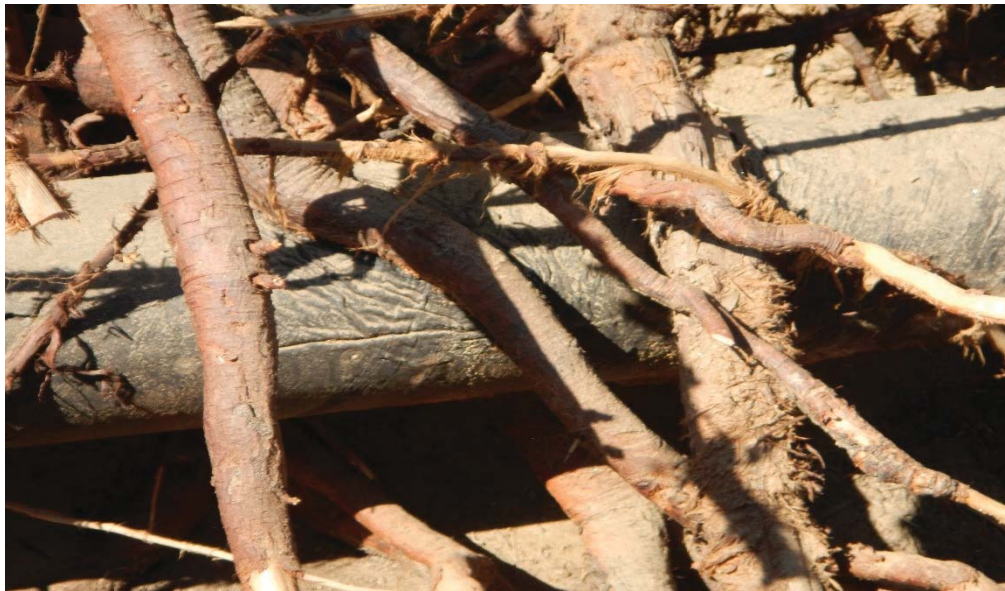
**Figure 3. RWVIM-107-13 (Weber Lane)
(CTE coating damage)**

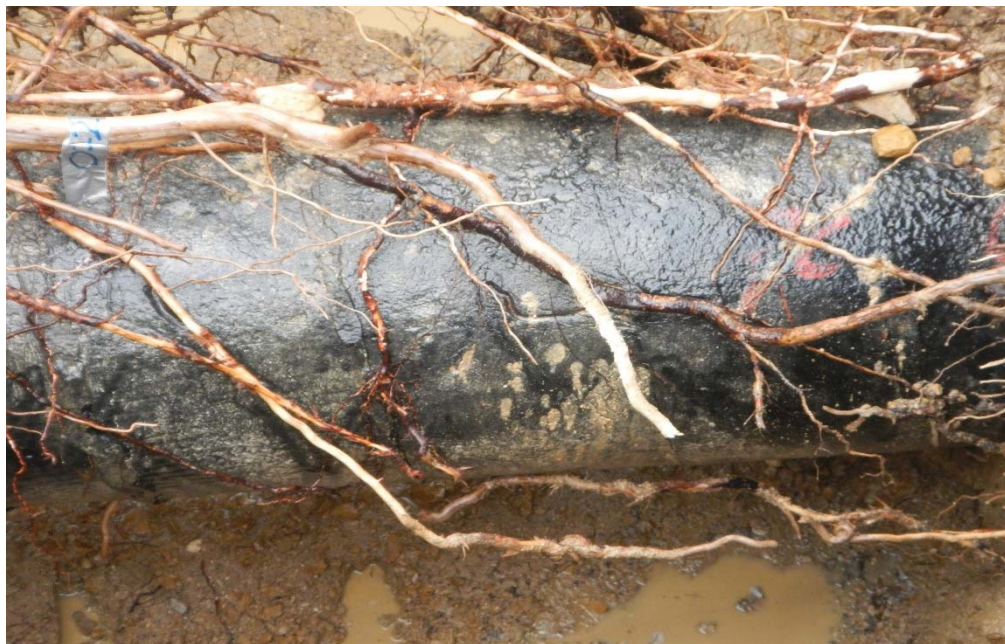
**Figure 4. RWVIM-74-13 (Atascadero)
(Tape coating damage)**

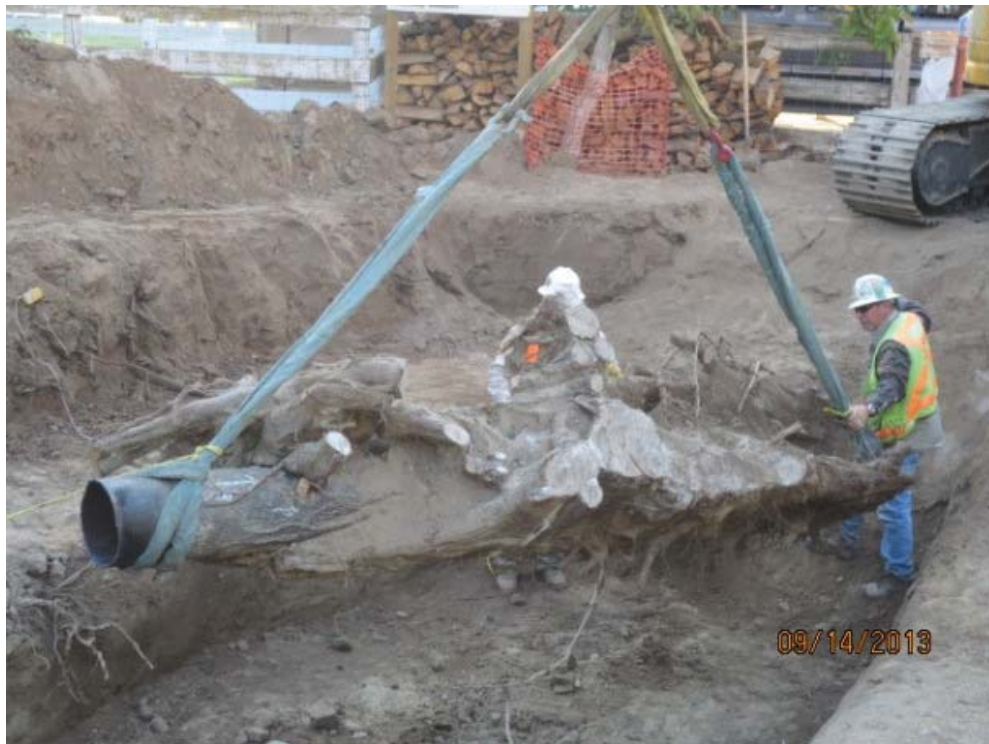
Figure 6. RWVIM-90-13 (Hall Road)

8. There is the potential for tree roots to structurally damage the pipeline, including inducing increased bending strains, if tree roots are uprooted by external forces. While this was not observed at any of the 53 sites, one site in particular (Hall Road) clearly demonstrated the significance of this potential threat. The root ball was located directly above the pipe and the pipeline was fully encapsulated by the Valley Oak tree roots. In a similar situation, if external forces and events (such as seismic, high winds) caused movement of the tree and tree roots, the forces created by such movement could damage the buried pipeline.

The Hall Road site provides evidence of what can occur when a tree root ball and root system is located in close proximity to a buried pipeline. A primary concern under these conditions is that weather (e.g., high force winds, flooding, seismic events) may cause tree and root movement, resulting in pipe damage. In addition, since the buried pipeline and tree root systems are interconnected, a lightning strike to the tree would most likely also impact the pipeline and provide an electrical path for the strike and may also provide a path for the electrical discharge.
