Pacific Gas and Electric Company

Tree Root Interference Assessment

February 19, 2014

Dynamic Risk Assessment Systems, Inc.

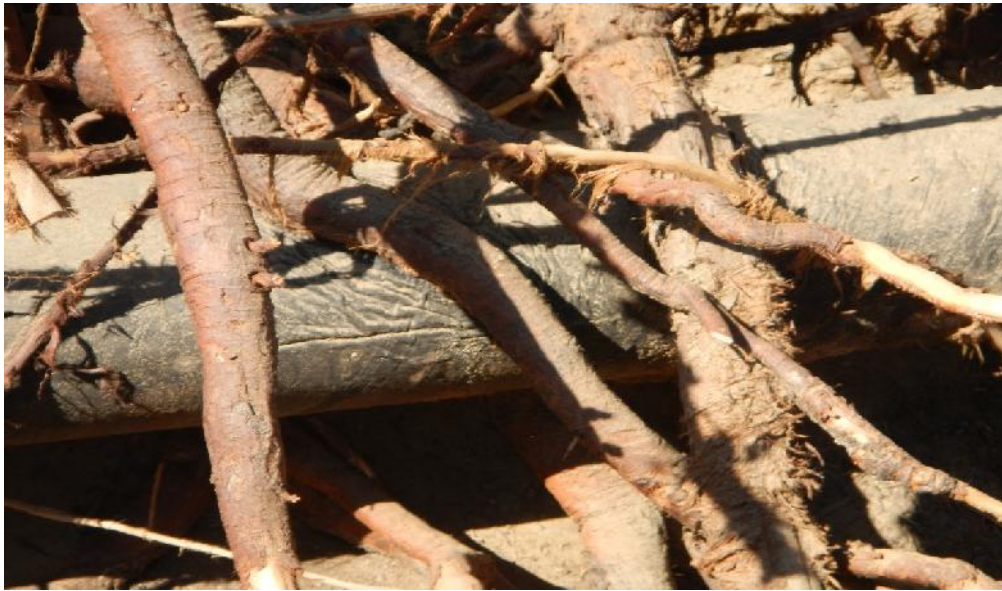
**Figure 3. RWVIM-107-13 (Weber Lane)
(CTE coating damage)**

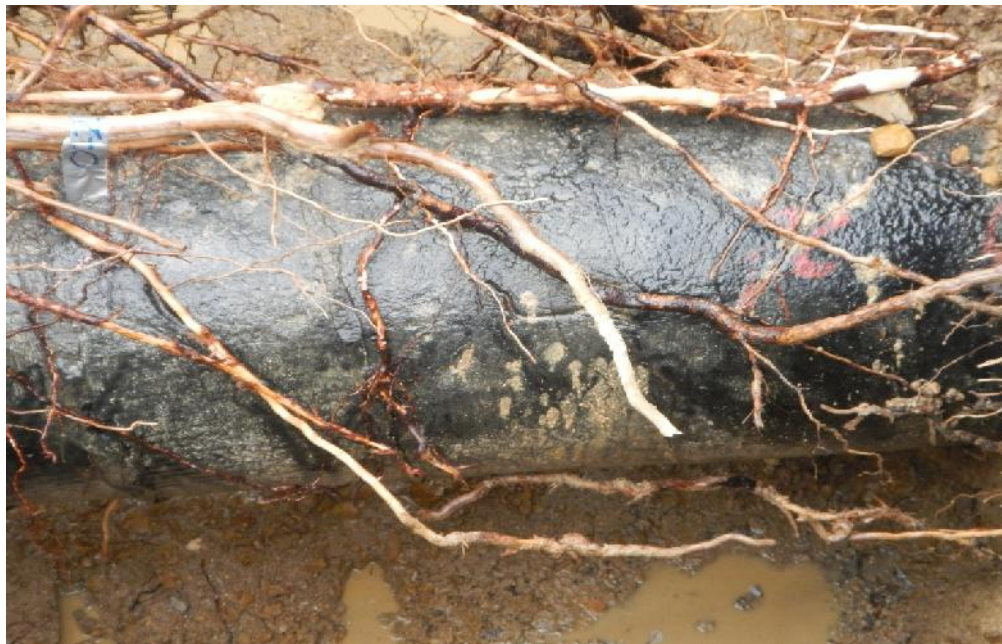
**Figure 4. RWVIM-74-13 (Atascadero)
(Tape coating damage)**

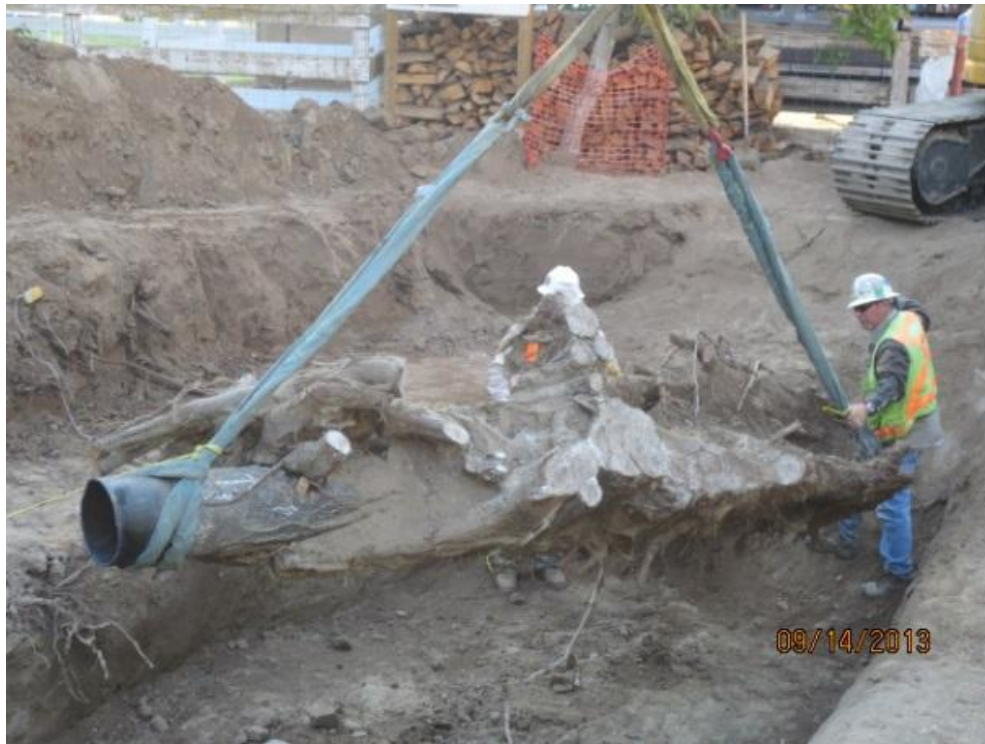
Figure 6. RWVIM-90-13 (Hall Road)

Tree root and pipeline interactive conditions were reviewed relative to the potential for pipeline structural damage. An example of one location where the tree root ball was situated directly on top of the pipe and the tree roots encapsulated the buried pipe is presented in Figure 6 (RWVIM-90-13, Hall Road).

The Hall Road site provides evidence of what can occur when a tree root ball and root system is located in close proximity to a buried pipeline. A primary concern under these conditions is that weather (e.g., high force winds, flooding, seismic events) may cause tree and root movement, resulting in pipe damage. In addition, since the buried pipeline and tree root systems are interconnected, a lightning strike to the tree would most likely also impact the pipeline and provide an electrical path for the strike and may also provide a path for the electrical discharge.
