FINAL REPORT
VOLUME I
R-PG&E-20150427

Pacific Gas and Electric Company

Tree Root Interference Assessment

April 27, 2015

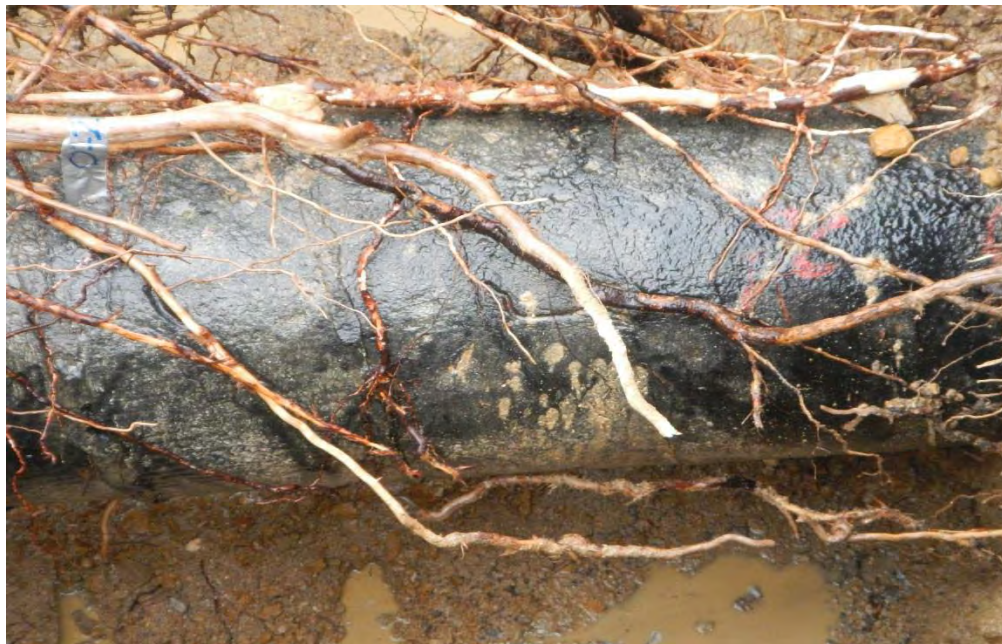
**Figure 3. RWVIM-107-13 (Weber Lane)
(CTE coating damage)**

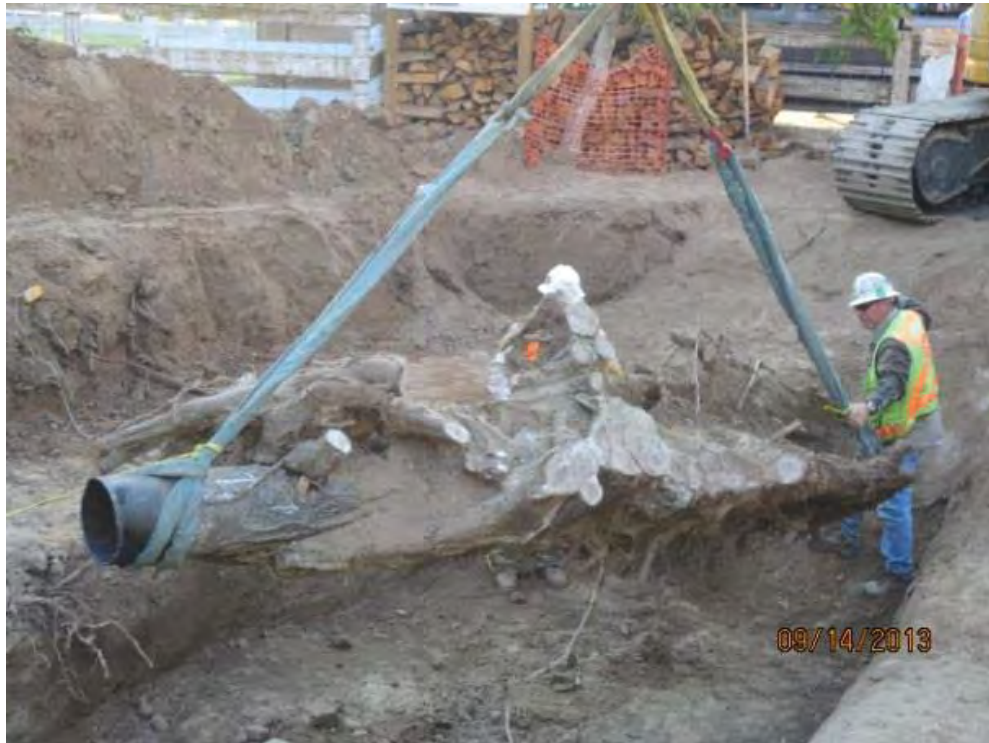
Figure 6. RWVIM-90-13 (Hall Road)

high force winds, flooding, seismic events) may cause tree and root movement, resulting in pipe damage. In addition, since the buried pipeline and tree root systems are interconnected, a lightning strike to the tree would most likely also impact the pipeline and provide an electrical path for the strike and may also provide a path for the electrical discharge.

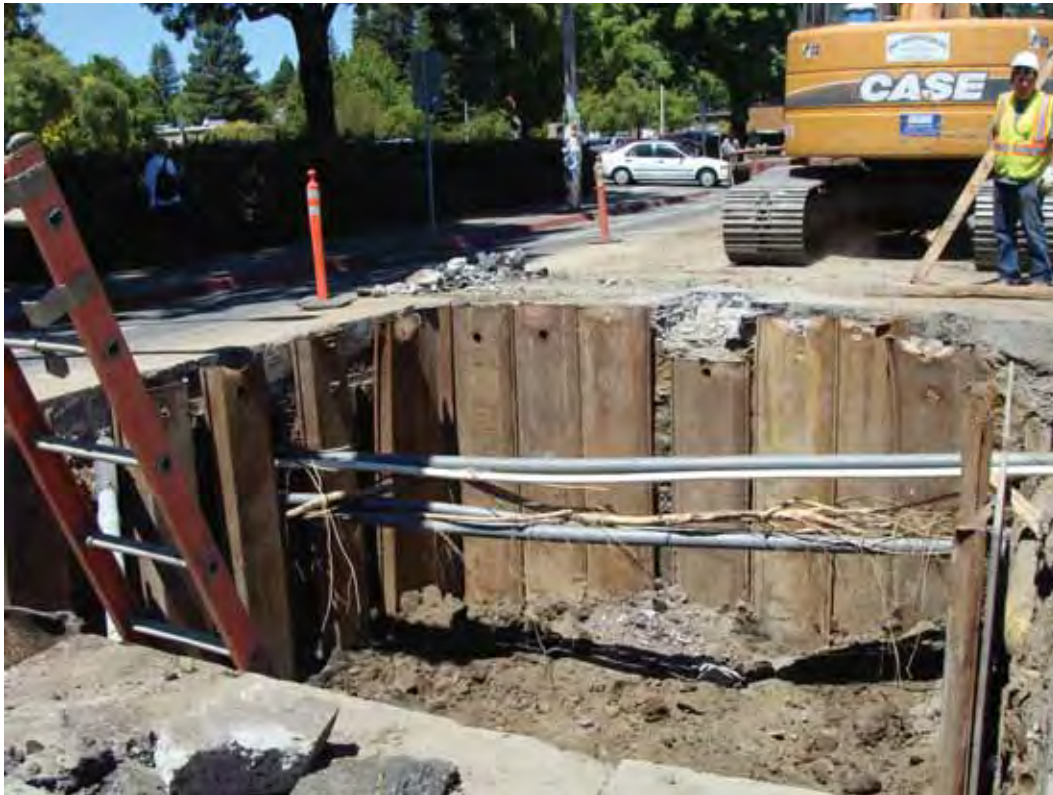
Figure 3. Tree roots can proliferate in utility trenches. Here, lateral roots of ash (*Fraxinus* sp.) have grown along buried utility lines. Photo by K. S. Jones.

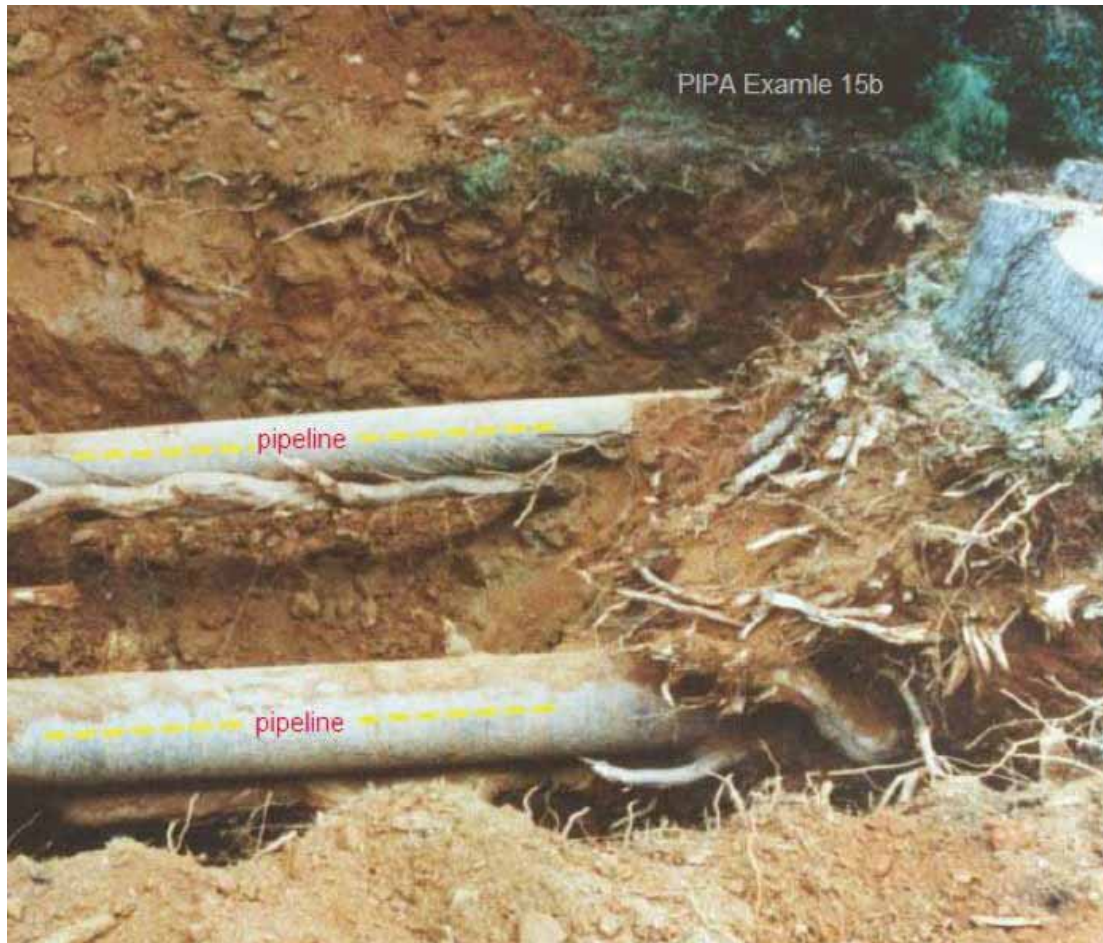
Figure 4. Roots in proximity to buried utility lines (note proximity of trunk to pipes). Pipe diameter is unknown, but appears to be approximately 6 inches. Photo from PIPA (2010).

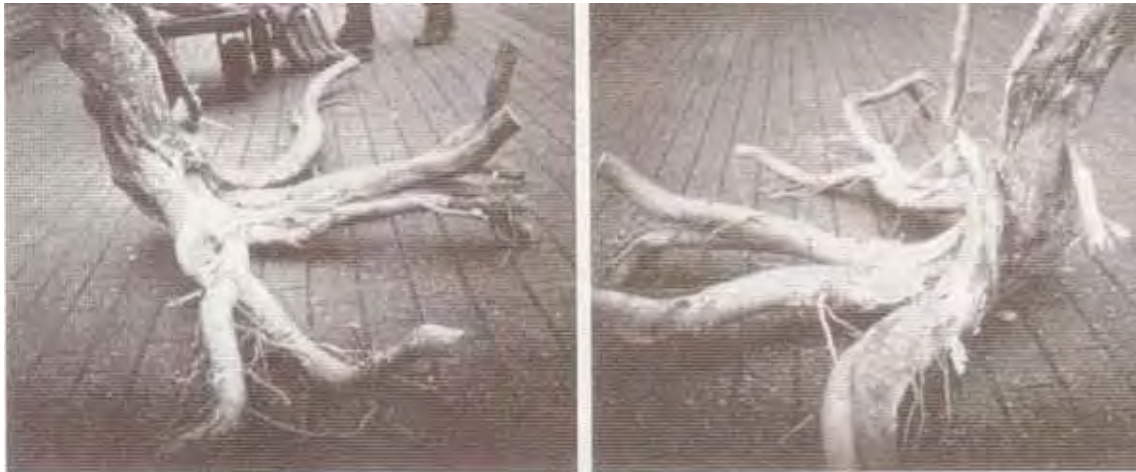
Figure 8. Lateral roots near the base of a tree formed a cradle under a gas pipeline in a situation similar to that depicted in Figure 7. Eventually, movement of the roots caused fatigue in the pipe, which failed at a faulty welded joint. From Mattheck and Breloer (1994), used with permission.

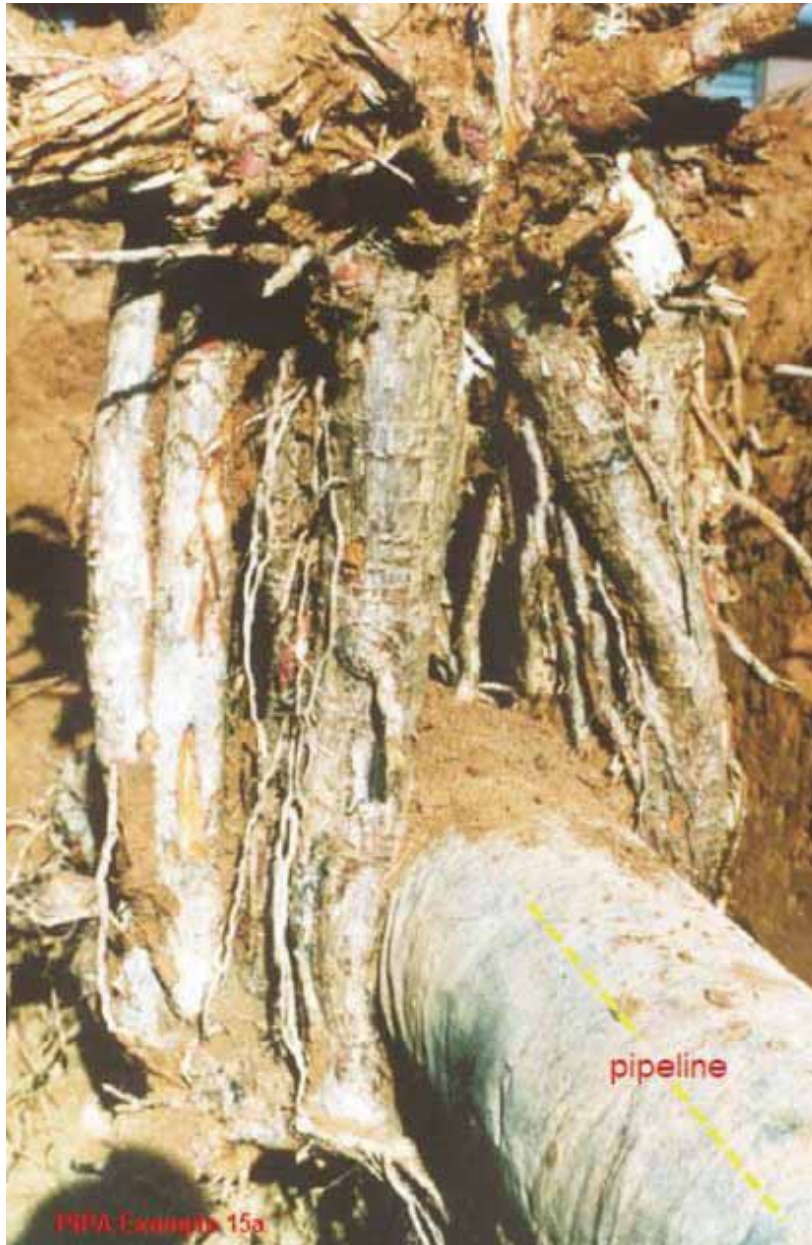
Figure 10. Oblique roots of a tree planted in proximity to a buried pipeline have come in contact with the pipe coating, causing damage. Photo from PIPA (2010).

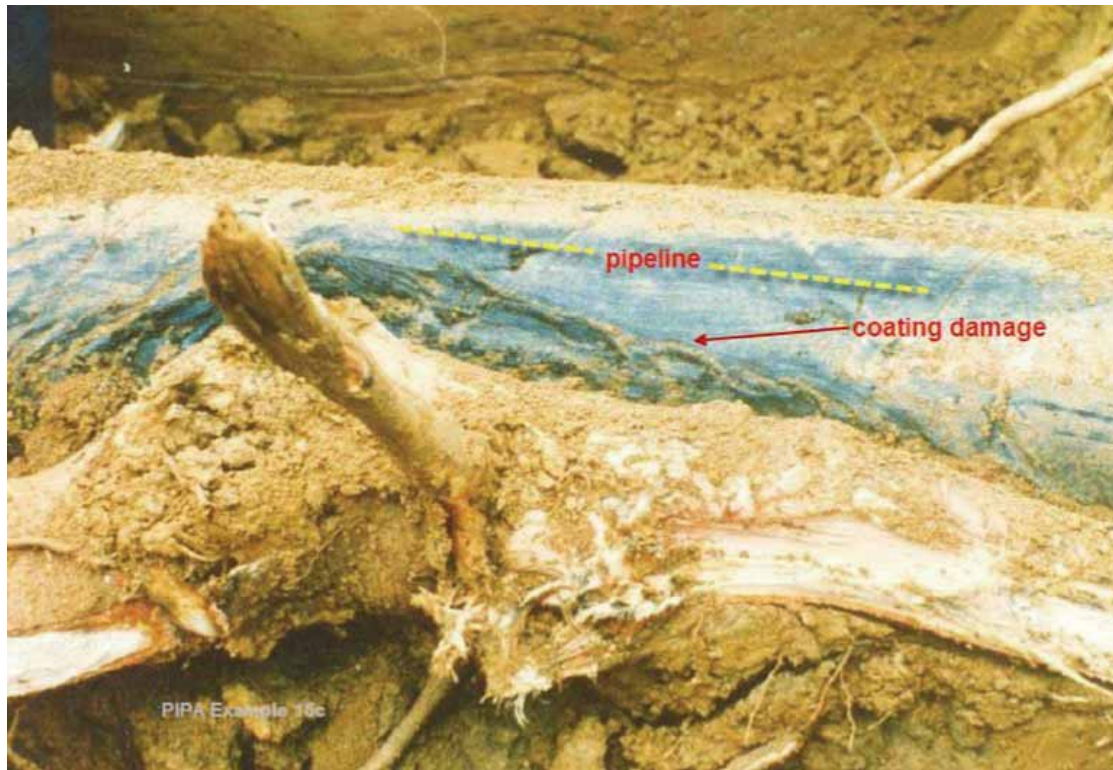
Figure 11. A lateral root growing along a buried pipeline caused damage to the pipe's coating. Photo from PIPA (2010).

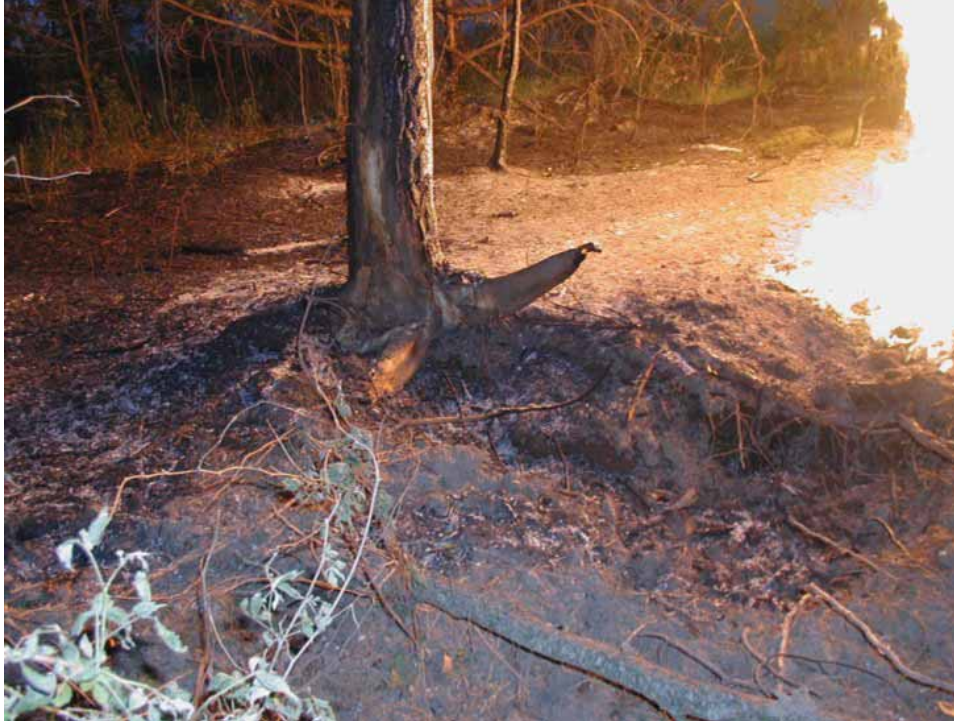
Figure 12. A tree growing close to a buried pipeline was struck by lightning. The electric current passed through the roots to the wet soil, causing soil moisture to vaporize. The resulting rapid expansion of the soil created a crater and damaged the pipe. Photo from PIPA (2010).

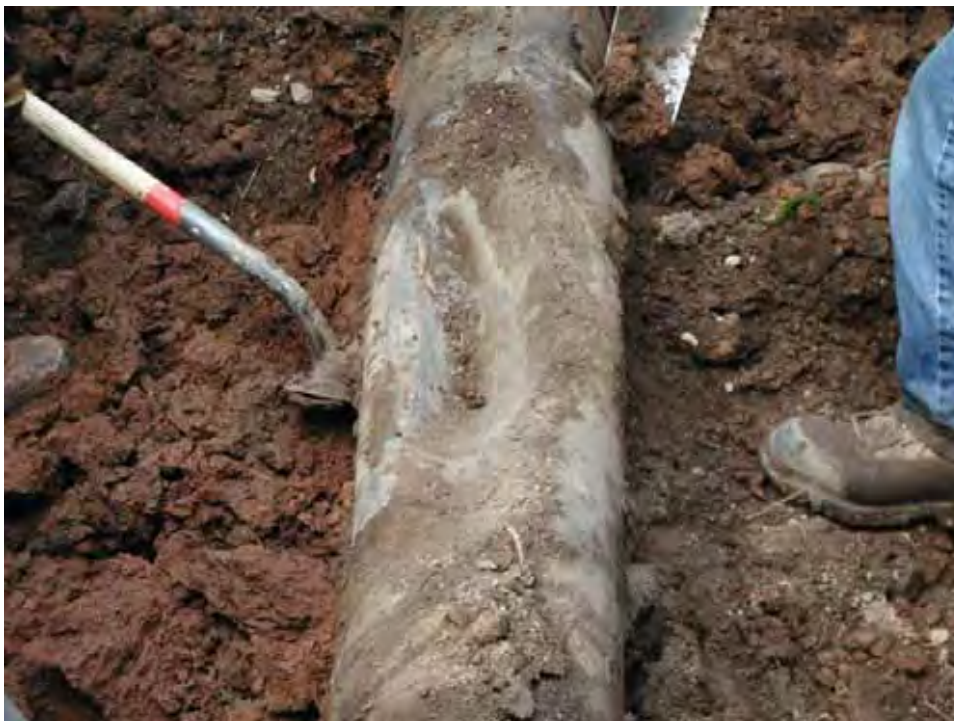
Figure 13. Apparently, the top of this pipe was dented by the explosive expansion of soil after a tree was struck by lightning, as described in Figure 12. Photo from PIPA (2010).

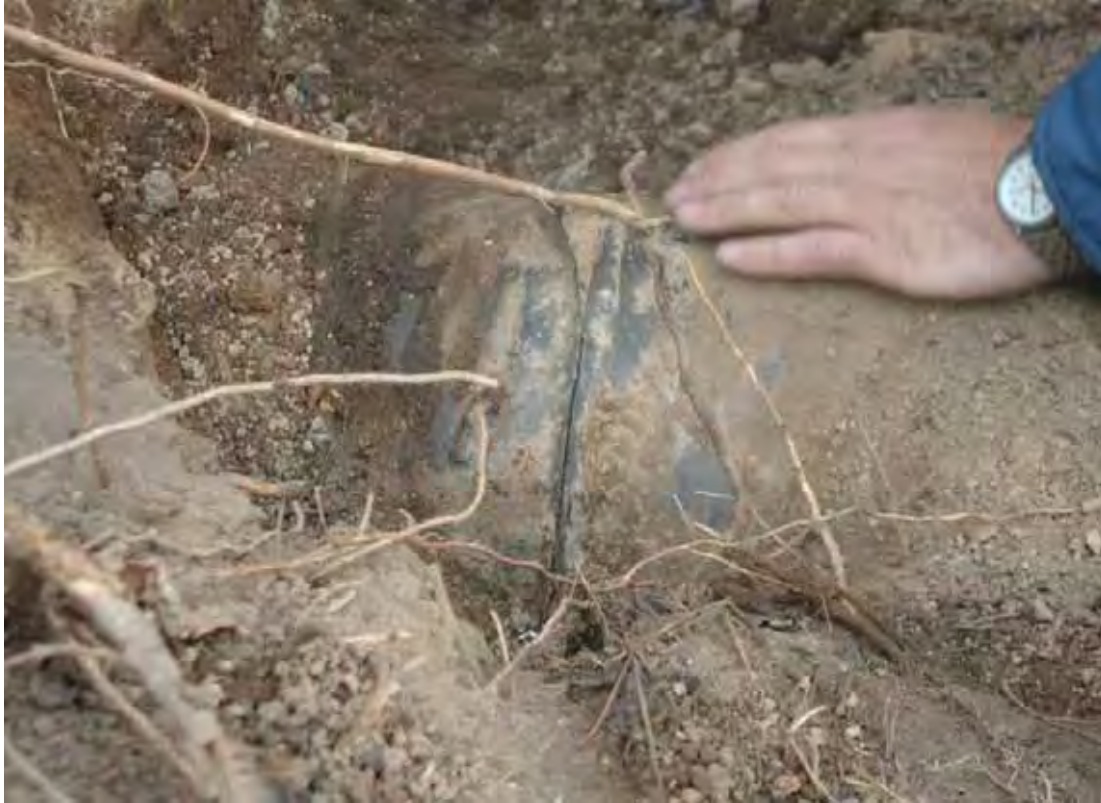
Figure 14. Tension in the pipeline caused by the lightning strike described in Figure 13 resulted in the formation of a crack in a girth weld in the pipe. Photo from PIPA (2010).

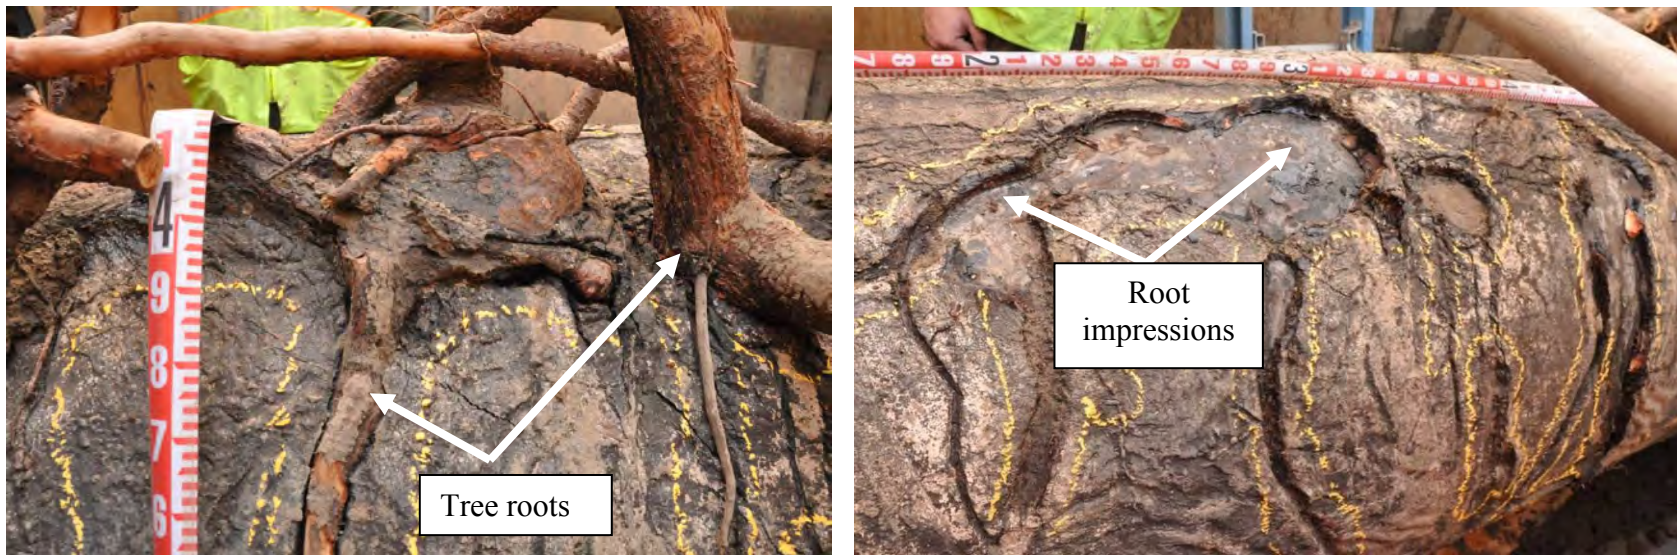
Figure 1. Photographs showing the interaction of tree roots with the pipe section from Dig RWVIM-153 - 4, which was coated with hot applied asphalt: Tree roots in contact with pipe (Left) and coating damage after tree roots were removed (Right).

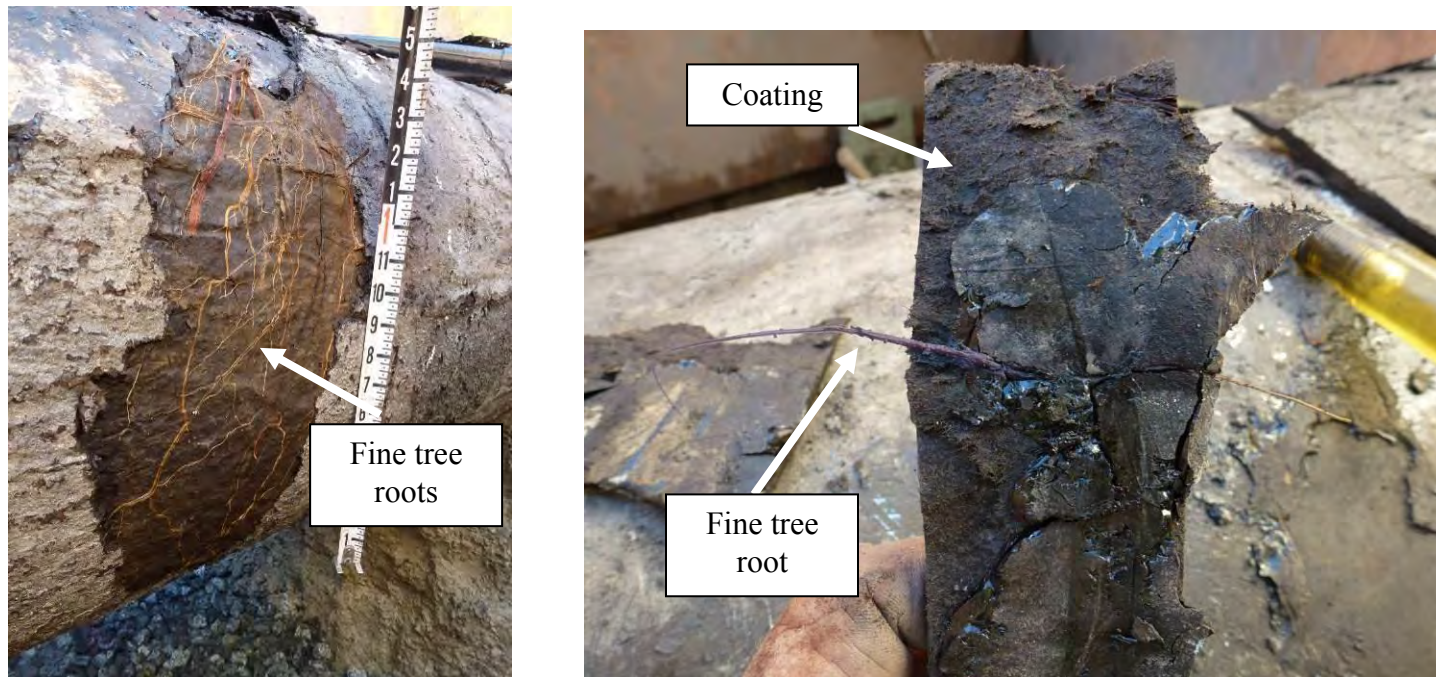
Figure 2. Photographs showing fine roots beneath the hot applied asphalt coating for the pipe section associated with Dig RWVIM 132 -8.

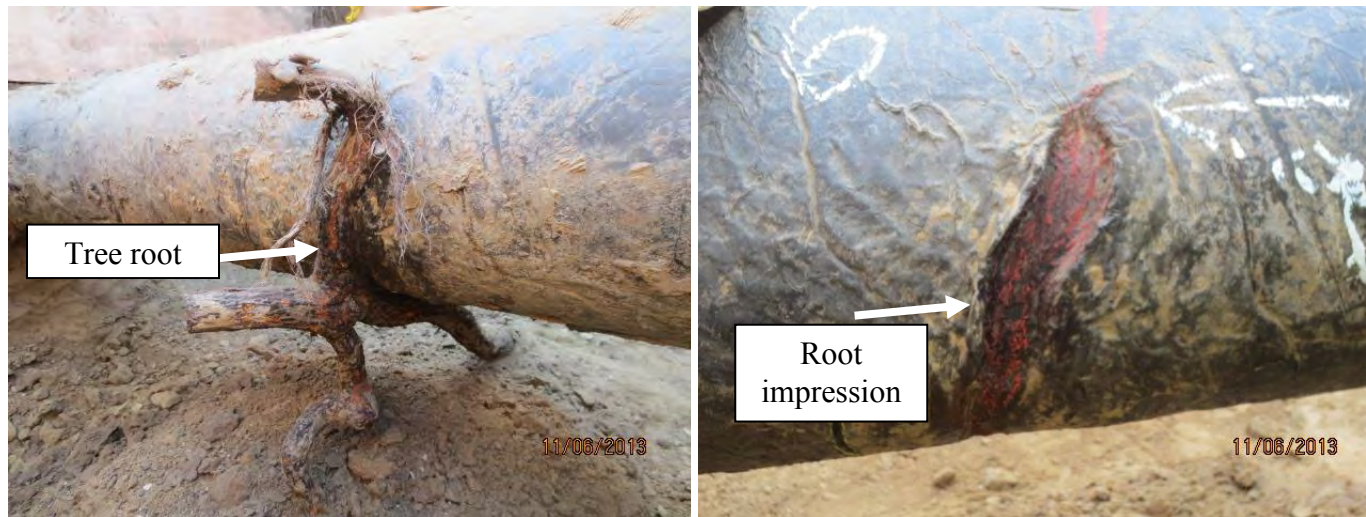
Figure 3. Photographs showing the interaction of a tree root with the pipe section from Dig RWVIM-259-13, which was coated with hot applied asphalt: Tree root in contact with pipe (Left) and coating damage after the tree root was removed (Right).

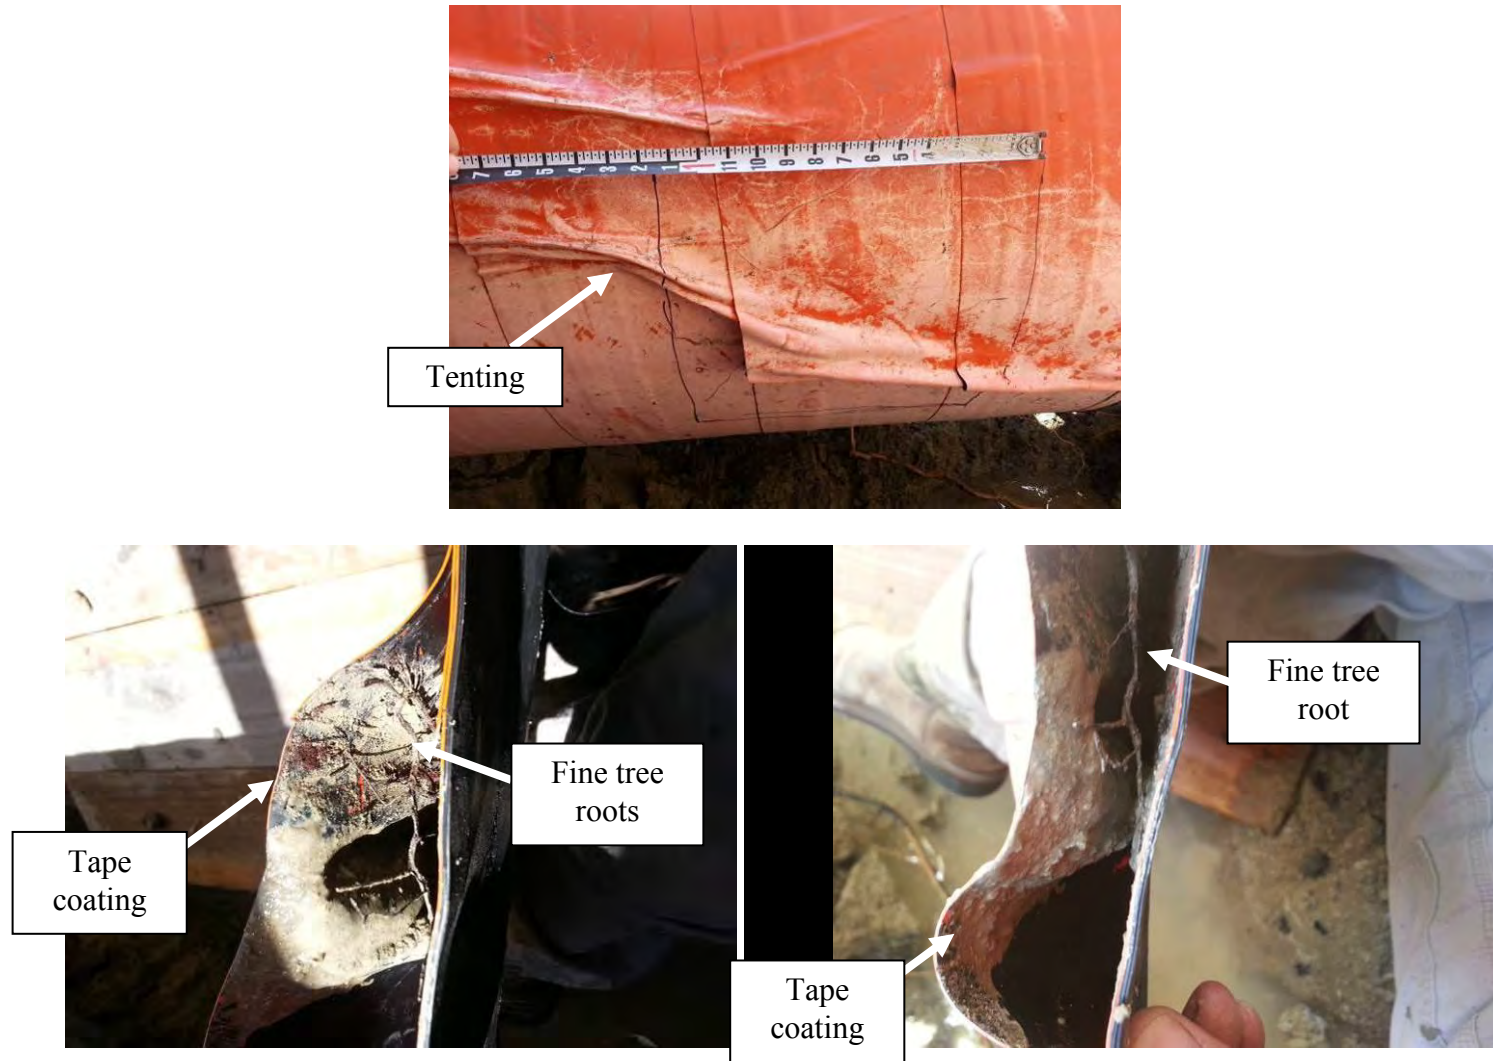
Figure 5. Photographs showing coating damage observed on pipe sections coated with tape.

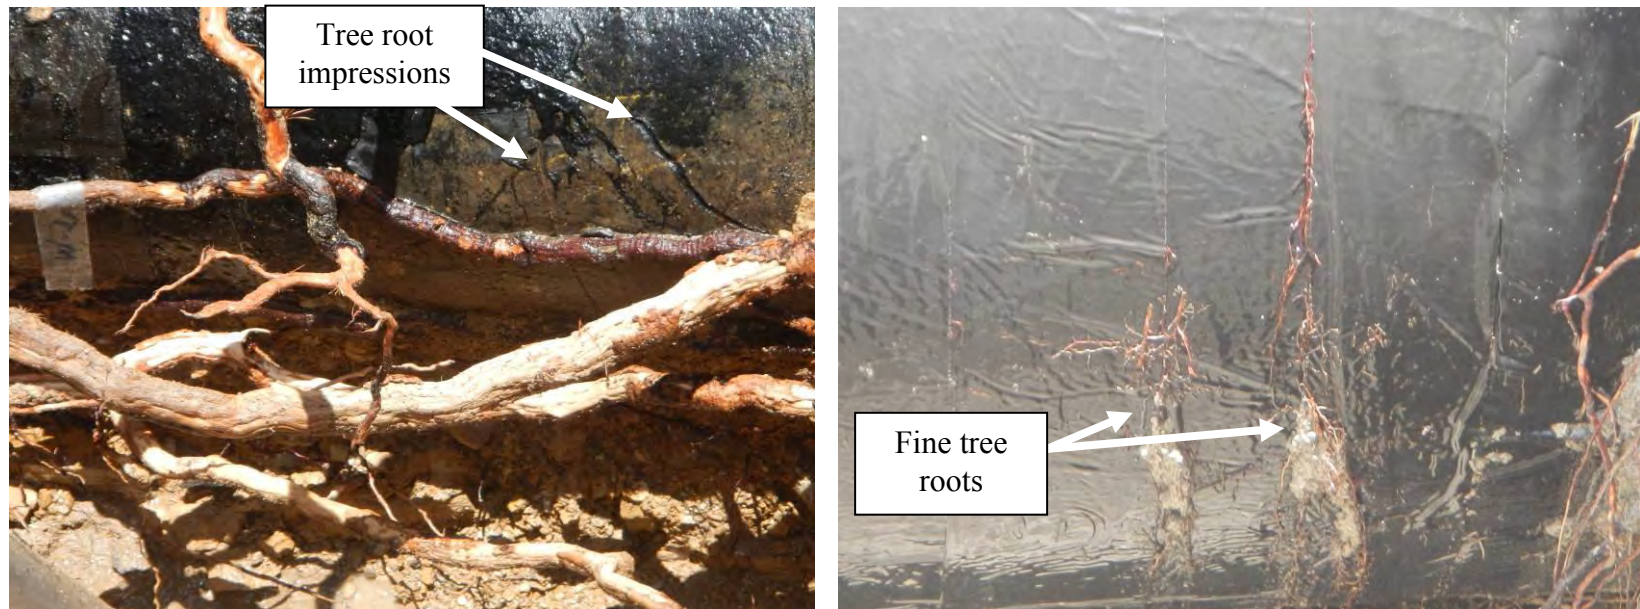
Figure 6. Photographs showing coating damage observed on pipe sections coated with tape.

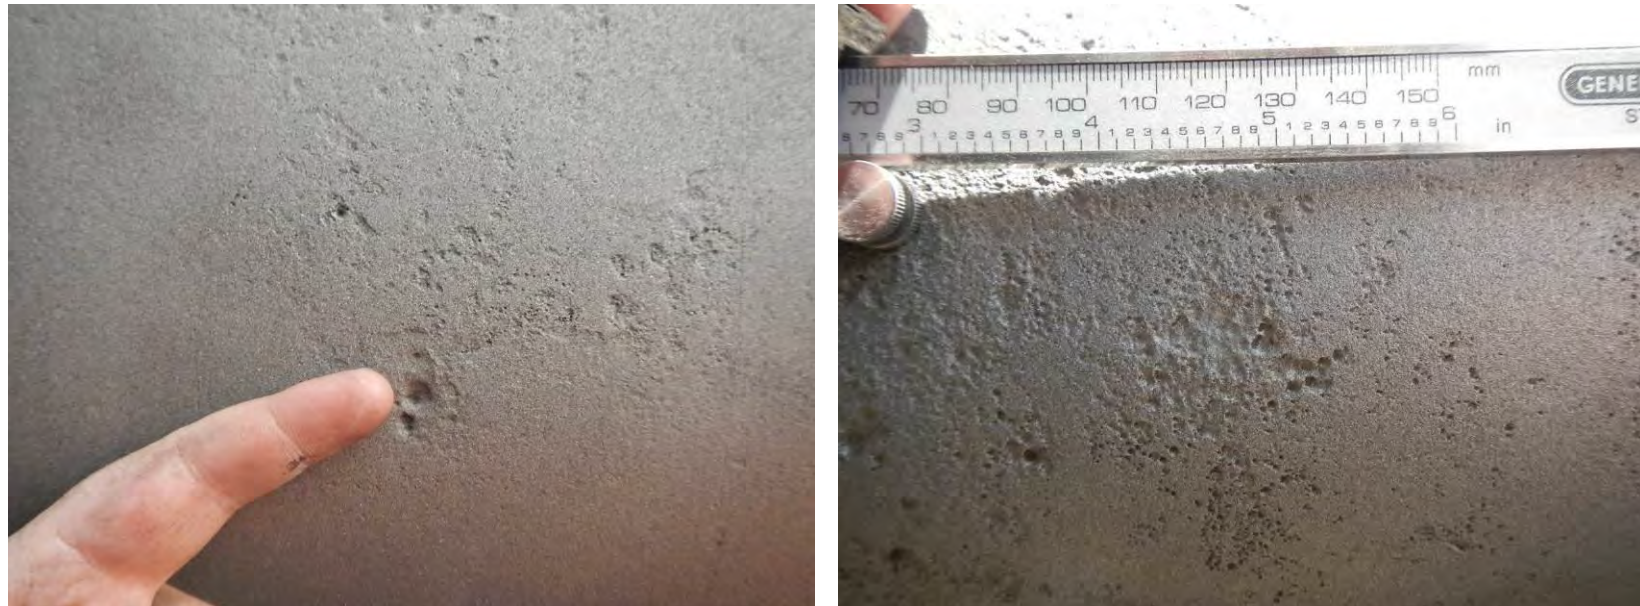
Figure 7. Representative photographs showing external corrosion on pipe segments.

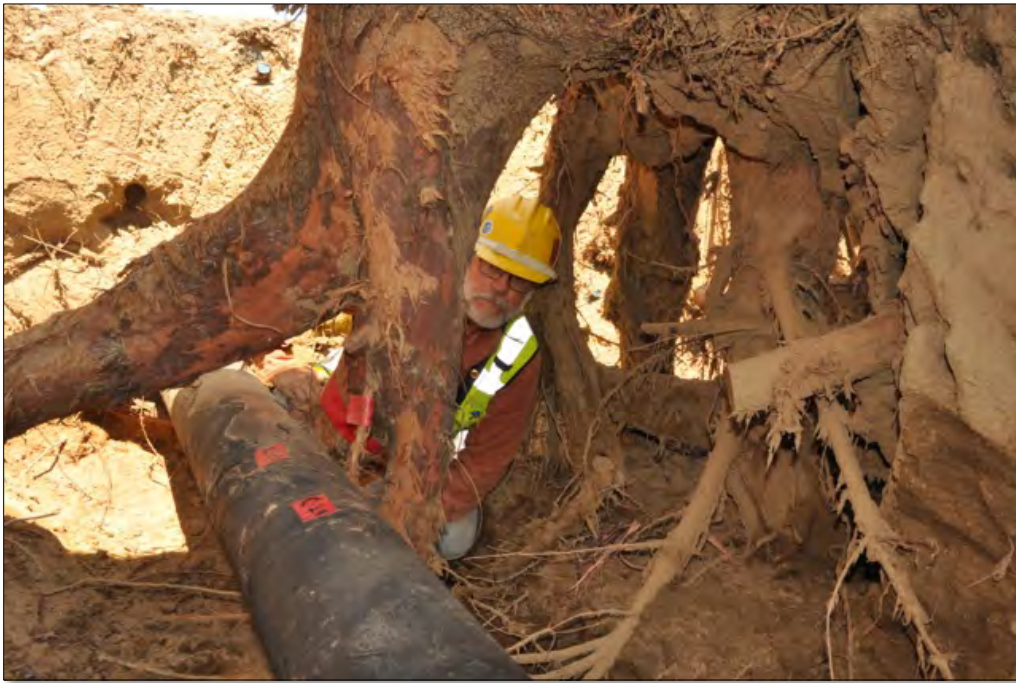
Figure 14. Eucalyptus root system in un-irrigated soils at dig site RWVIM-126-13

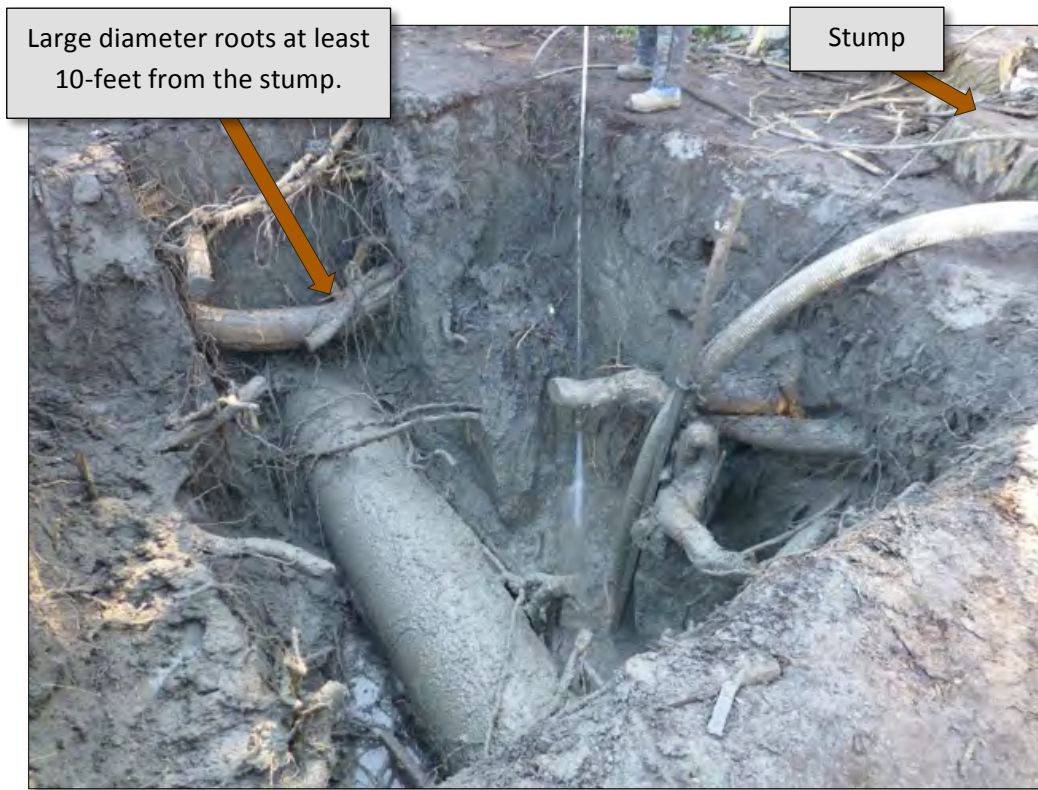
Figure 17. Dig site RWVC-51-13 (RWVIM-104-13)

Two species growing in un-irrigated, deep clay soils, were observed to contact pipe coatings at great distances from the trees (Figures 17 and 18).

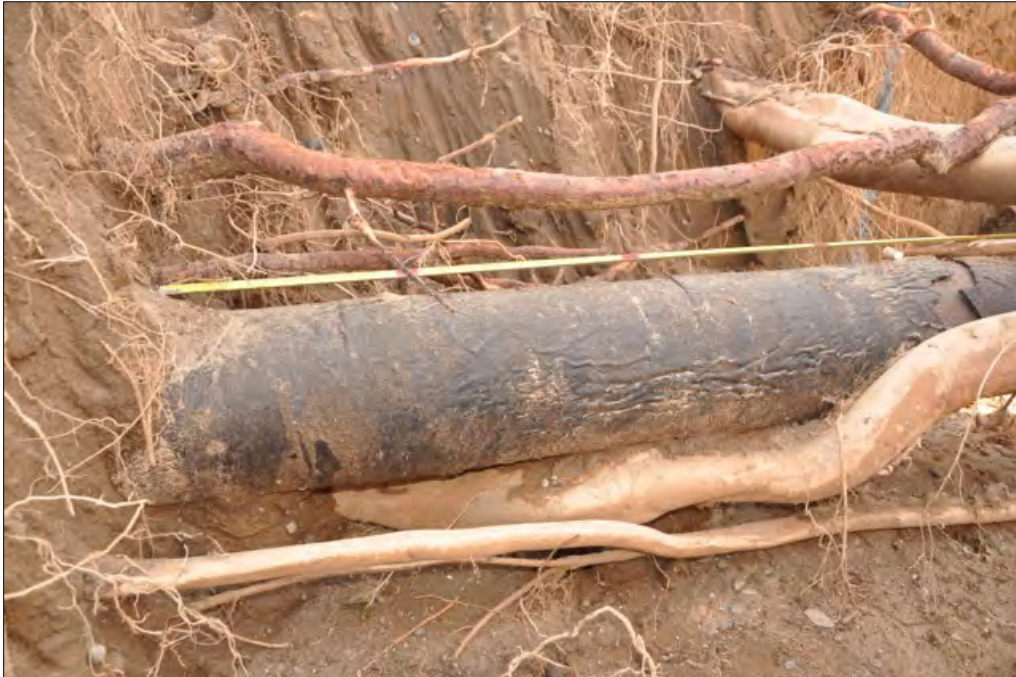
Figure 21. Dig site RWVIM-106-13.

At several dig sites, roots growing from various directions, came into contact with the pipe then turned and maintained contact with the pipe for great distances. At two dig sites the pit was enlarged in order to follow the roots in contact: Eucalyptus (RWVIM-126-13) roots were found to grow at least 15 feet along the pipe and Hackberry (RWVIM-106-13) roots were found to grow at least 16 feet along the pipe. In both cases, the roots were parallel to and in contact with the pipe as they exited the extended pit wall. It was not determined how far these roots stayed in contact with the pipe (Figure 21).

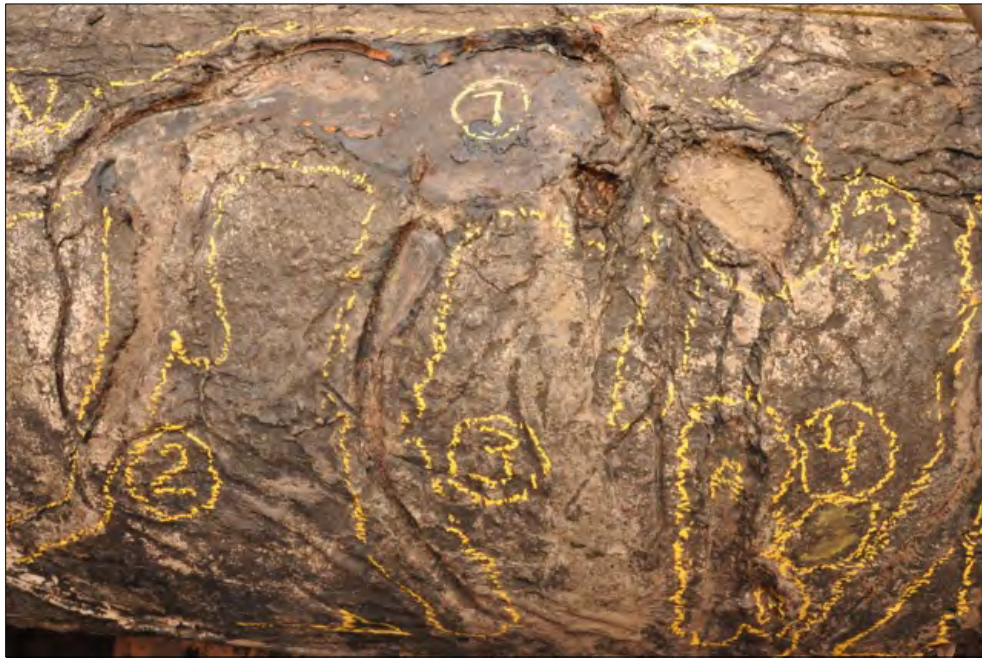
2) 'Holiday' is a hole or gap in the coating that exposes the metal surface of the pipe. For the purposes of this report, only root-caused holidays are discussed. Many pipe sections excavated in the root study had other holidays that could not be positively identified as root-caused and therefore were not measured during our investigation (Figure 25).

Figure 25. Holidays at dig site 153-4.

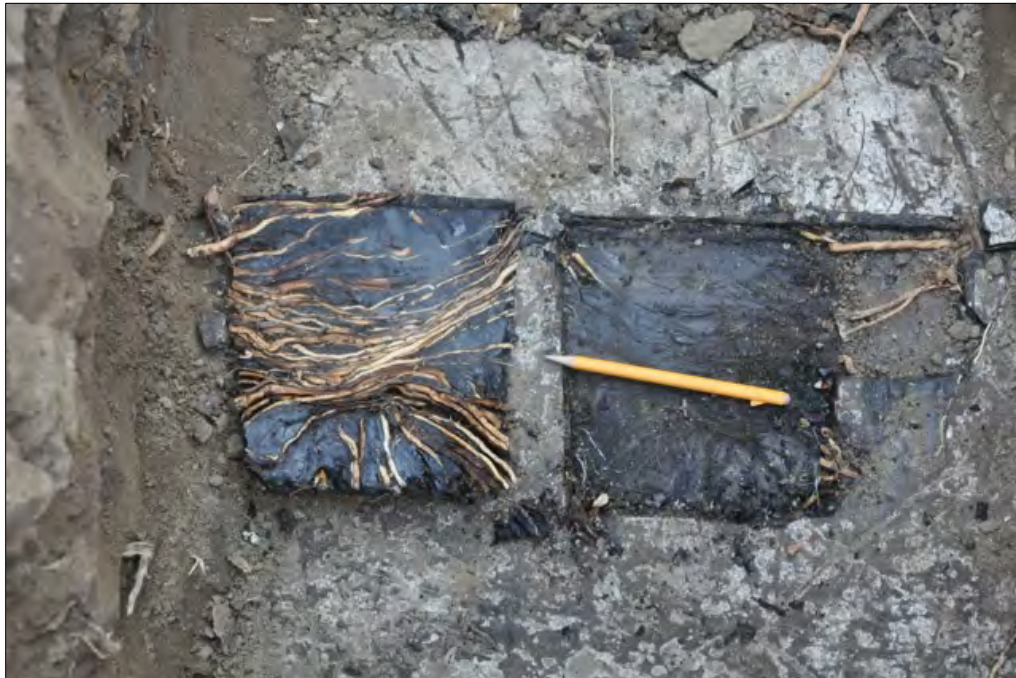
The only palm tree (RWVC-44-13/RWVIM-100-13), a Date palm, in the root study had more contact with the pipe coating than any other tree, even at great distances and depths. This was evident in all three of the small excavation pits on this site. The non-woody palm roots grew into and through the coating and on the pipe. The roots were unlike any other tree in the root study in that they did not impress or displace the coating. At the time, it was not possible to quantify our observations. Palm trees are sometimes planted in rows of multiple trees. If a condition exists where a row of palms is located near the pipeline, significant root-pipe interactions are possible (Figure 30).

Figure 30. At dig site RWVC-44-13 (RWVIM-100-13) (Palm tree) a 6-inch square sample of coating was removed.
