**FINAL REPORT
VOLUME II
R-PGE-20150427**

Pacific Gas and Electric Company

**Tree Root Interference Assessment
Attachments**

April 27, 2015

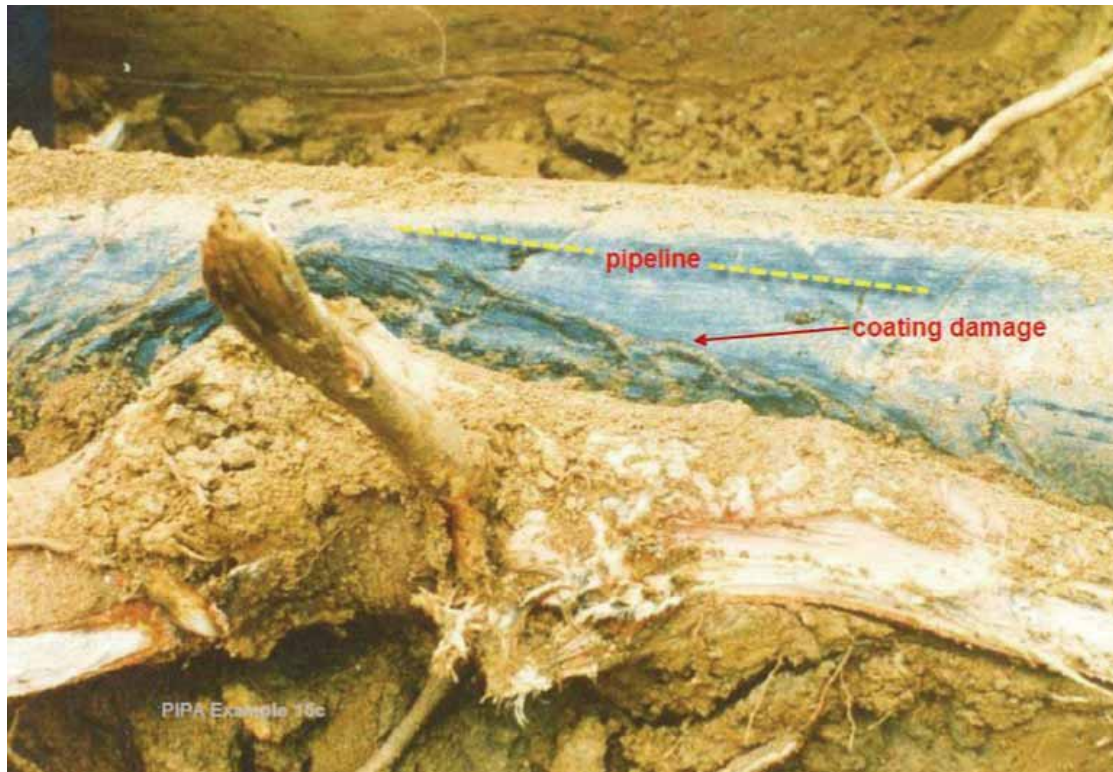
Figure 11. A lateral root growing along a buried pipeline caused damage to the pipe's coating. Photo from PIPA (2010).

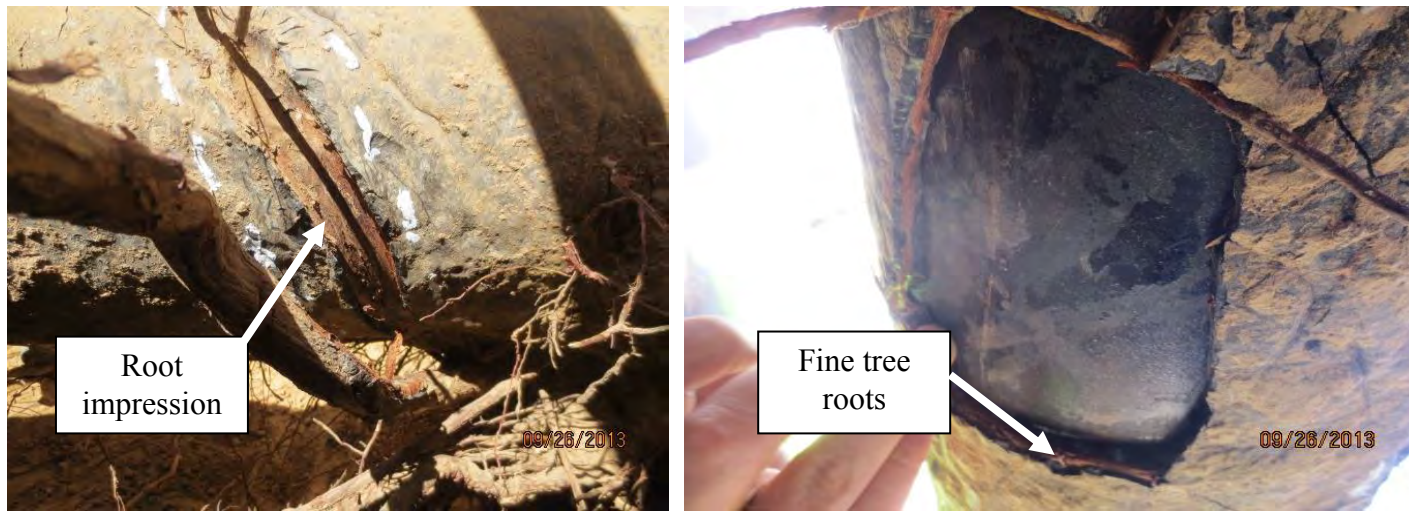
Figure 4. Photographs from Dig RWVIM 76-13 showing: A root impression in the coal tar enamel coating (Left) and disbonded coating with root intrusions (Right).

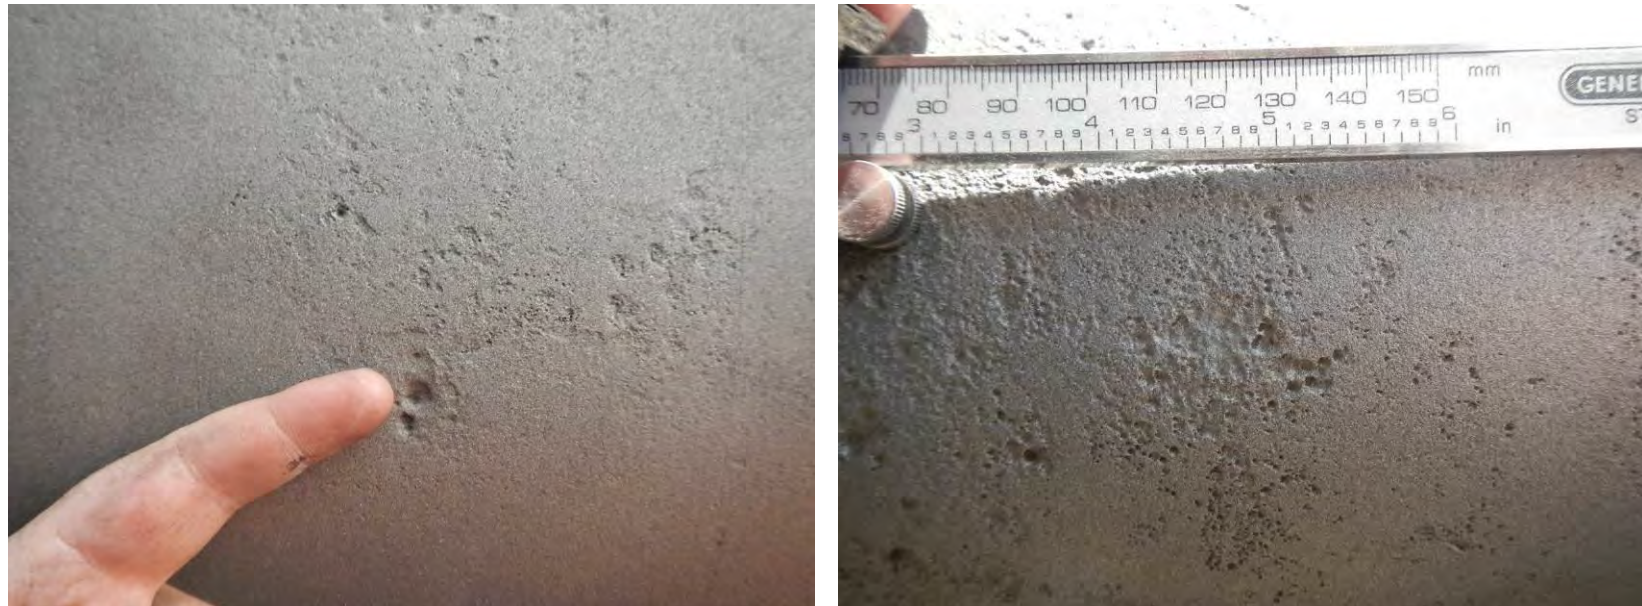
Figure 7. Representative photographs showing external corrosion on pipe segments.

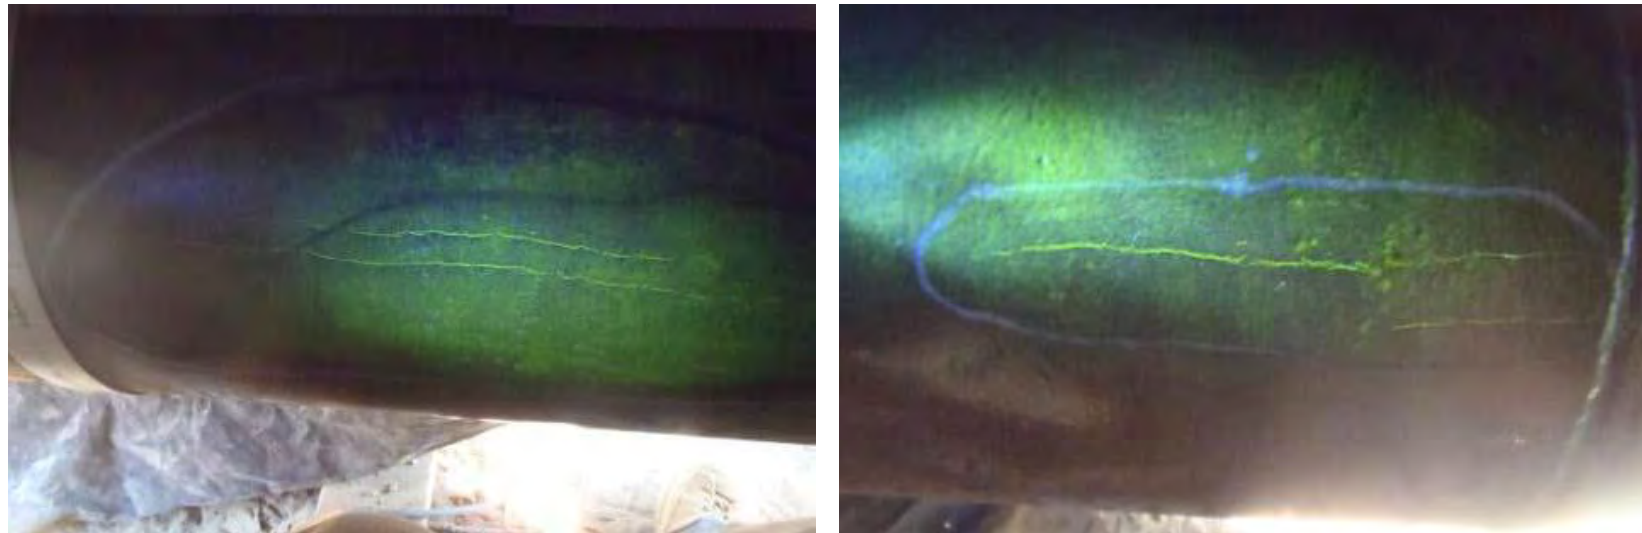
Figure 8. Photographs, provided from Dig RWVIM 89-13, showing representative linear indications identified using wet fluorescent magnetic particle inspection.

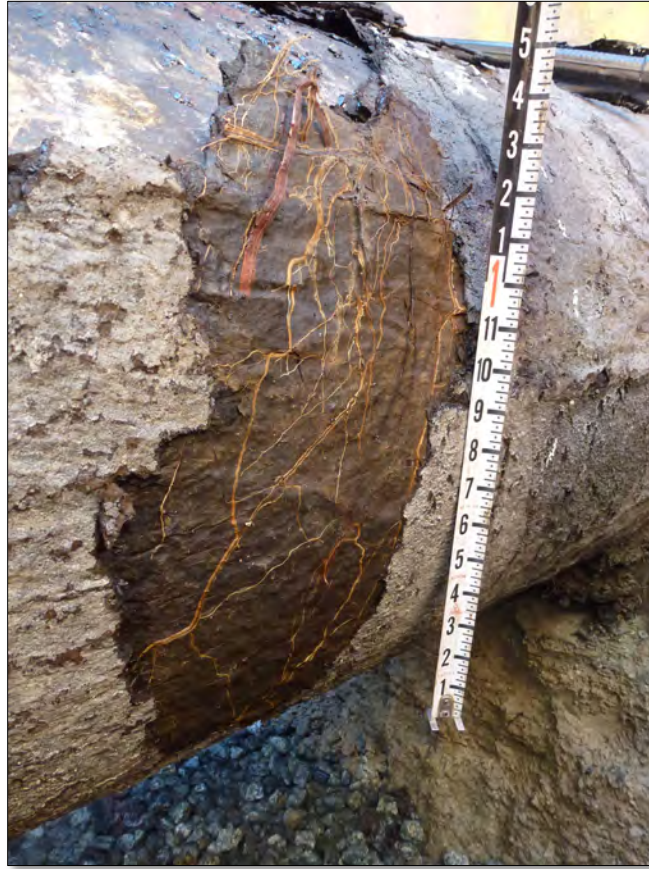
Fine roots, for the purpose of this root study, are less than 0.1-inch in diameter. It was observed that fine roots interacted with the pipe coatings at most of the 53 dig sites. Of the 53 dig sites, 38 digs (72%) had observable fine root interactions with pipe coatings; 8 digs had no observable fine roots associated with the pipe/coating; 3 digs involved dead trees where fine roots may have rotted away, and 1 dig had inconclusive results. It should be noted that the excavation process, including hydro-vac, can destroy small roots. Fine root interaction with coatings was not restricted to pipes with shallow cover depths. Fine roots were present on pipes in excess of 8-feet.

Figure 11. Dig site 132-8 fine roots are growing between the layers of the HAA coating.

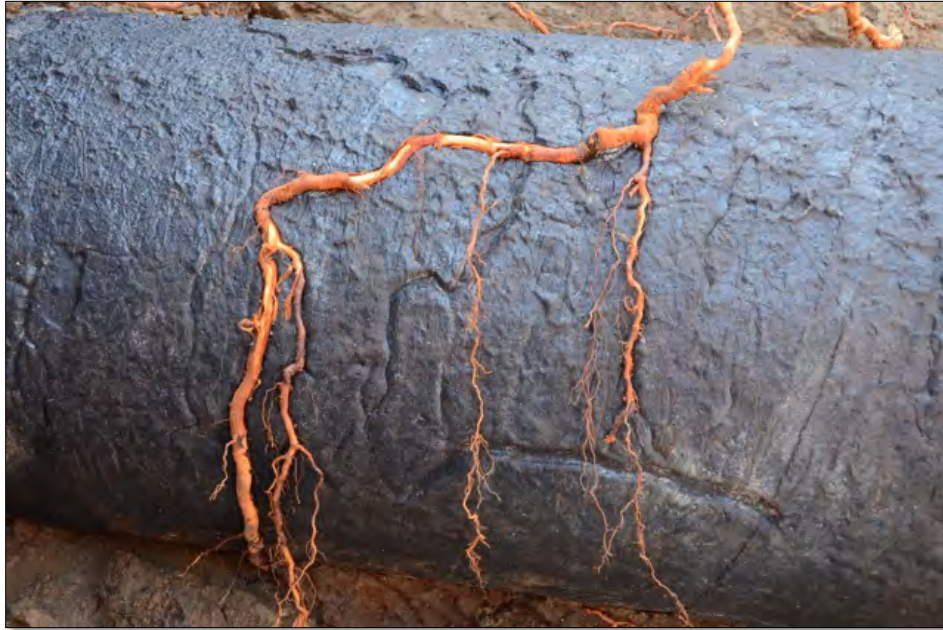
1) 'Coating Impression' is coating that has had its surface deformed by pressure from a root. Most commonly, coating impressions were discovered in this investigation by removing roots in contact with the pipe coating. Occasionally impressions were observed with no associated root present because (a) the root had died and decayed leaving no trace of the root that caused the impression or (b) the root was dislodged by the excavation process (Figure 24).

Figure 24. At dig site RWVIM-165-13 some impressions still had roots imbedded while other impressions were vacant.
