Tree Assessment

3666-3682 Mt. Diablo Boulevard
Lafayette, California

Prepared by:
Samuel Oakley
ISA Certified Arborist WE-9474A

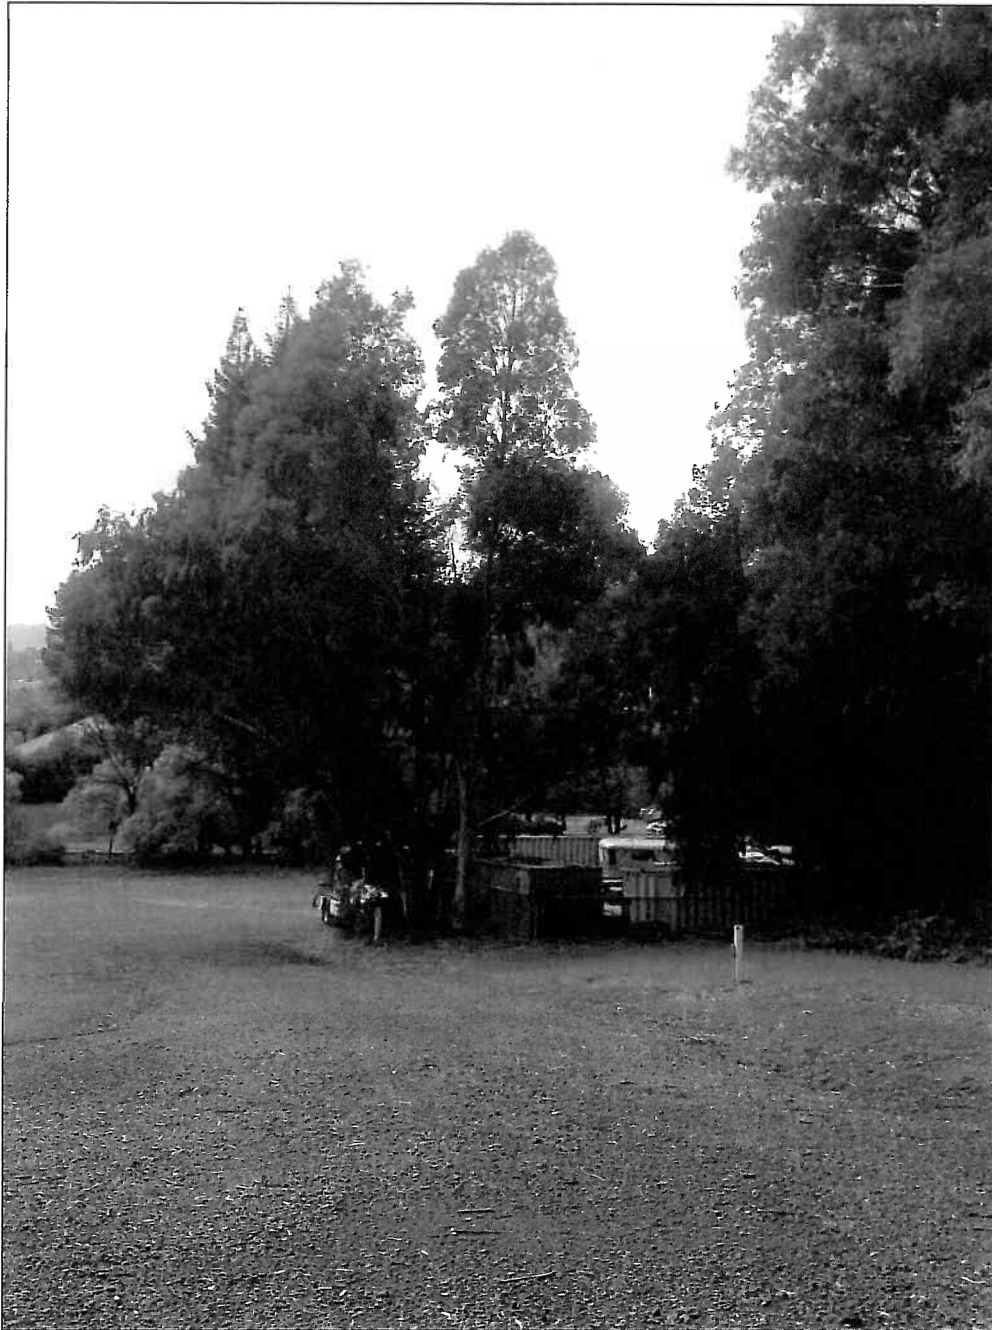
Figure 3: an image of Trees 21 through 26 toward the north-side of the property.

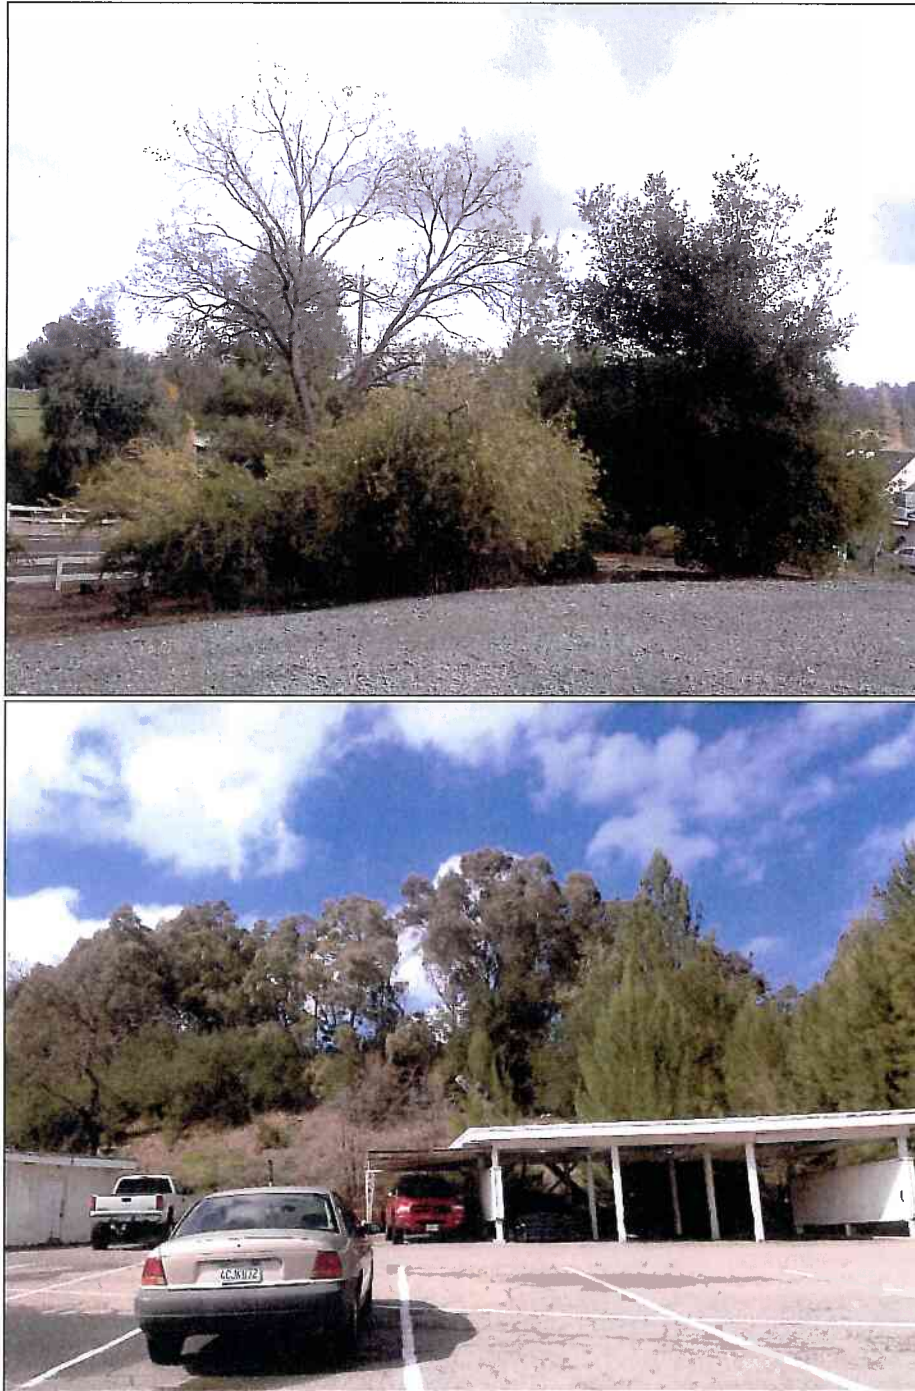
- f. Trees #41, #42, and #43 are located along Mt. Diablo Boulevard and are causing damage to the sidewalk and adjacent hardscape.
- g. Trees #1 through #14, #53, #54, and #55, as well as the small diameter vegetation located along the hillside contiguous with these trees, provide erosional/geological stability to the hillside on which they are growing.

Figure 4: images of the wooded hillside on northeast-side of the property. Top image is of Trees 27 through 32, while the bottom image is of Trees 1 through 12.

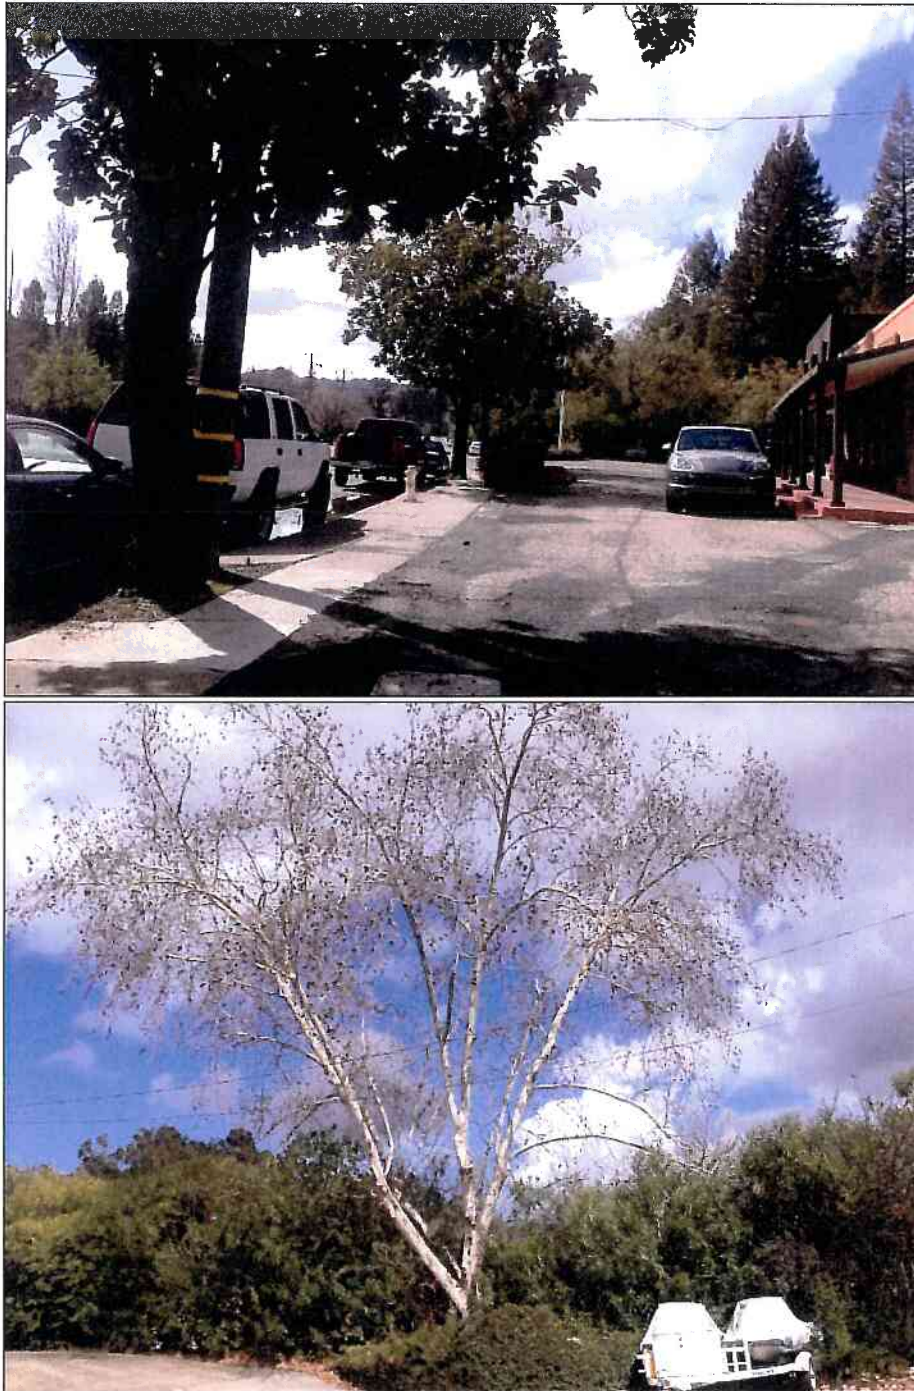
Figure 5: Street Trees 41, 42, and 43 along Mt. Diablo Boulevard (top image), and Tree 40, a candidate for transplanting (bottom image).

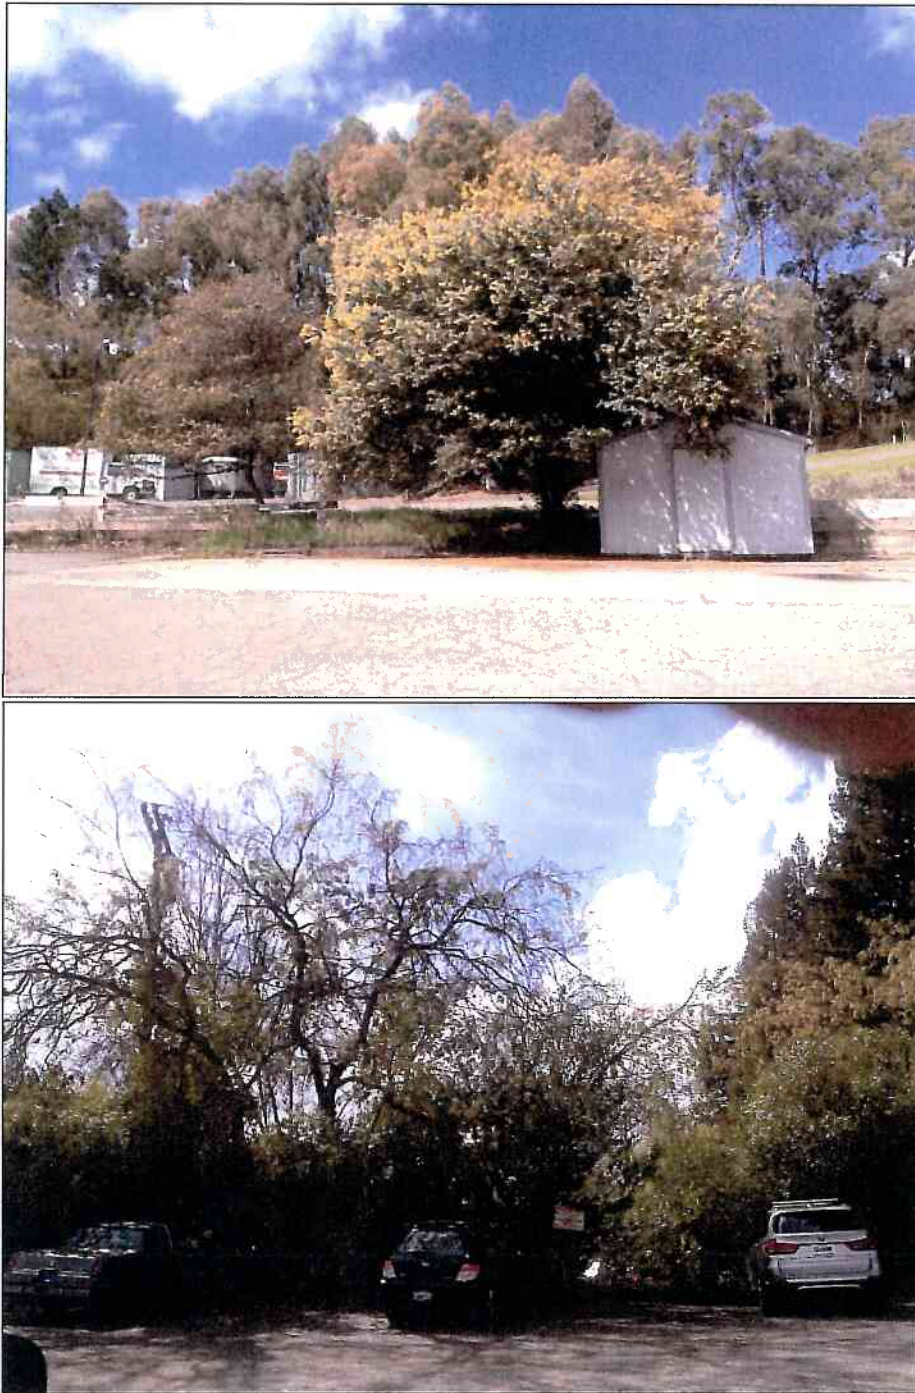
Figure 6: an image of Trees 15, 16, and 17 (top image), and Trees 44, and 45 (bottom image).

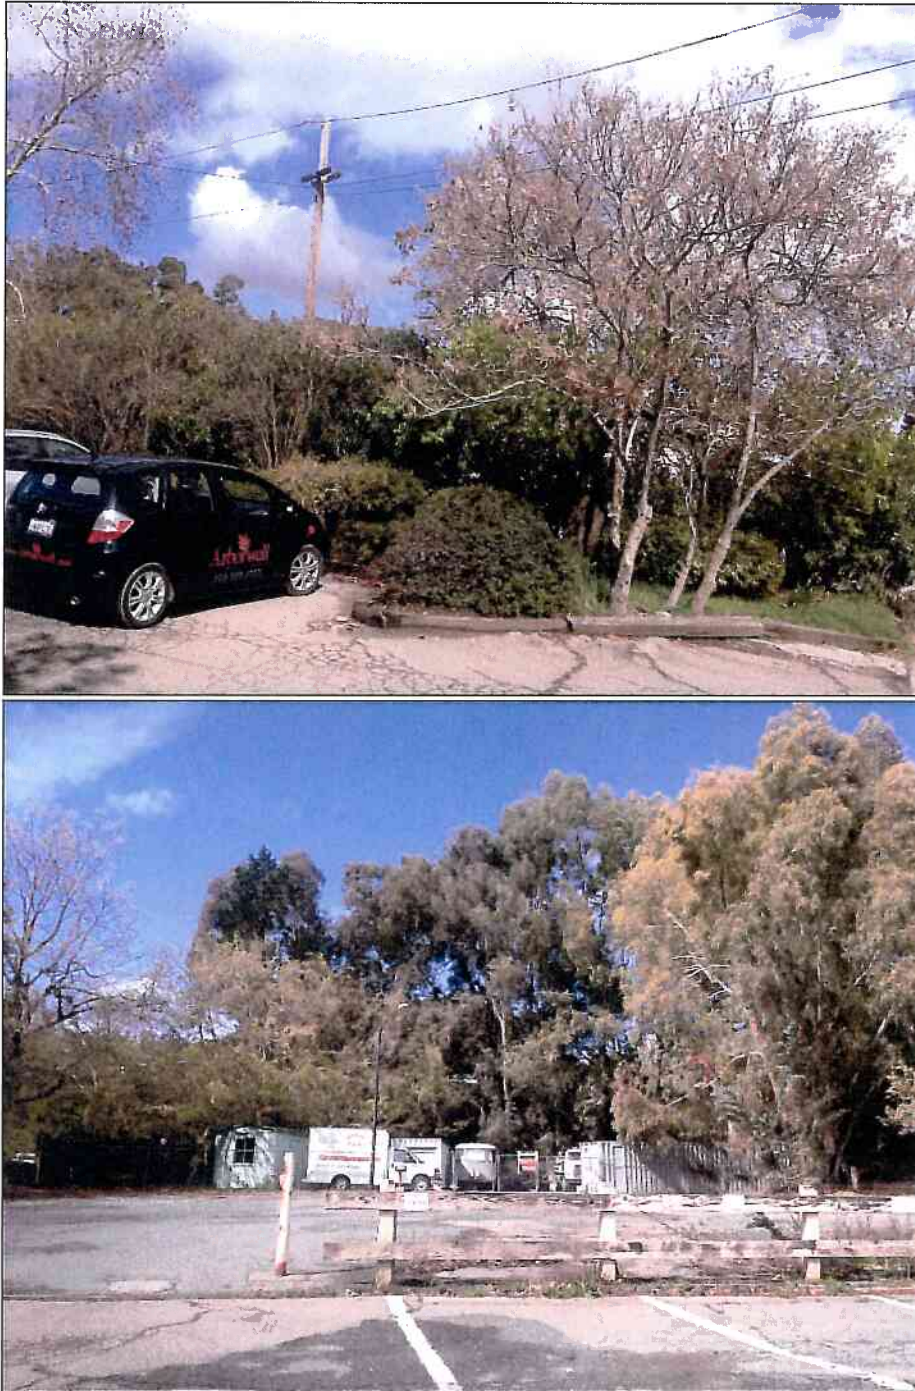
Figure 7: an image of Trees 34 through 39 (top image), and Trees 18 through 26 (bottom image).

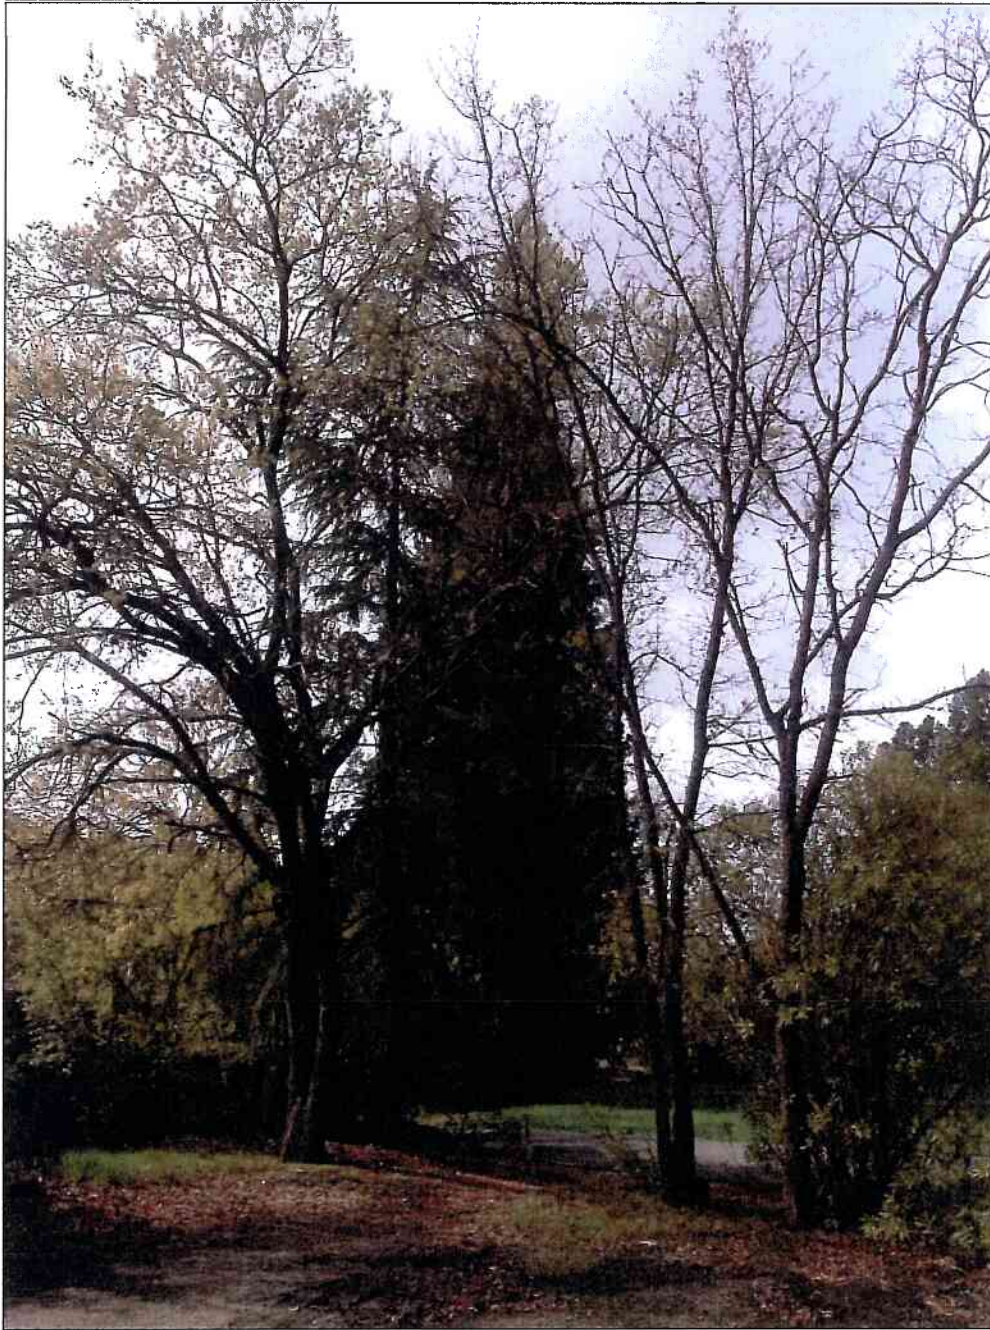
Figure 8: an image of Trees 57 through 60 along the west-side of the property. Trees 71 and 72 are in the background.

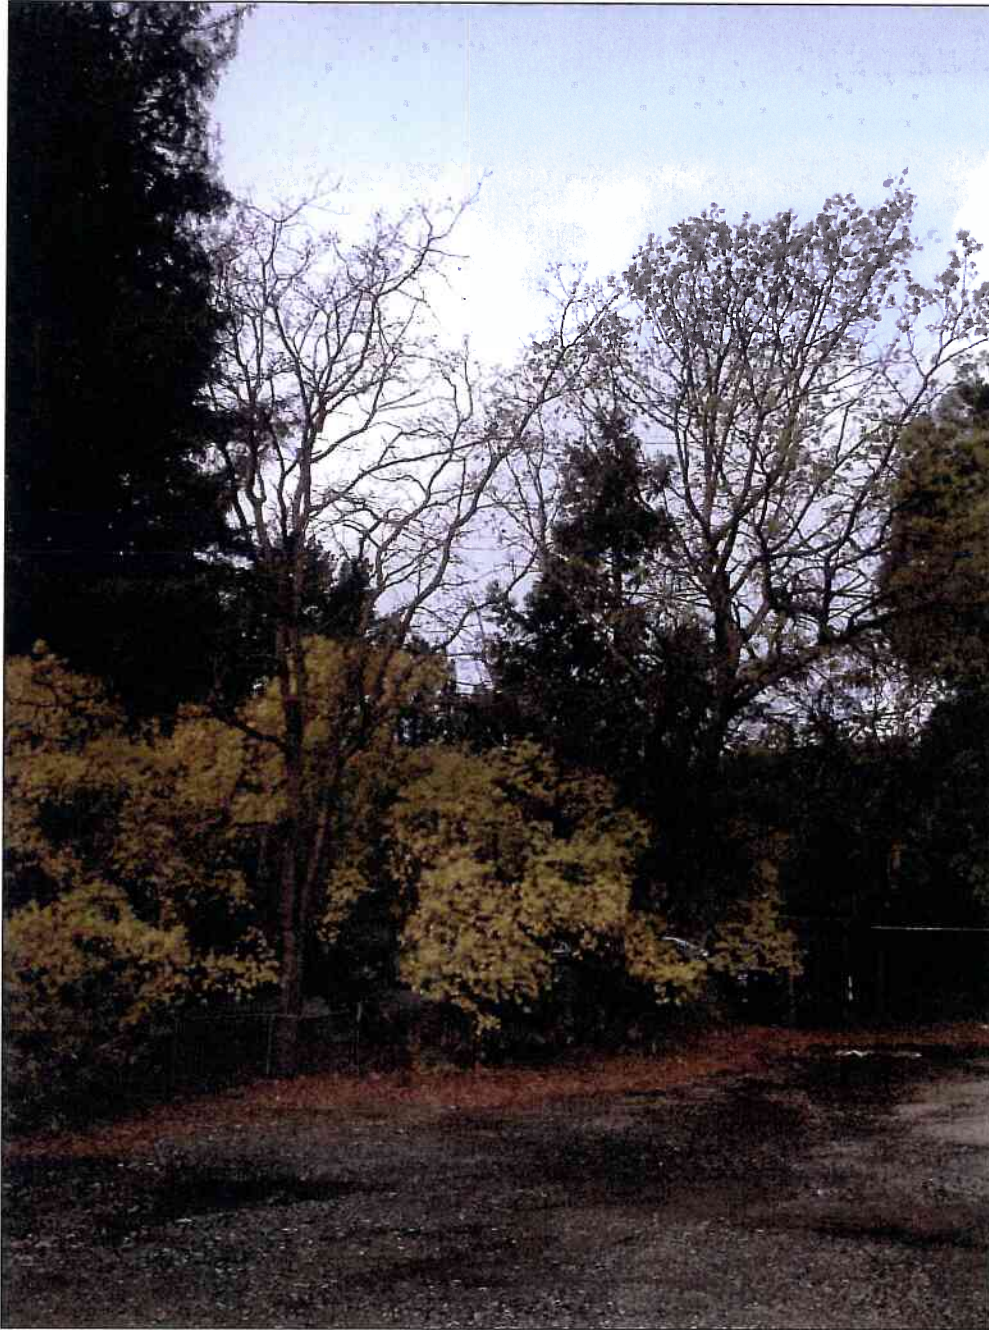
Figure 9: an image of Trees 61 through 67. Trees 94 through 102 are in the background.

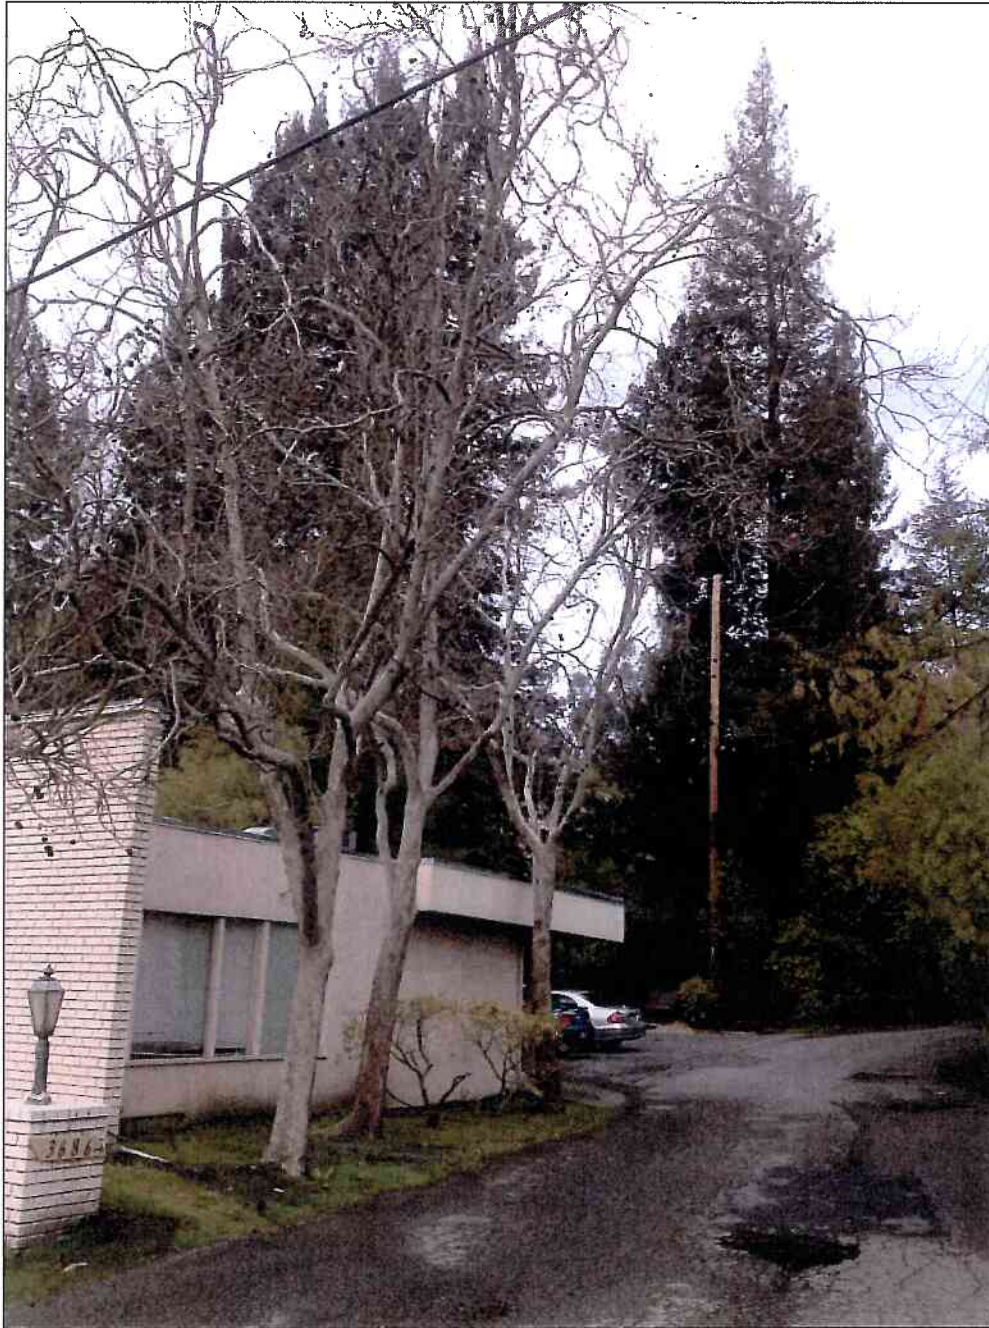
Figure 10: an image of Trees 73, 74, and 75. The top of Trees 103 and 104 can be seen above the building as well as Trees 71 and 72 in the background. All are located on the neighboring property to the west.

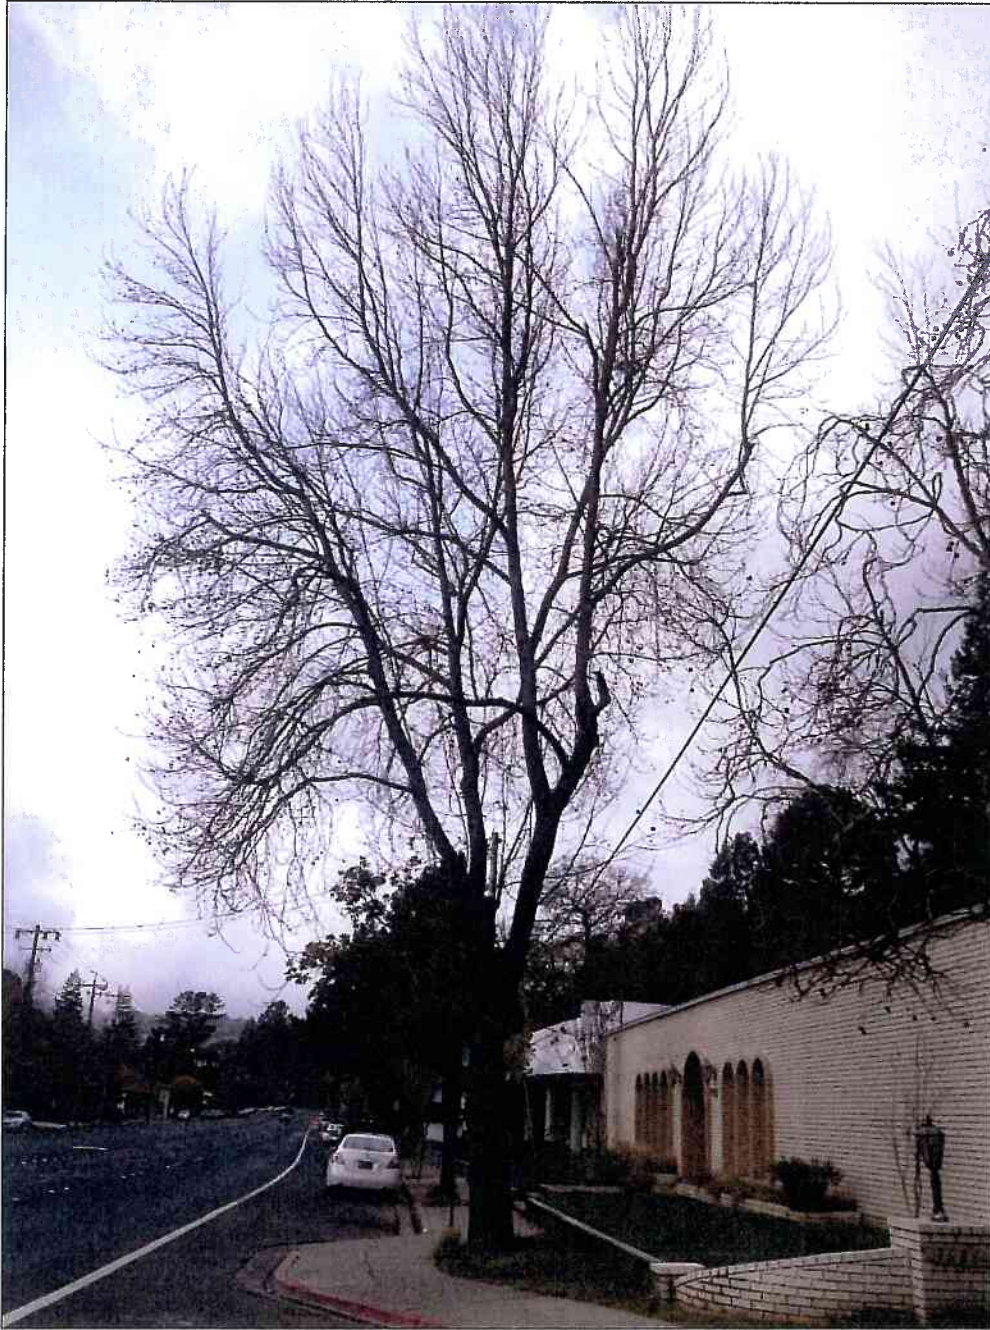
Figure 11: an image of Street Tree 76 located west of the property.

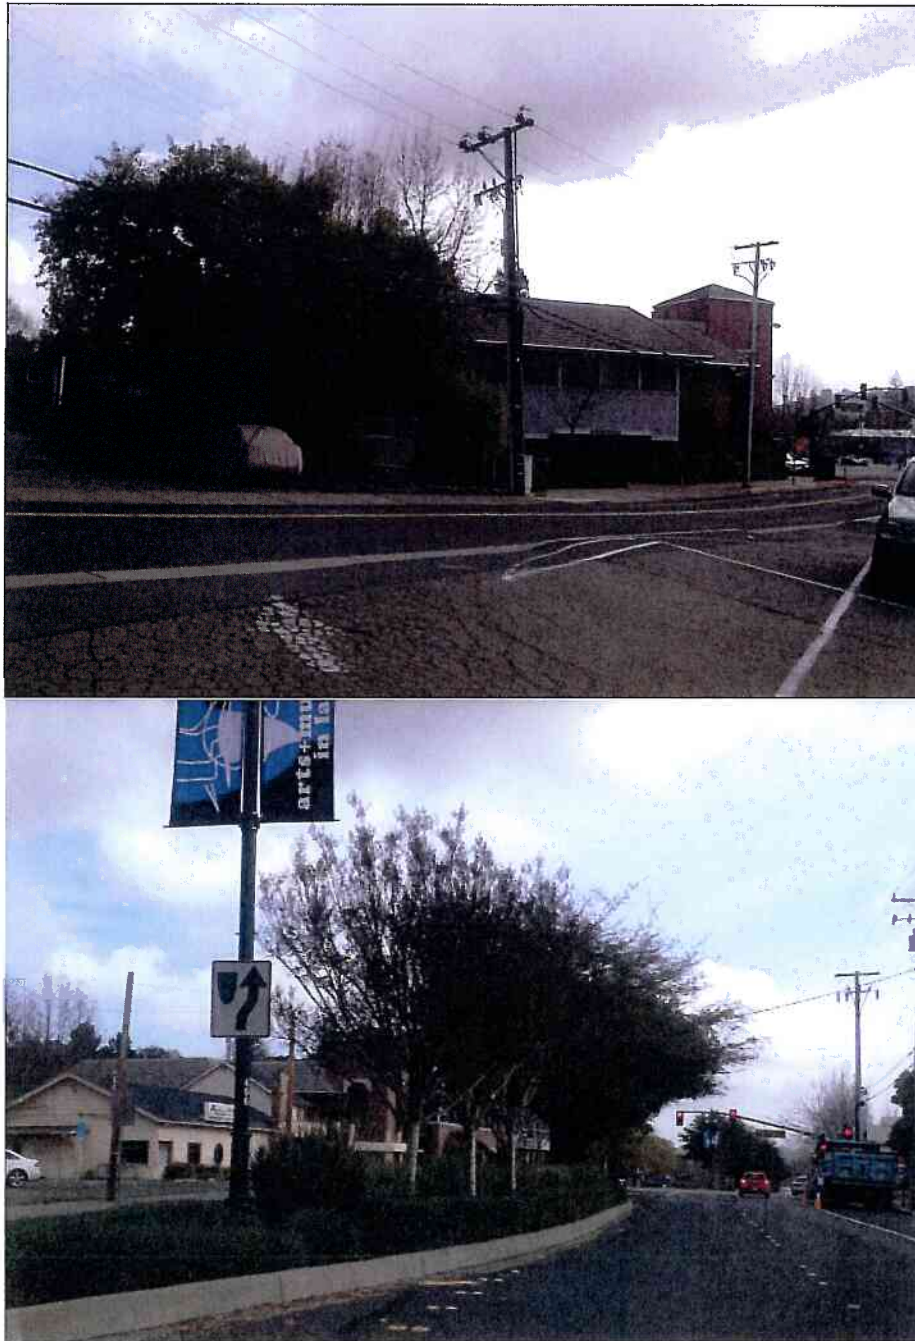
Figure 12: an image of Trees 85 through 90 on the neighboring property to the west (top image) and Center Median Trees 77 through 84 (bottom image).

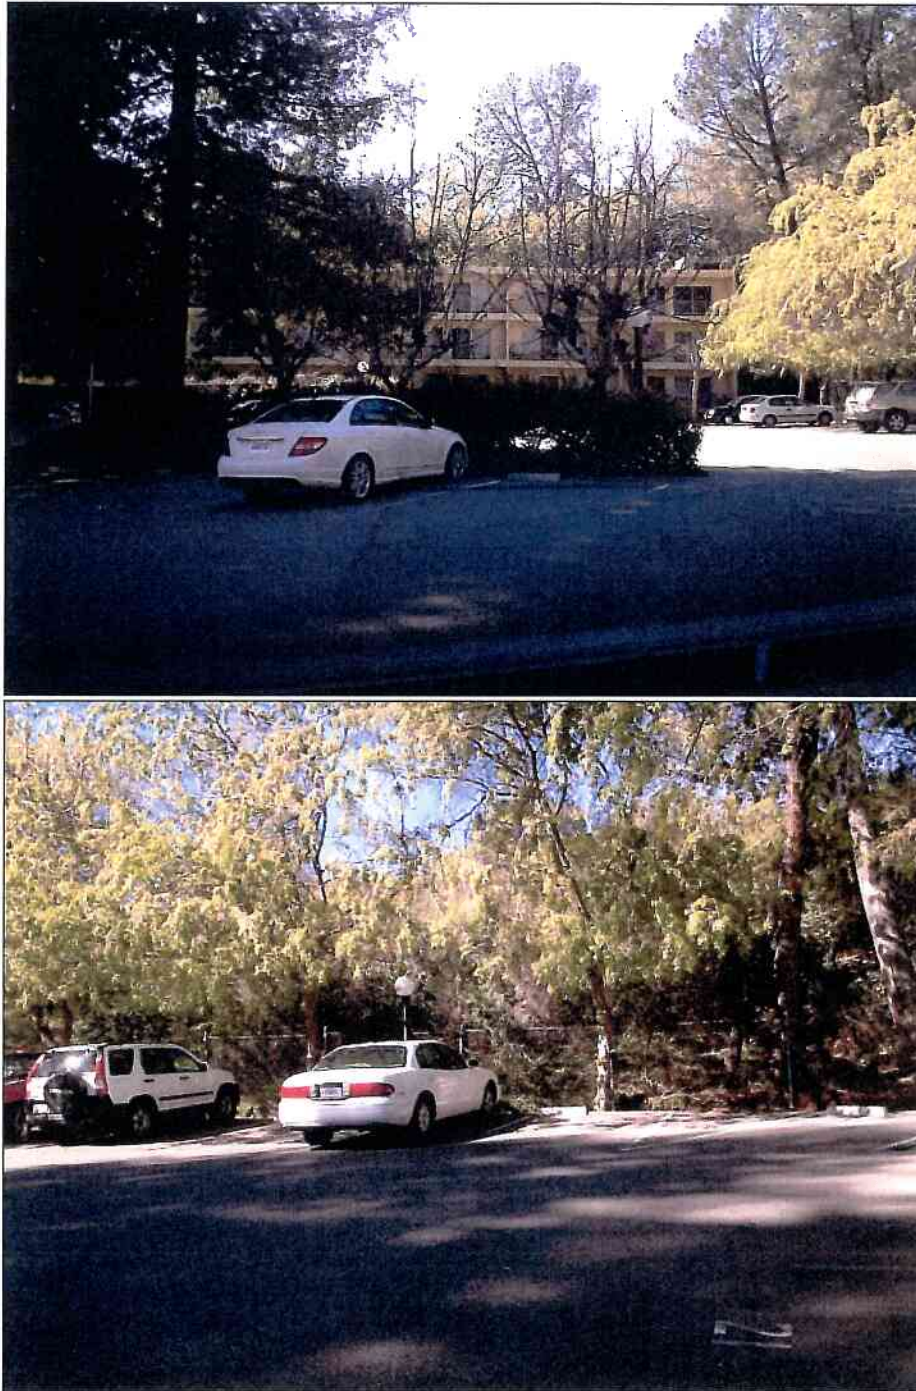
Figure 13: an image of Trees 94 through 98 (top image) and Tree 99 through 102 (bottom image), all located on the neighboring property to the east.
