### Feasibility and Options Study for Traffic Operation Improvements - Existing Conditions Report

Along the Olympic Boulevard and Reliez Station Road Corridor

City of Lafayette

Stantec

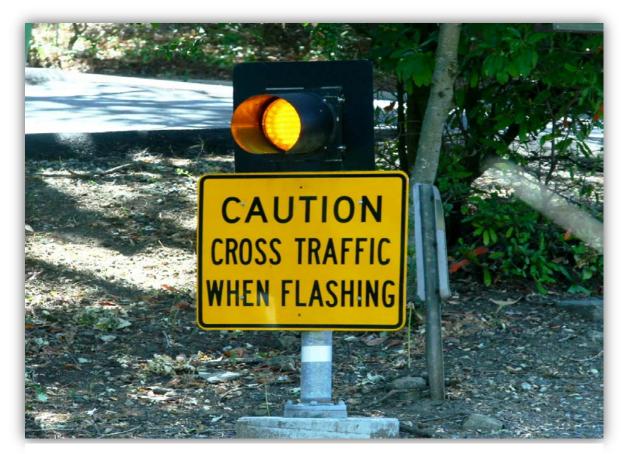
Figure 1: Flashing Beacon Warning of Cross Traffic Ahead

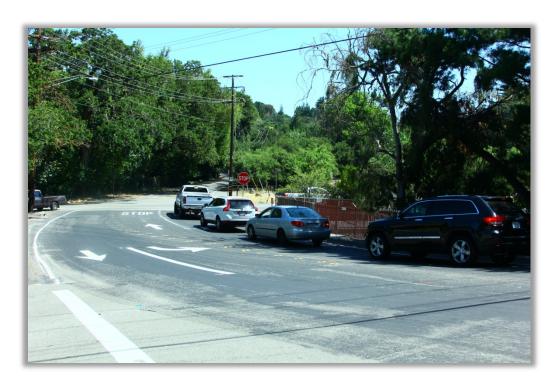
Figure 18: Sight Distance View from Beechwood to the Stop Line at Reliez Station Road and Olympic Boulevard

The figures on the following pages (Figure 18 through Figure 28) demonstrate the measured sight distance as well as provide a photographic point of view from the side street approaches. Most of the photographs were taken from the perspective of drivers with the front of their car at the stop line, as this is the point from which sight distance is measured. However, it should be noted that drivers will place their cars closer to the roadway if it is safe to do so and it provides them with improved lines of sight.

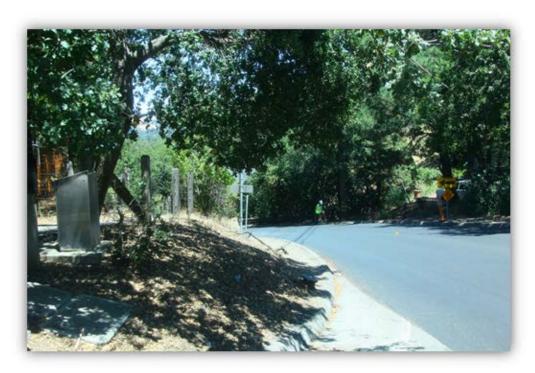
Figure 22: Sight Distance View from Las Trampas Road #1

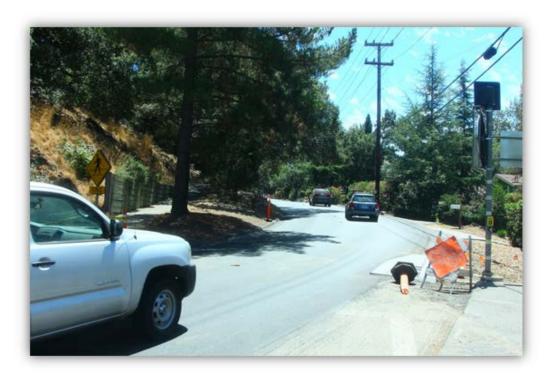
Figure 24: Sight Distance View from Las Trampas Road #2

While the sight distance looking right while egressing from Las Trampas Road is technically relatively long, it is partially obstructed by the hillside, as shown in **Figure 24**.

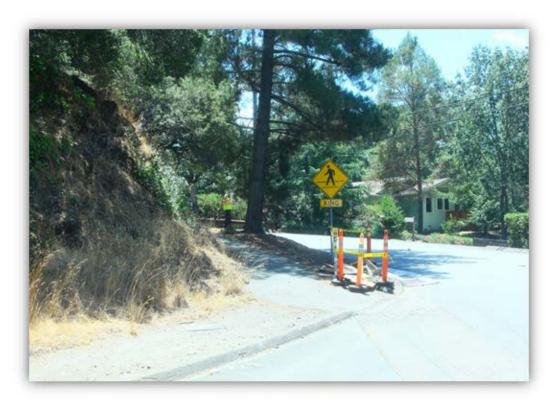
Figure 26: Sight Distance View from Richelle Court #1

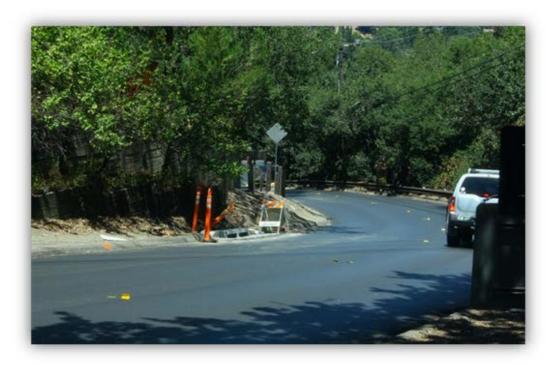
Figure 28: Sight Distance View from Richelle Court #2
