APPENDIX HI:
USACE JURISDICTIONAL
DELINEATION FOR
THE DOG PARK SITE

**U.S. ARMY CORPS OF ENGINEERS
JURISDICTIONAL DELINEATION**

AMD PROPERTY

CONTRA COSTA COUNTY, CALIFORNIA

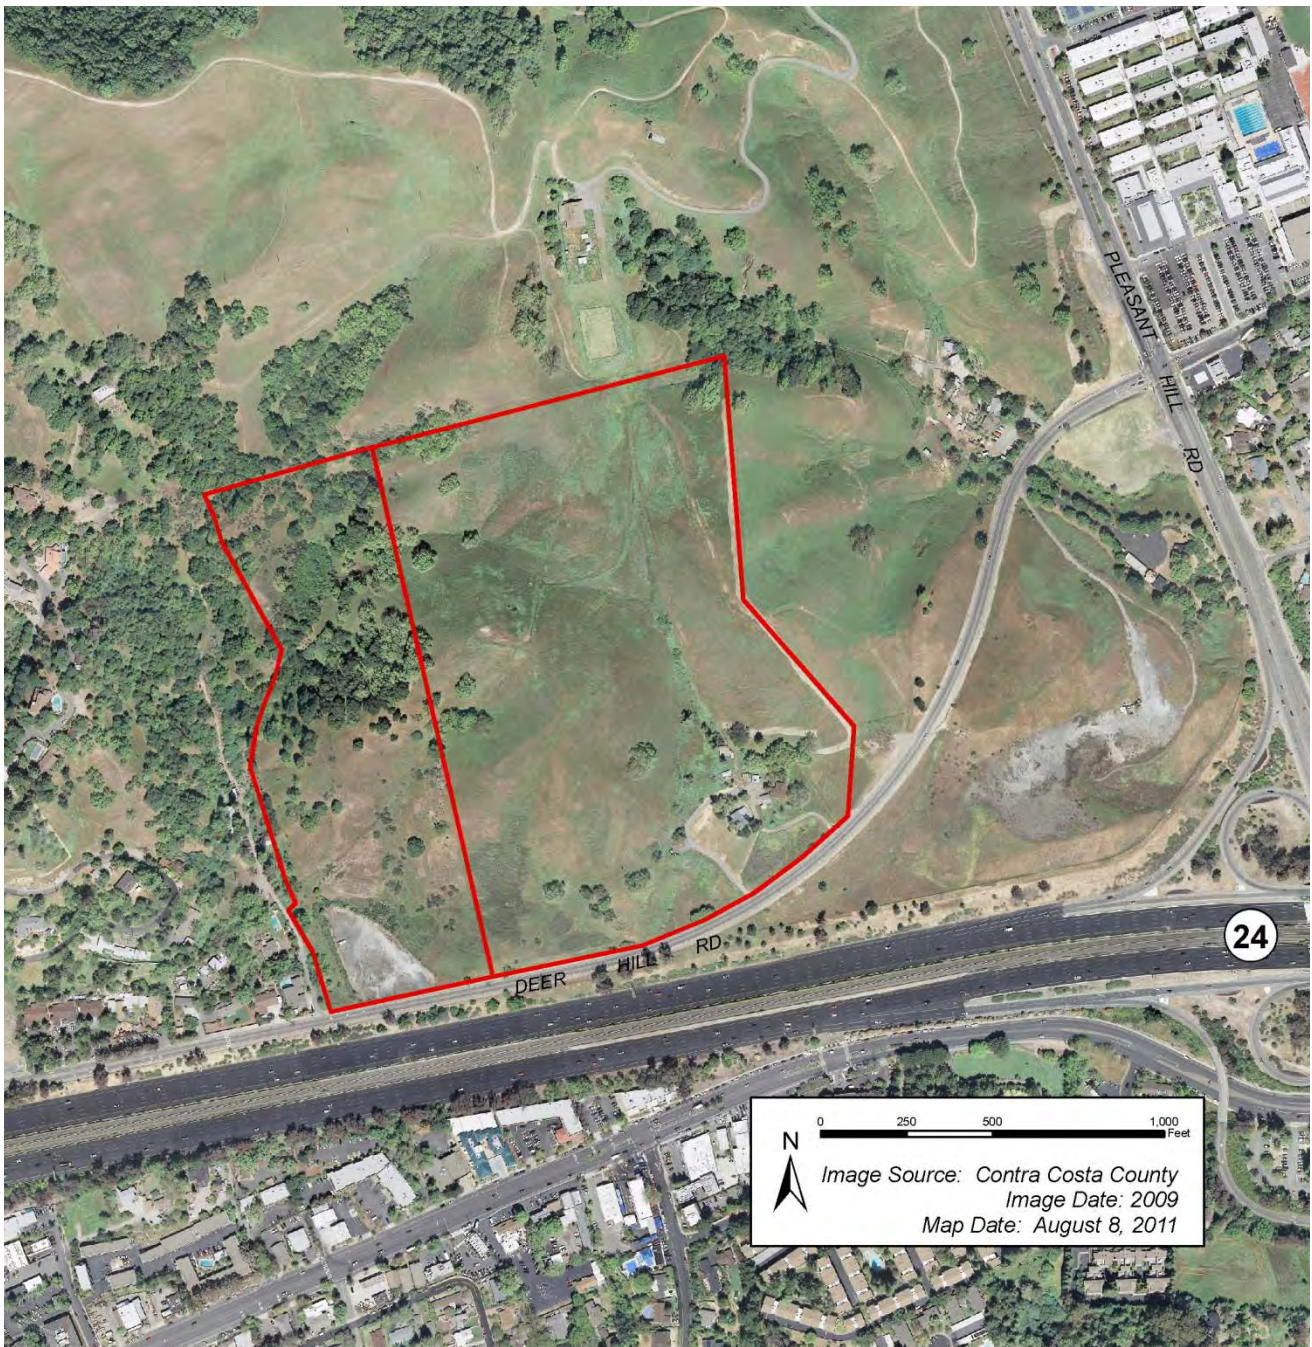
Figure 4
Aerial Photograph of the AMD Property
Contra Costa County, California

The Property is located north of Highway 24 and west of Pleasant Hill Road in Contra Costa County, California (USGS Walnut Creek 7.5 minute quadrangle). Attachment 1, Figure 1 depicts the regional location of the Property in Contra Costa County and Figure 2 identifies the vicinity location. Figure 3 is a topographic map on the USGS 7.5 Quadrangle Map for Walnut Creek. An aerial photograph of the Property is provided in Figure 4.

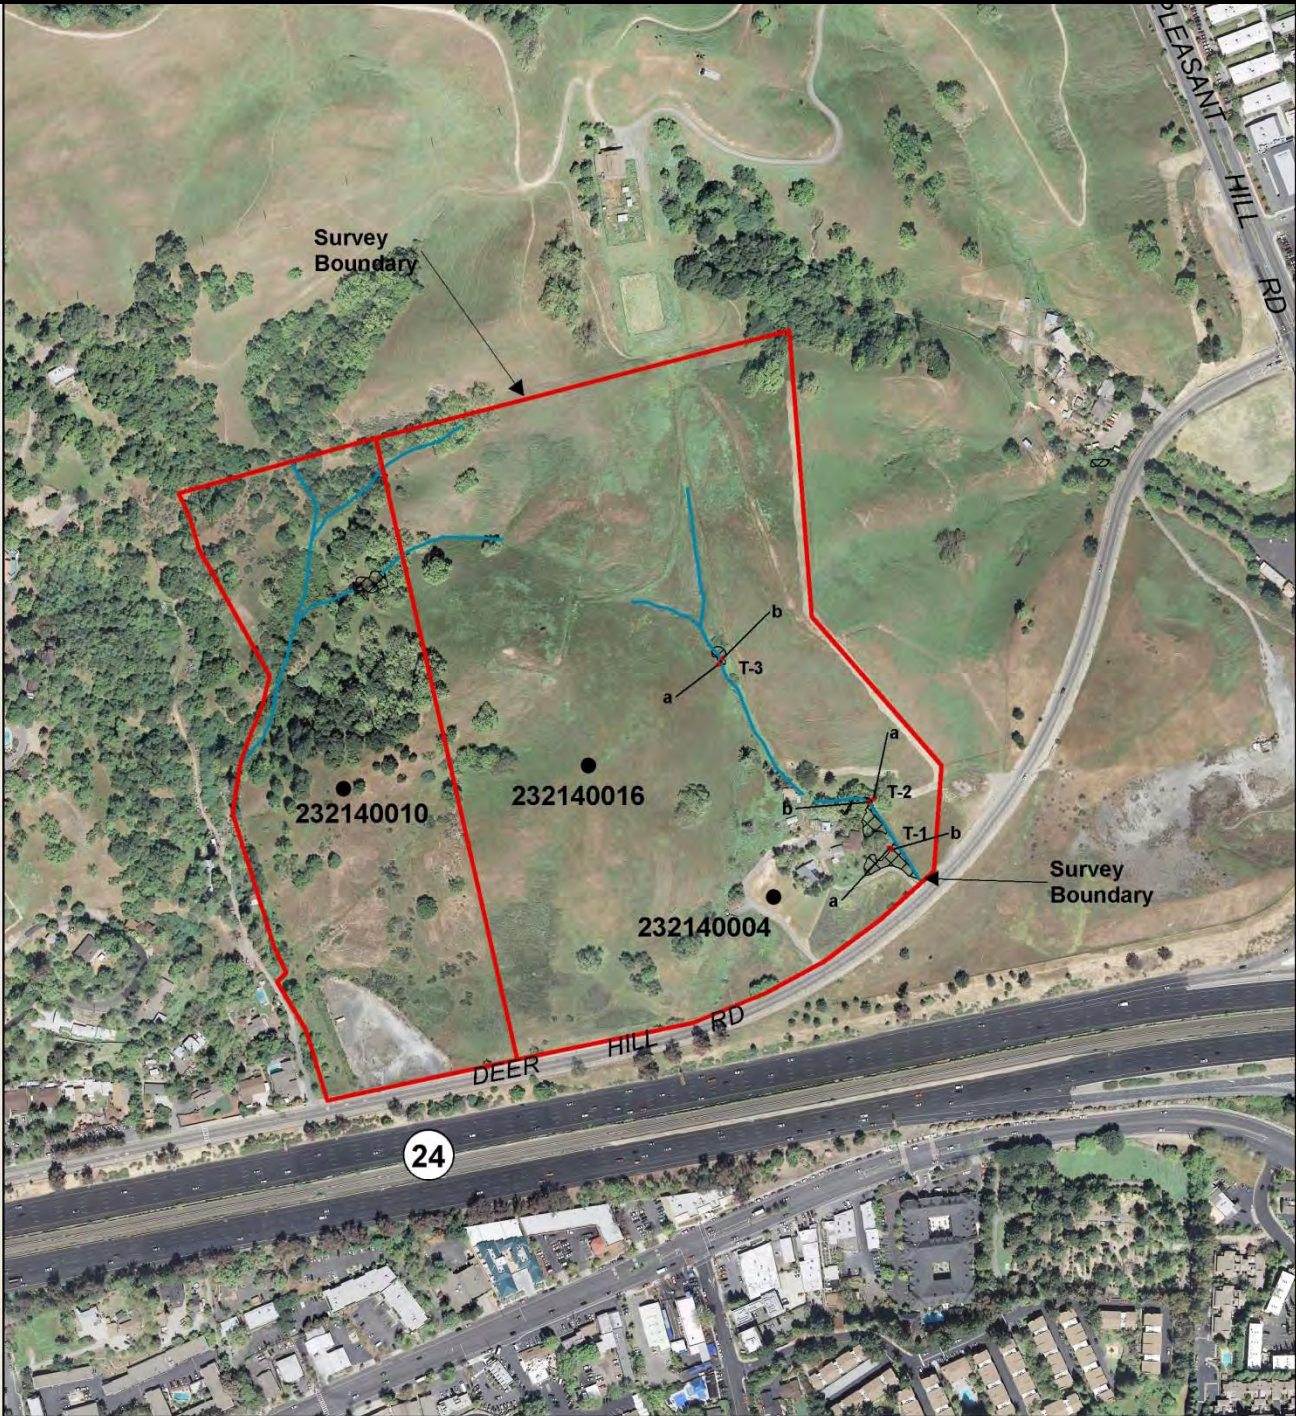
Figure 5
Corps Delineation Map

A total of six soil pits were dug by shovel to a maximum depth of 18 inches at locations representative of various hydrogeomorphic surface conditions within the Property (Attachment 1, Figure 5).

Figure 5
Jurisdictional Waters Map of the AMD
Property
 Contra Costa County, California

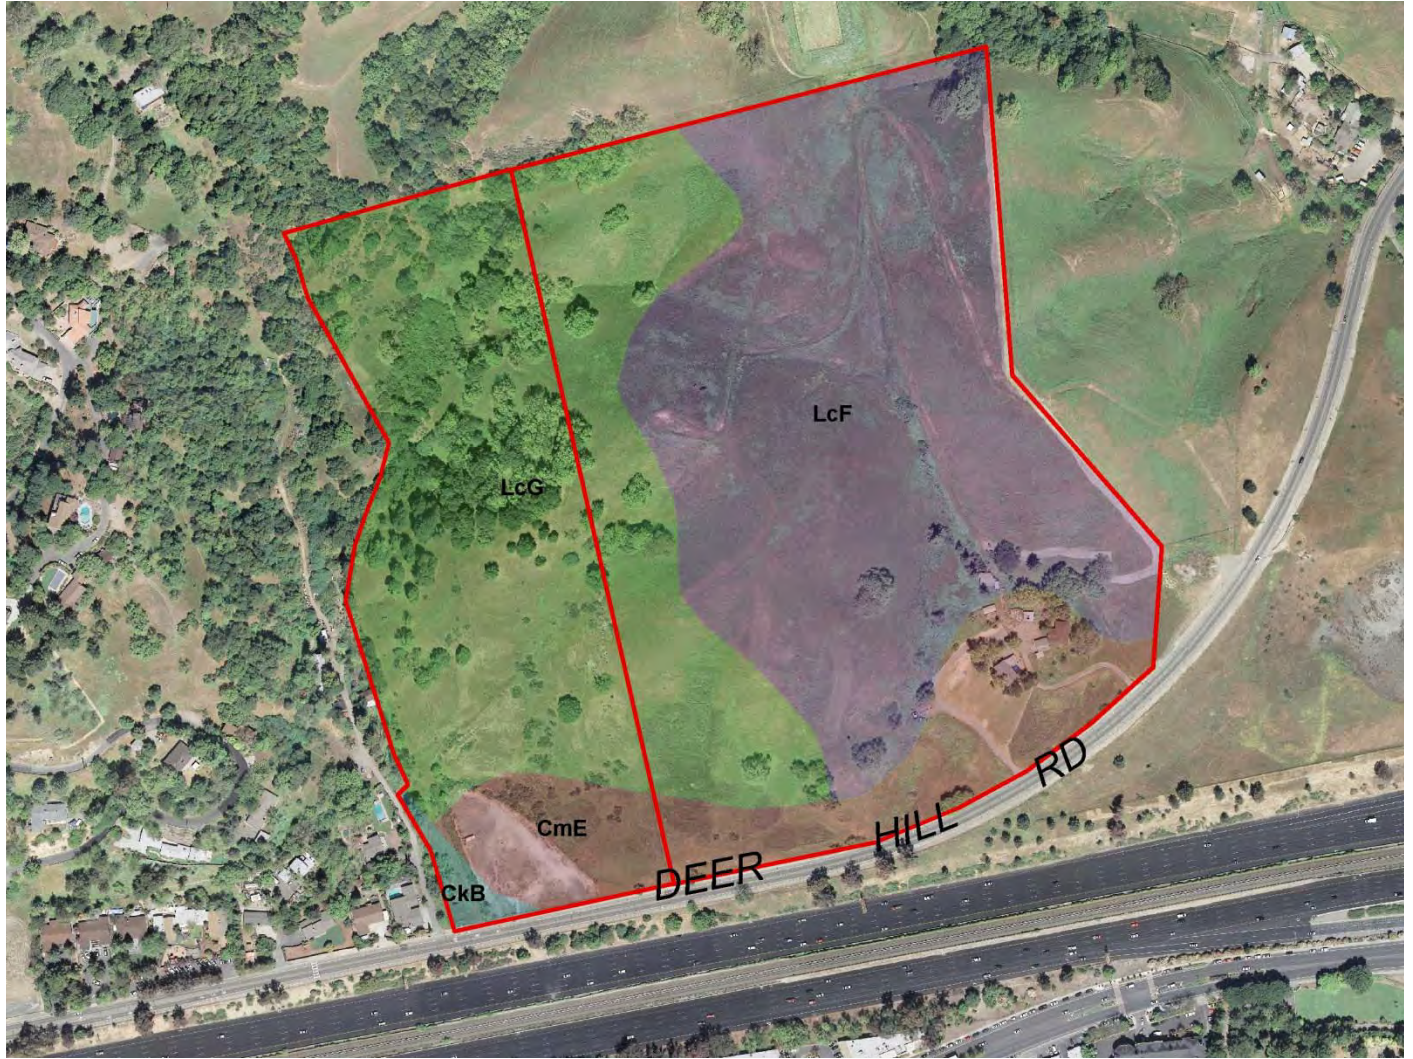
Figure 6
Soils Map

Map Unit Symbol	Percentage within Property	Map Unit Name
CkB	0.7 %	Cropley clay, 2 to 5 percent slopes
CmE	10.0 %	Cut and fill land – Diablo complex, 9 to 30 percent slopes
LcF	58.6 %	Lodo clay loam, 30 to 50 percent slopes
LcG	30.7 %	Lodo clay loam, 50 to 75 percent slopes

A detailed map of these soils for the Property can be found in Attachment 5. The soils mapped included the following types:

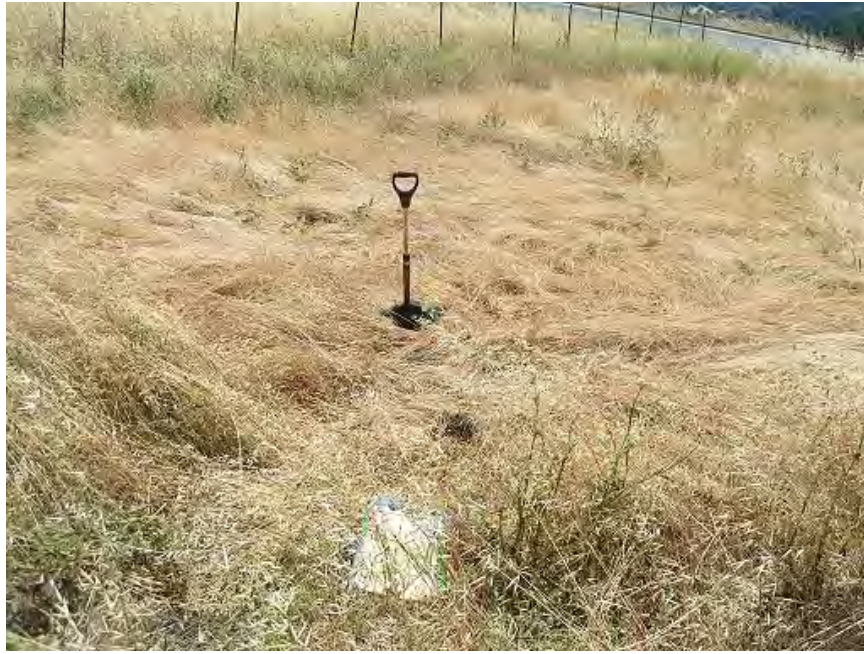
Photograph 1. Seasonal wetland in south-central portion of Property facing south towards Deer Hill Road showing the location of T-1. Shovel marks the location of sample point T-1b and field notebook the upland boundary (T-1a). Note the nearly pure stand of matted perennial ryegrass (FAC) in the mapped feature.

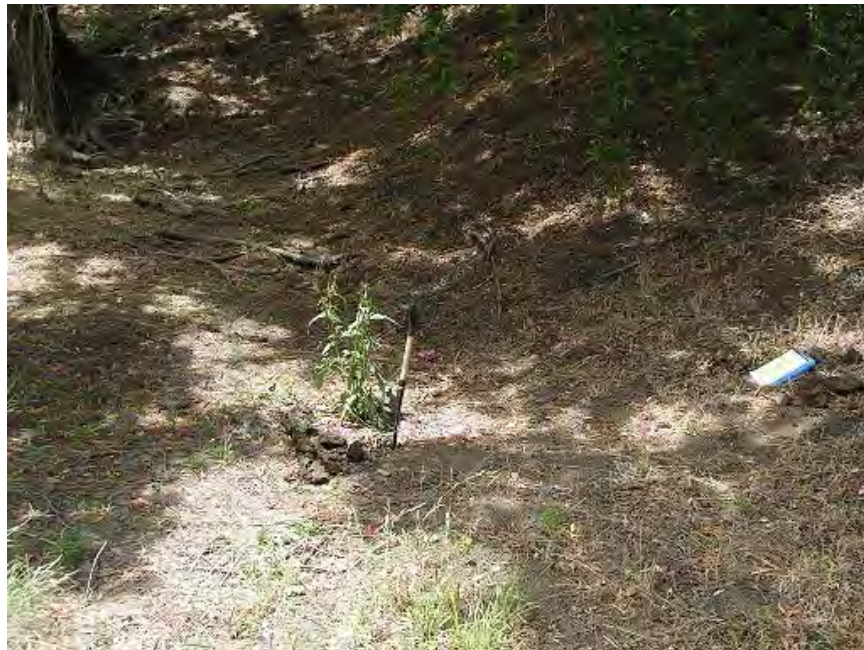
Photograph 2. Low-gradient swale in south-central portion of Property showing the location of T-2. Vegetation in the groundlayer was sparse; woody canopy dominated by California bay laurel (FAC) and valley oak (FAC). Shovel marks the location of sample point T-2b; field notebook the upland boundary (T-2a).

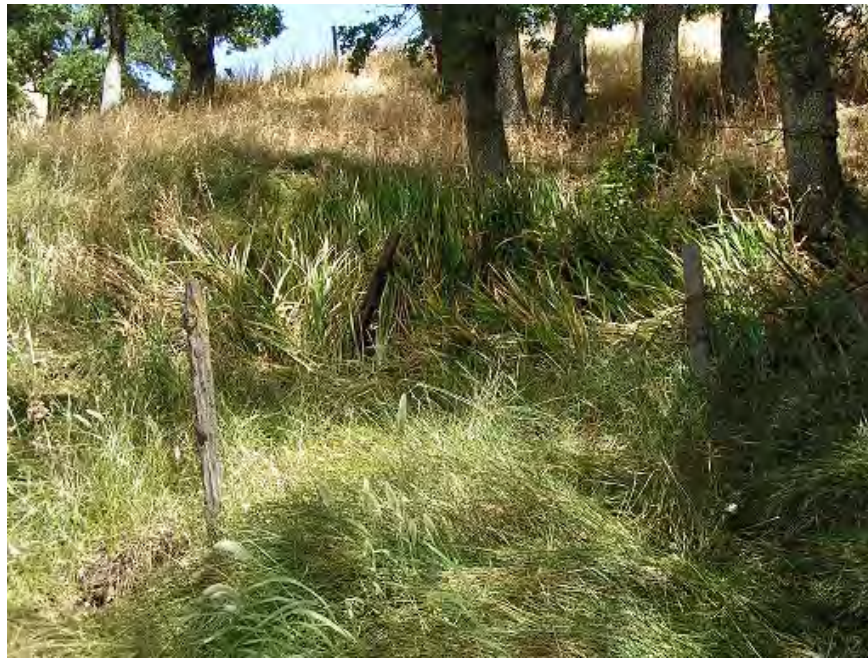
Photograph 3. Hillslope seep located in northwestern portion of property. Surface water was present at the time of the July 13 field delineation, indicating groundwater upwelling; the remnants of an old springbox were also found. The green hydrophytic vegetation in the photo supported by this feature include iris, Baltic rush, and annual beardgrass; valley oak occur along the perimeter.

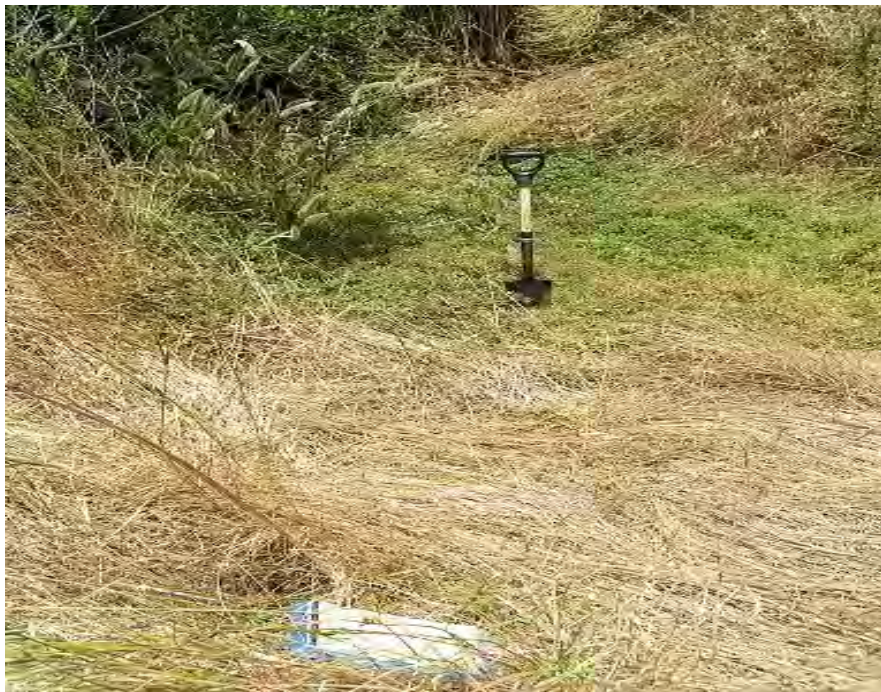
Photograph 4. Location of T-3 at seep embedded within drainage in central portion of property. Shovel marks the location of T-3b; field notebook T-3a.

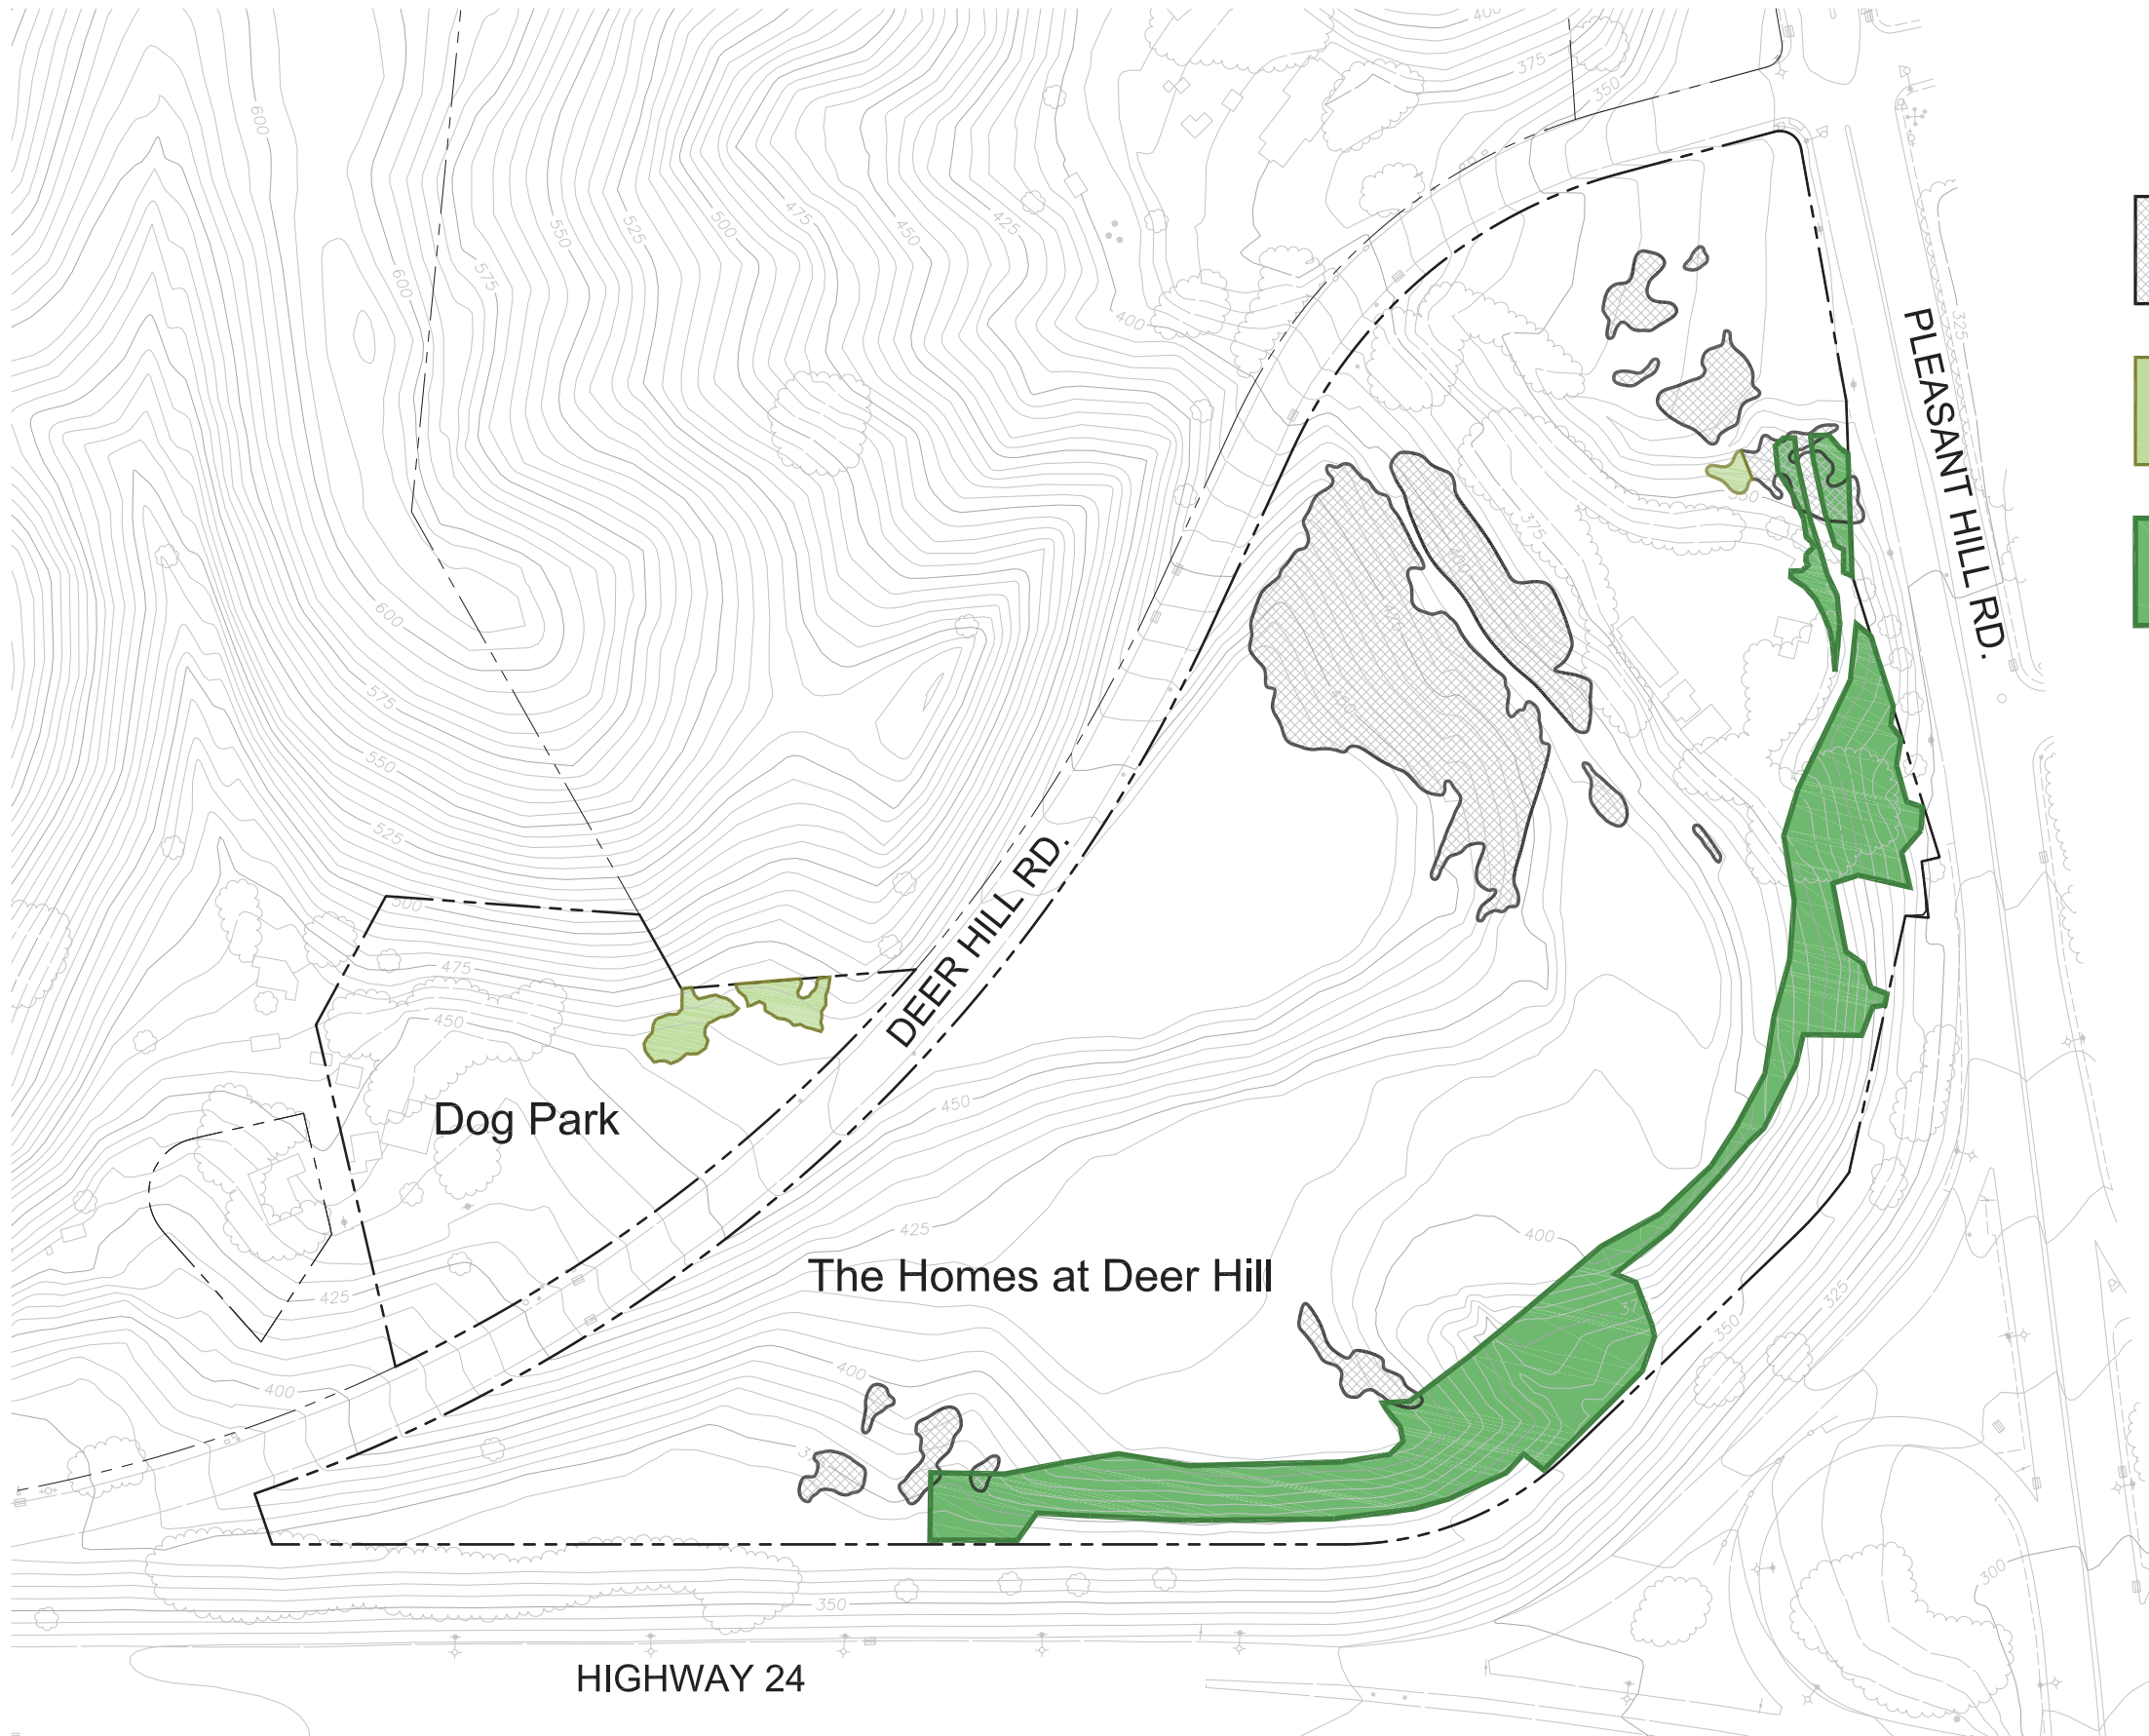
Wildrye Native Grassland Avoidance and Replacement Plan
 1" = 80' 0 80 160

NATIVE WILDRYE GRASSLAND TO BE IMPACTED BY PROJECT - 2.1 ACRES. GRASSES TO BE SALVAGED AND TRANSPLANTED AS SHOWN.
