# Feasibility and Options Study for Traffic Operation Improvements - Existing Conditions Report

Along the Olympic Boulevard and Reliez Station Road Corridor

City of Lafayette

Stantec

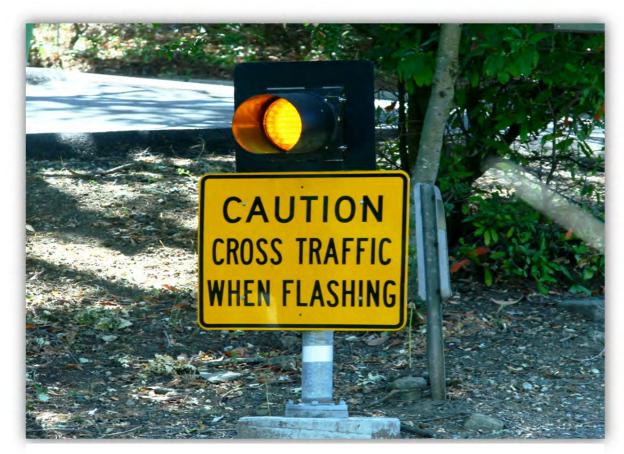
Figure 1: Flashing Beacon Warning of Cross Traffic Ahead

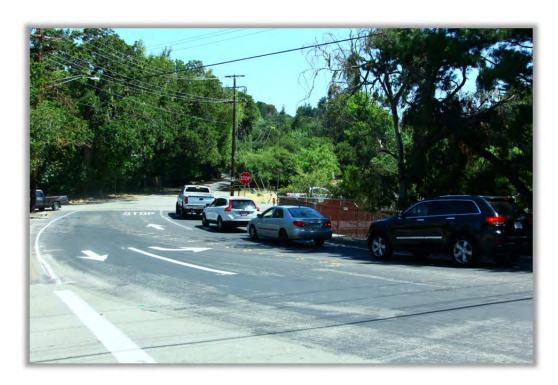
Figure 18: Sight Distance View from Beechwood to the Stop Line at Reliez Station Road and Olympic Boulevard

The figures on the following pages (**Figure 18** through **Figure 28**) demonstrate the measured sight distance as well as provide a photographic point of view from the side street approaches. Most of the photographs were taken from the perspective of drivers with the front of their car at the stop line, as this is the point from which sight distance is measured. However, it should be noted that drivers will place their cars closer to the roadway if it is safe to do so and it provides them with improved lines of sight.

<sup>[3]</sup> See Figures 18 through 28 for actual measured sight distances.

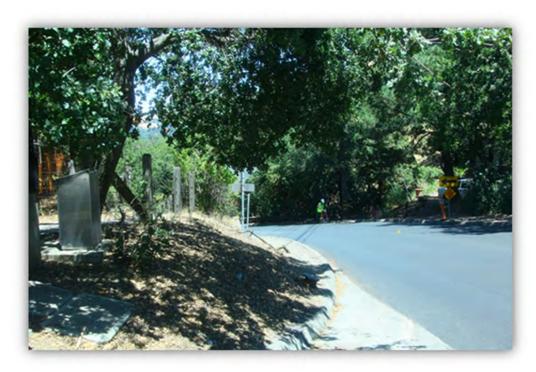
Figure 22: Sight Distance View from Las Trampas Road #1

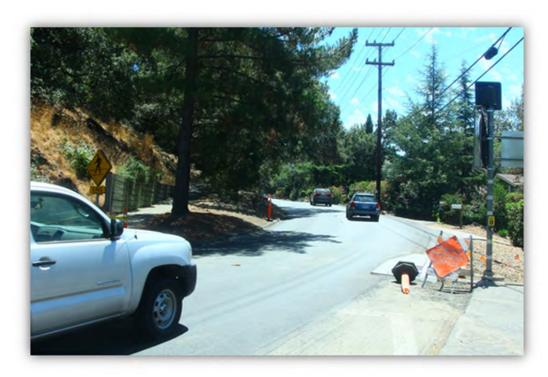
While the sight distance looking right while egressing from Las Trampas Road is technically relatively long, it is partially obstructed by the hillside, as shown in **Figure 24**.

Figure 24: Sight Distance View from Las Trampas Road #2

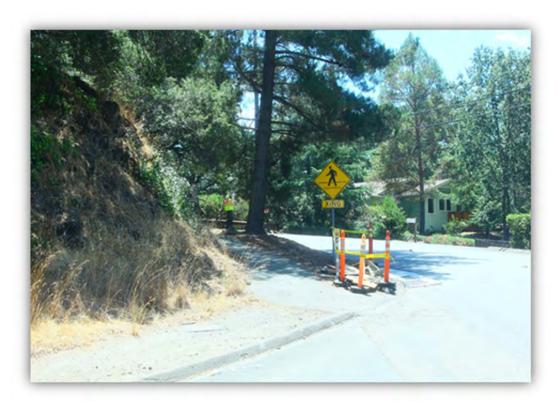
Figure 26: Sight Distance View from Richelle Court #1

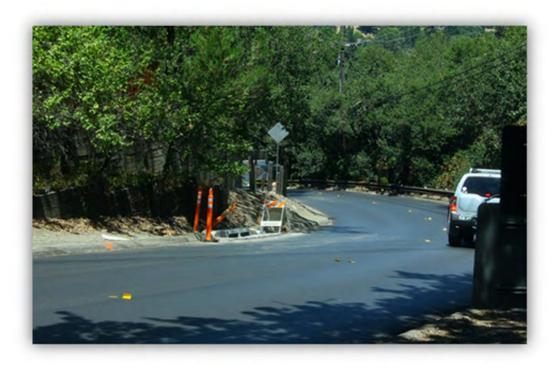
Figure 28: Sight Distance View from Richelle Court #2
