**DOWNTOWN CREEKS PRESERVATION, RESTORATION AND DEVELOPMENT PLAN**

ASSESSMENT SUMMARY OF EXISTING CREEK CONDITIONS, LAND USE AND ENHANCEMENT OPPORTUNITIES

LAFAYETTE, CALIFORNIA

February 2016

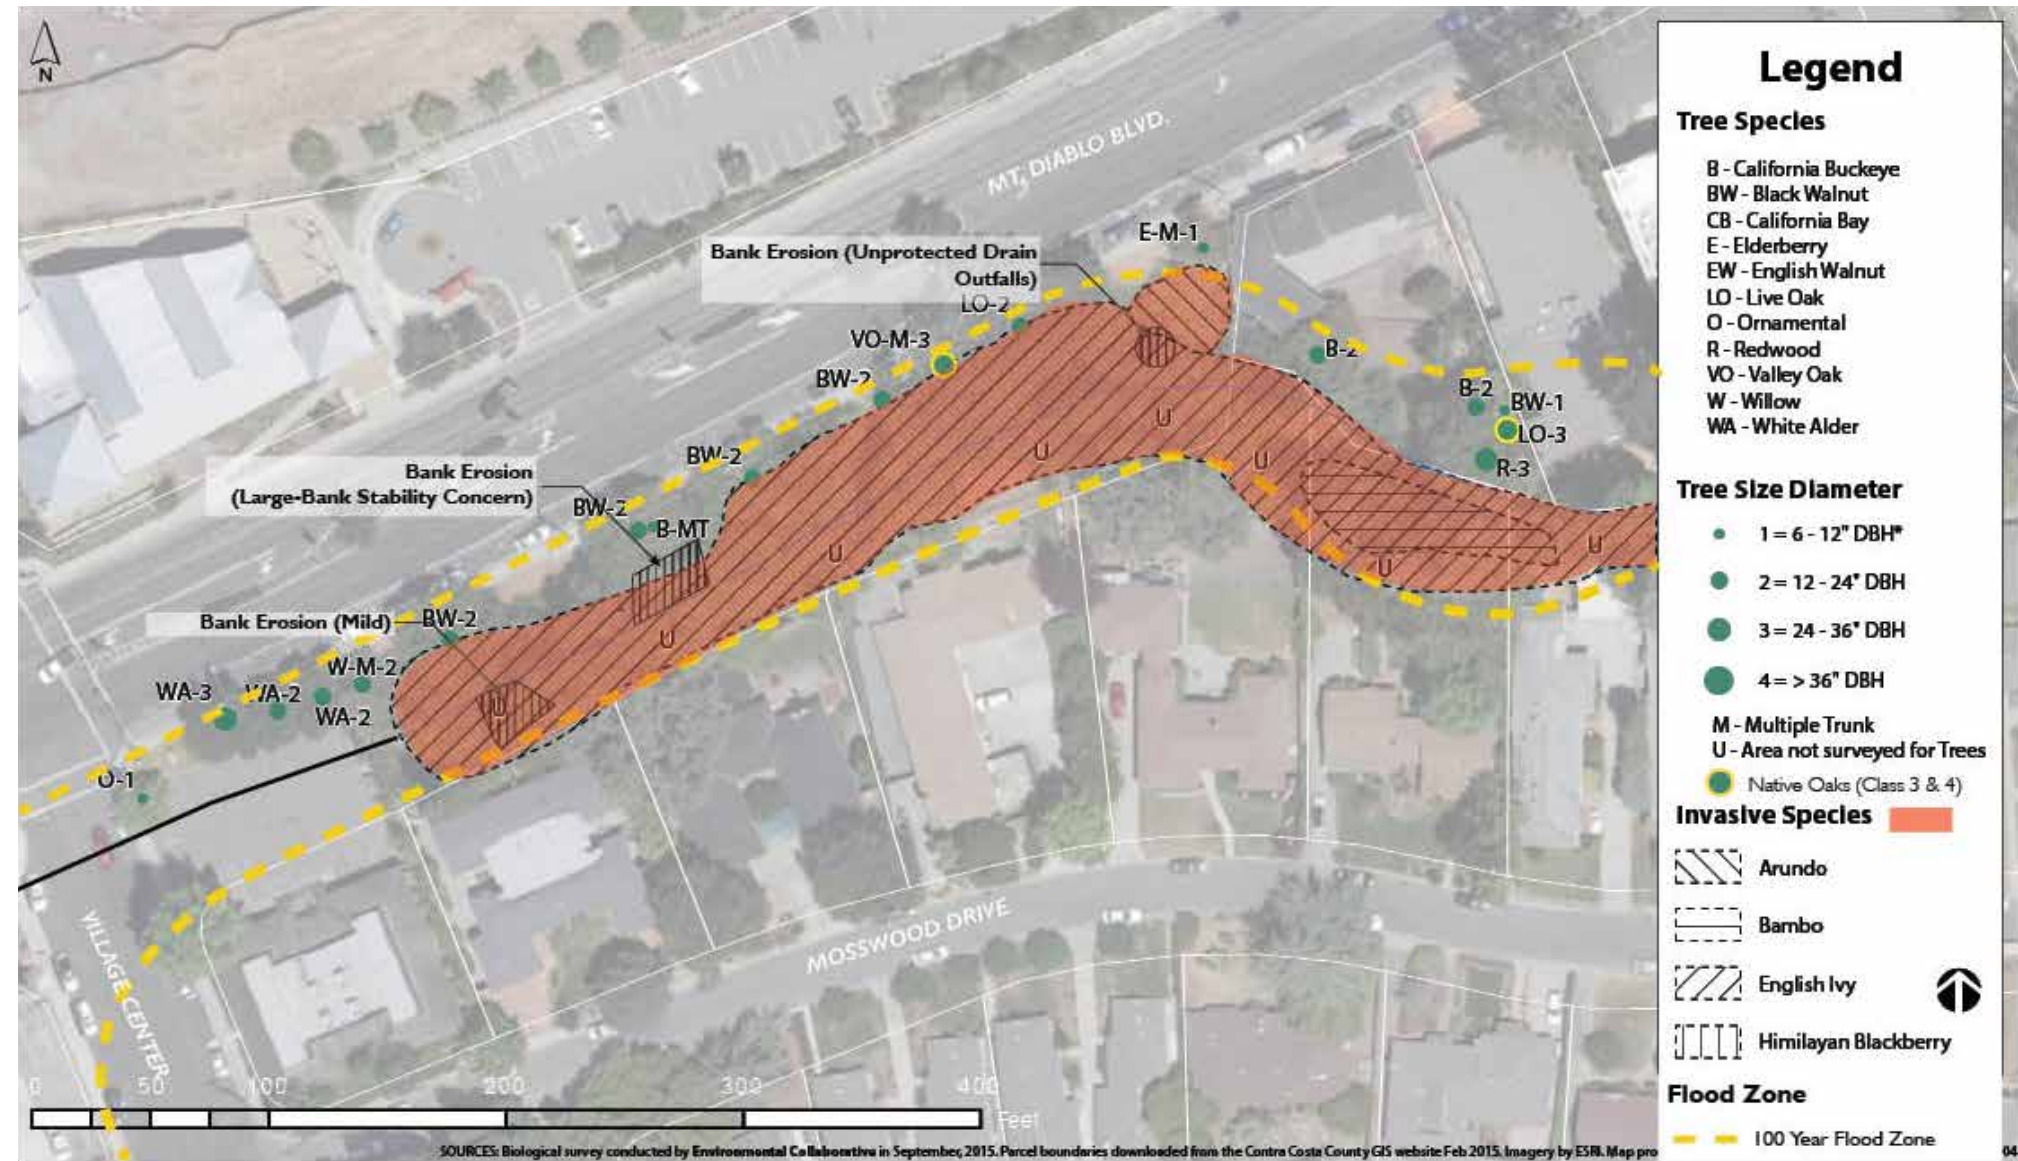
Figure 3-3: West Reach Biological Conditions

Trees in this section of the creek include black walnut (*Juglans hindsii*), white alder (*Alnus rhombifolia*), California buckeye (*Aesculus californica*), live oak (*Quercus agrifolia*), and valley oak (*Quercus lobata*).

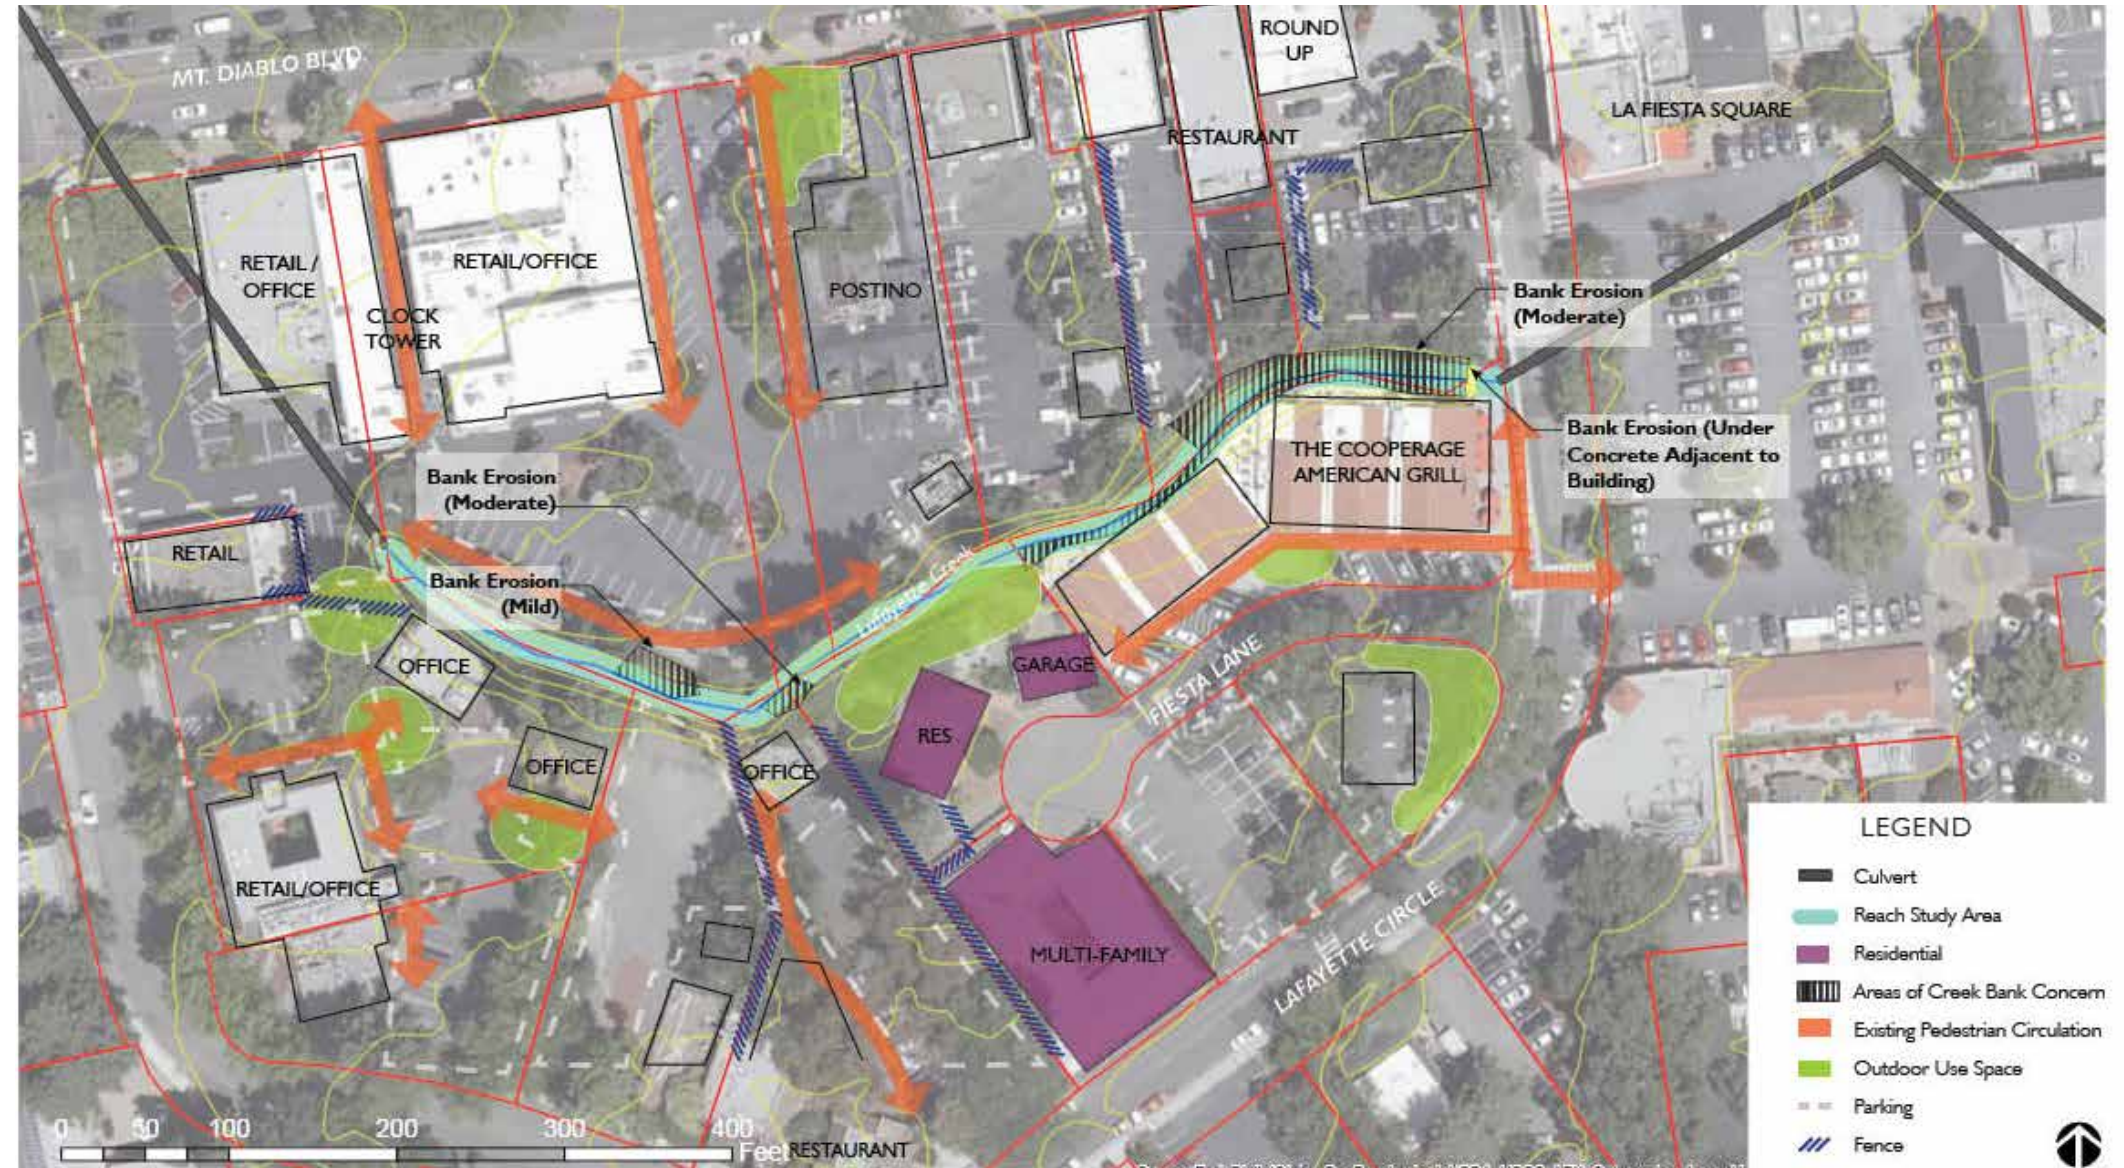
Figure 3-5: North Reach Existing Conditions

- A short existing path along the northern edge of the creek is not connected to other pedestrian paths.
- The Downtown Specific Plan has identified a potential Town Green site adjacent to the creek and several large valley oaks, behind the Roundup Saloon which is located on Mt. Diablo Blvd.
- There is no public outdoor use space immediately adjacent to the creek on the south bank.

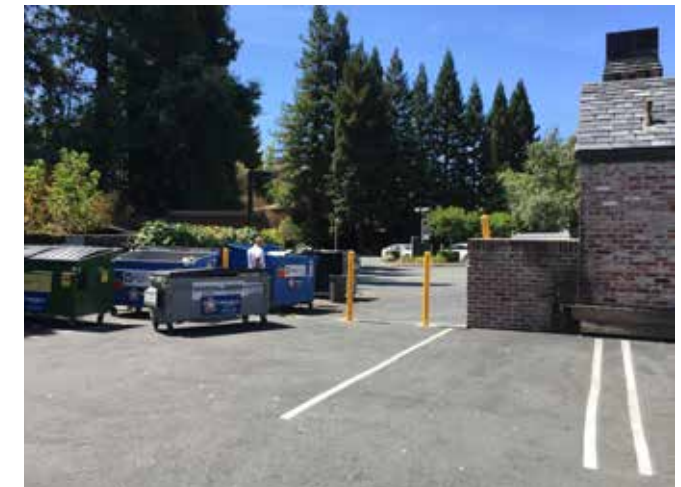
*The creek experience is dominated by parking lots and dumpster areas.*

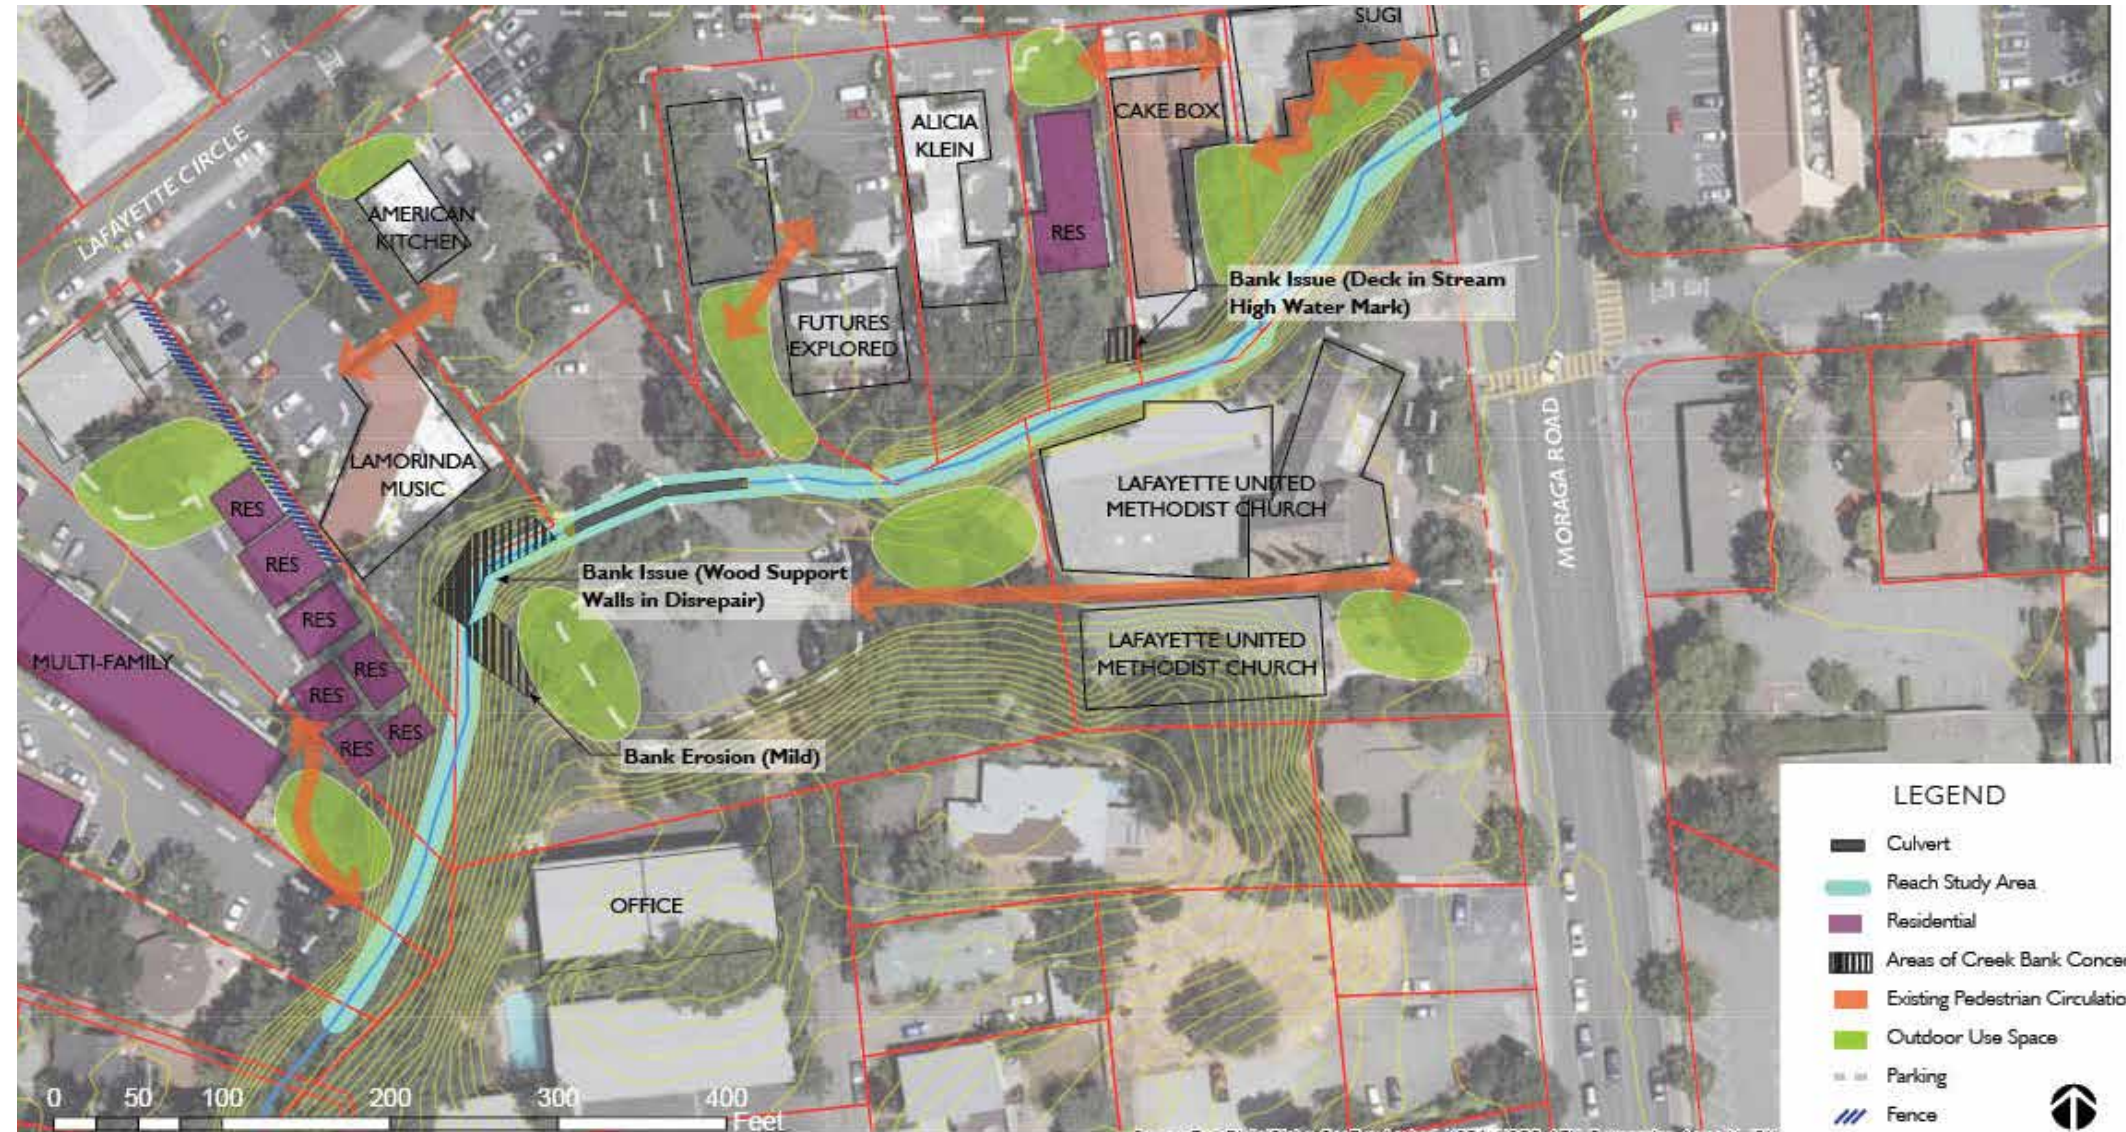
Figure 3-9: South Reach Existing Conditions

- Creek-side garden and outdoor areas exist on multi-family, Futures Explored, and the church properties.
- Existing pedestrian paths connect Moraga Road to the parking areas west of the church.

- Replace the culvert under the parking lot with a bridge, and restore the natural creek channel.
- Restore riparian habitat.
- Expand public access to the creeks via expanded pedestrian pathways.
- Develop public use space adjacent to Moraga Road.

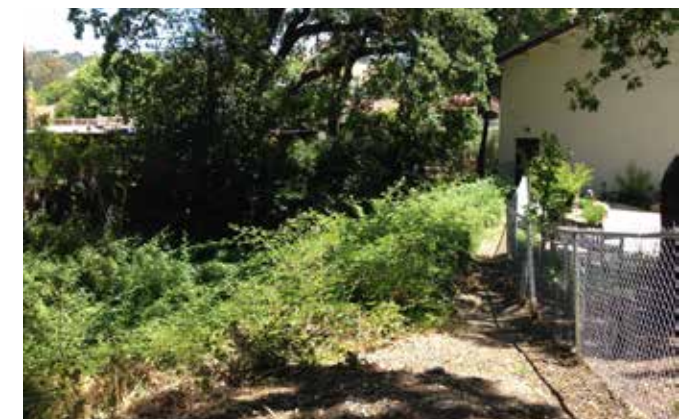
*Creek bank adjacent to the church is overgrown.*

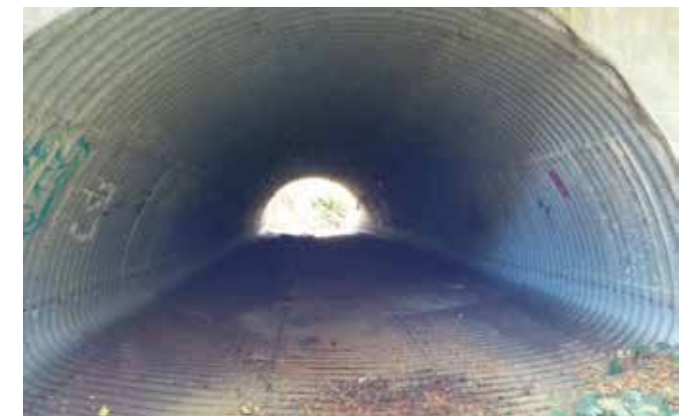
*Culvert beneath church parking lot*

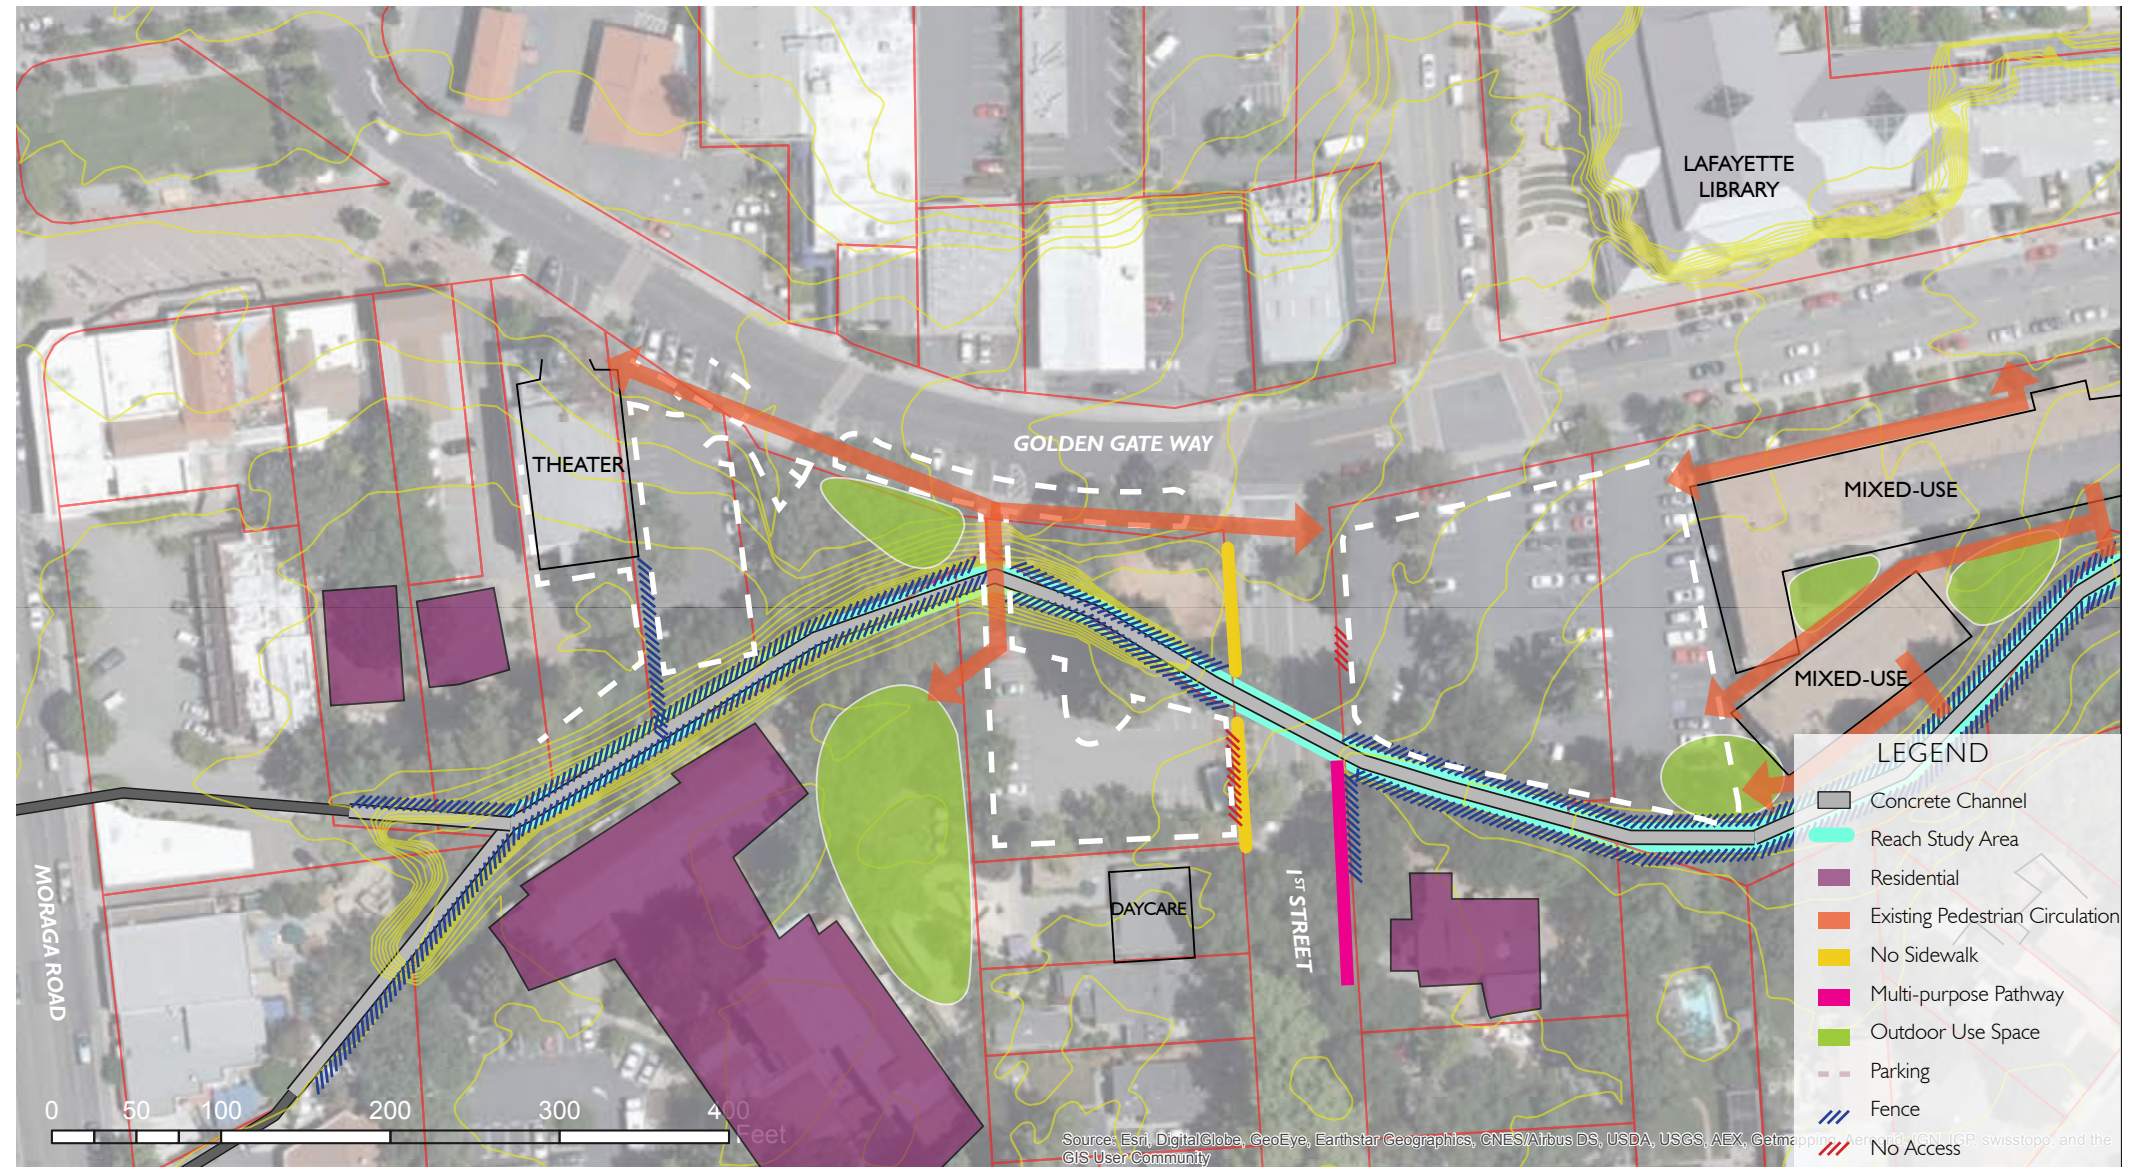
Figure 3-12: East Reach 1 Existing Conditions

- Modify / enhance the surface of the concrete

- Obscure the view of the barbed wire fence with taller native riparian vegetation
- Develop pocket parks along Golden Gate Way to link Lafayette Plaza Park to the library and future public park
- Create a pedestrian connection between Moraga Road and the Library
- Place utilities underground to provide unobstructed views of mature creekside trees

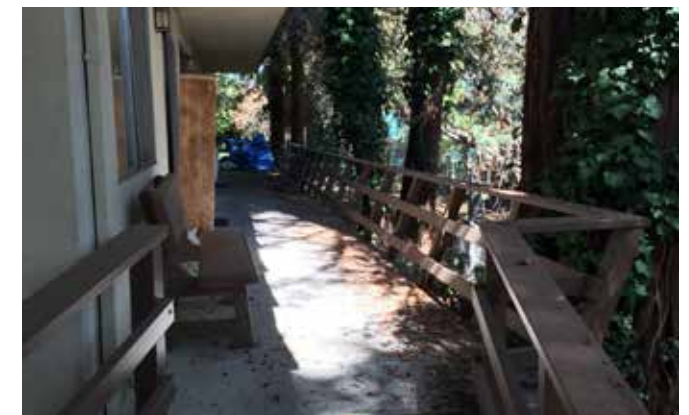
*Pedestrian walk adjacent to creek is unused.*

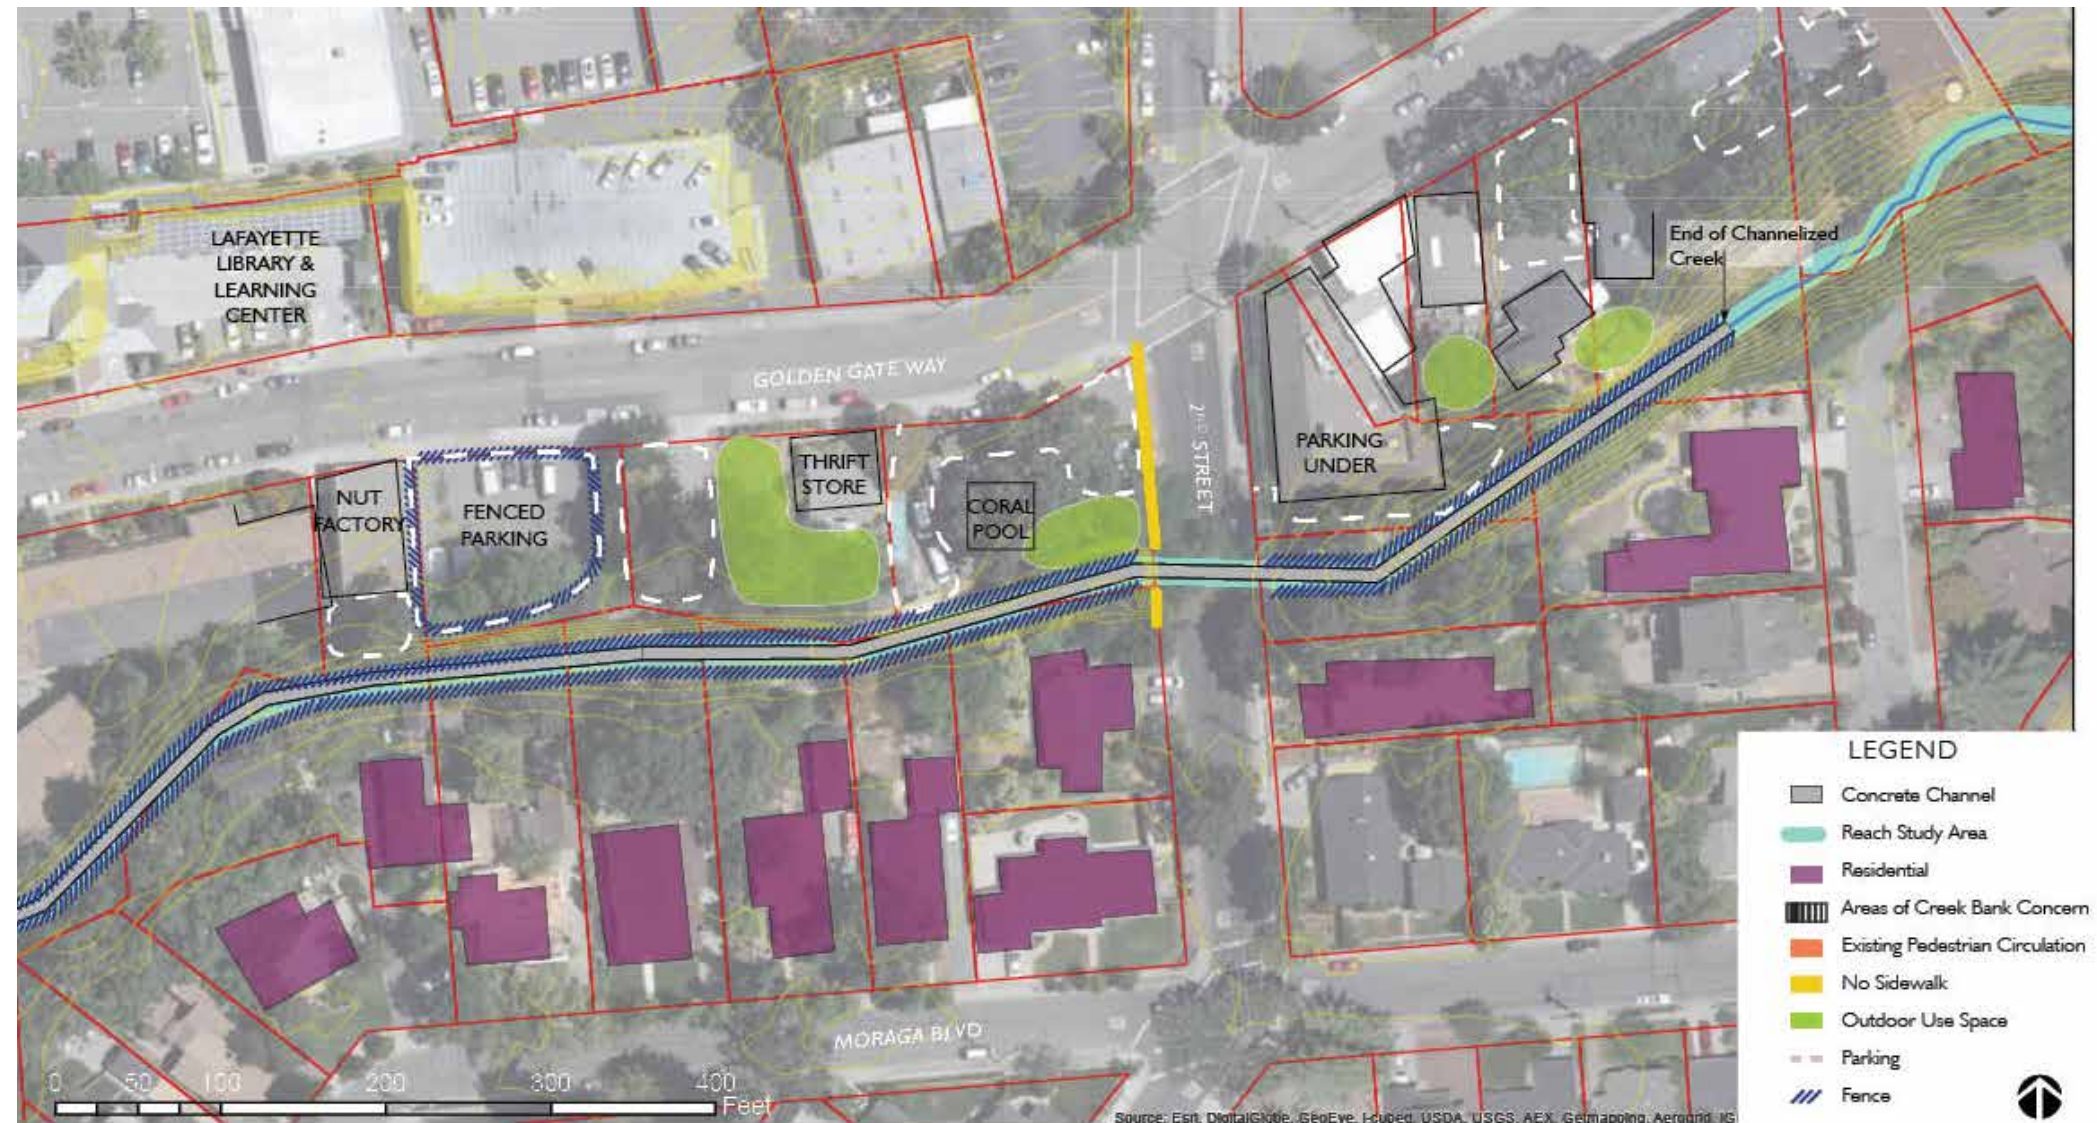
Figure 3-15: East Reach 2 Existing Conditions

- Existing outdoor public use space is located only along the north side of the creek.
- Backyard fences of homes are located along the south side of the creek.

- Create new pedestrian access on the north side of the channel and connect to the creek via 2nd Street
- Create an overlook at 2nd Street
- Remove non-native vegetation
- Modify / enhance the surface of the concrete channel to more closely mimic a natural creek channel and/or create more natural creek bed conditions
- Celebrate the majestic oak located on the Coral Pool property

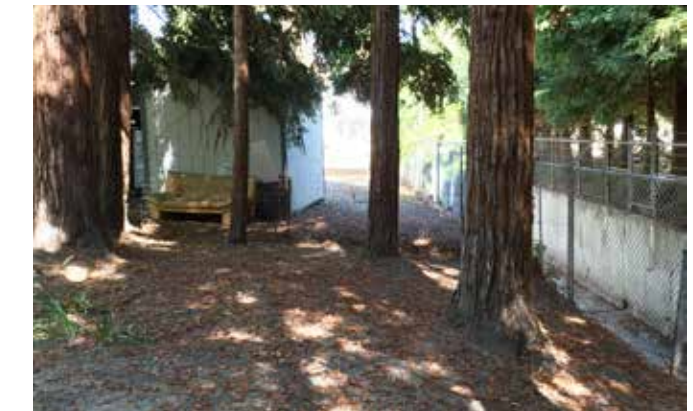
*Fences block views and interaction with the creek.*

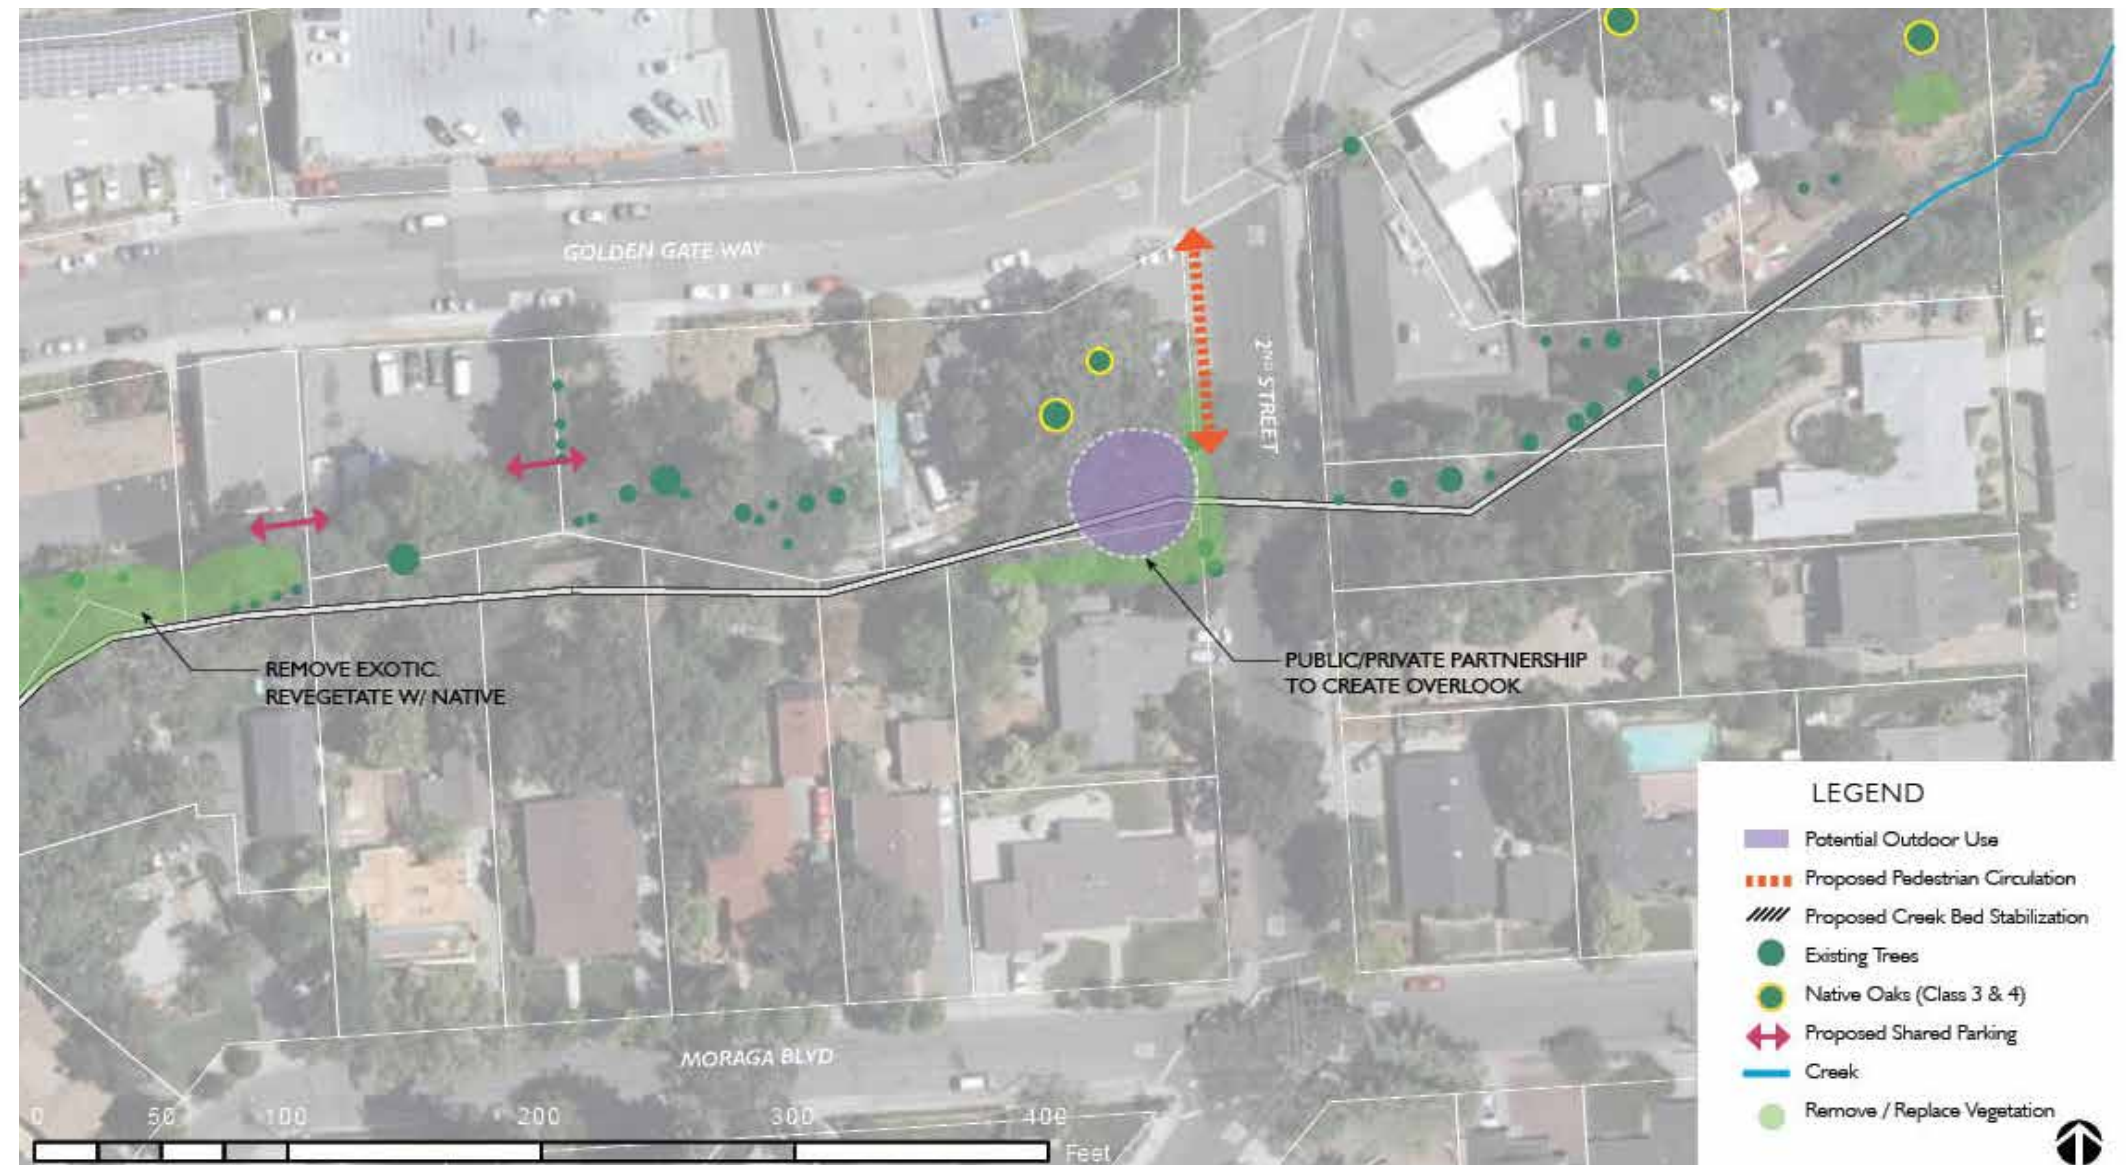
Figure3-17: East Reach 2 Opportunities

The majority of this section of the creek is within a concrete channel or culvert, which presents a near-term habitat restoration challenge for the creek. Nonetheless, habitat restoration is possible along the

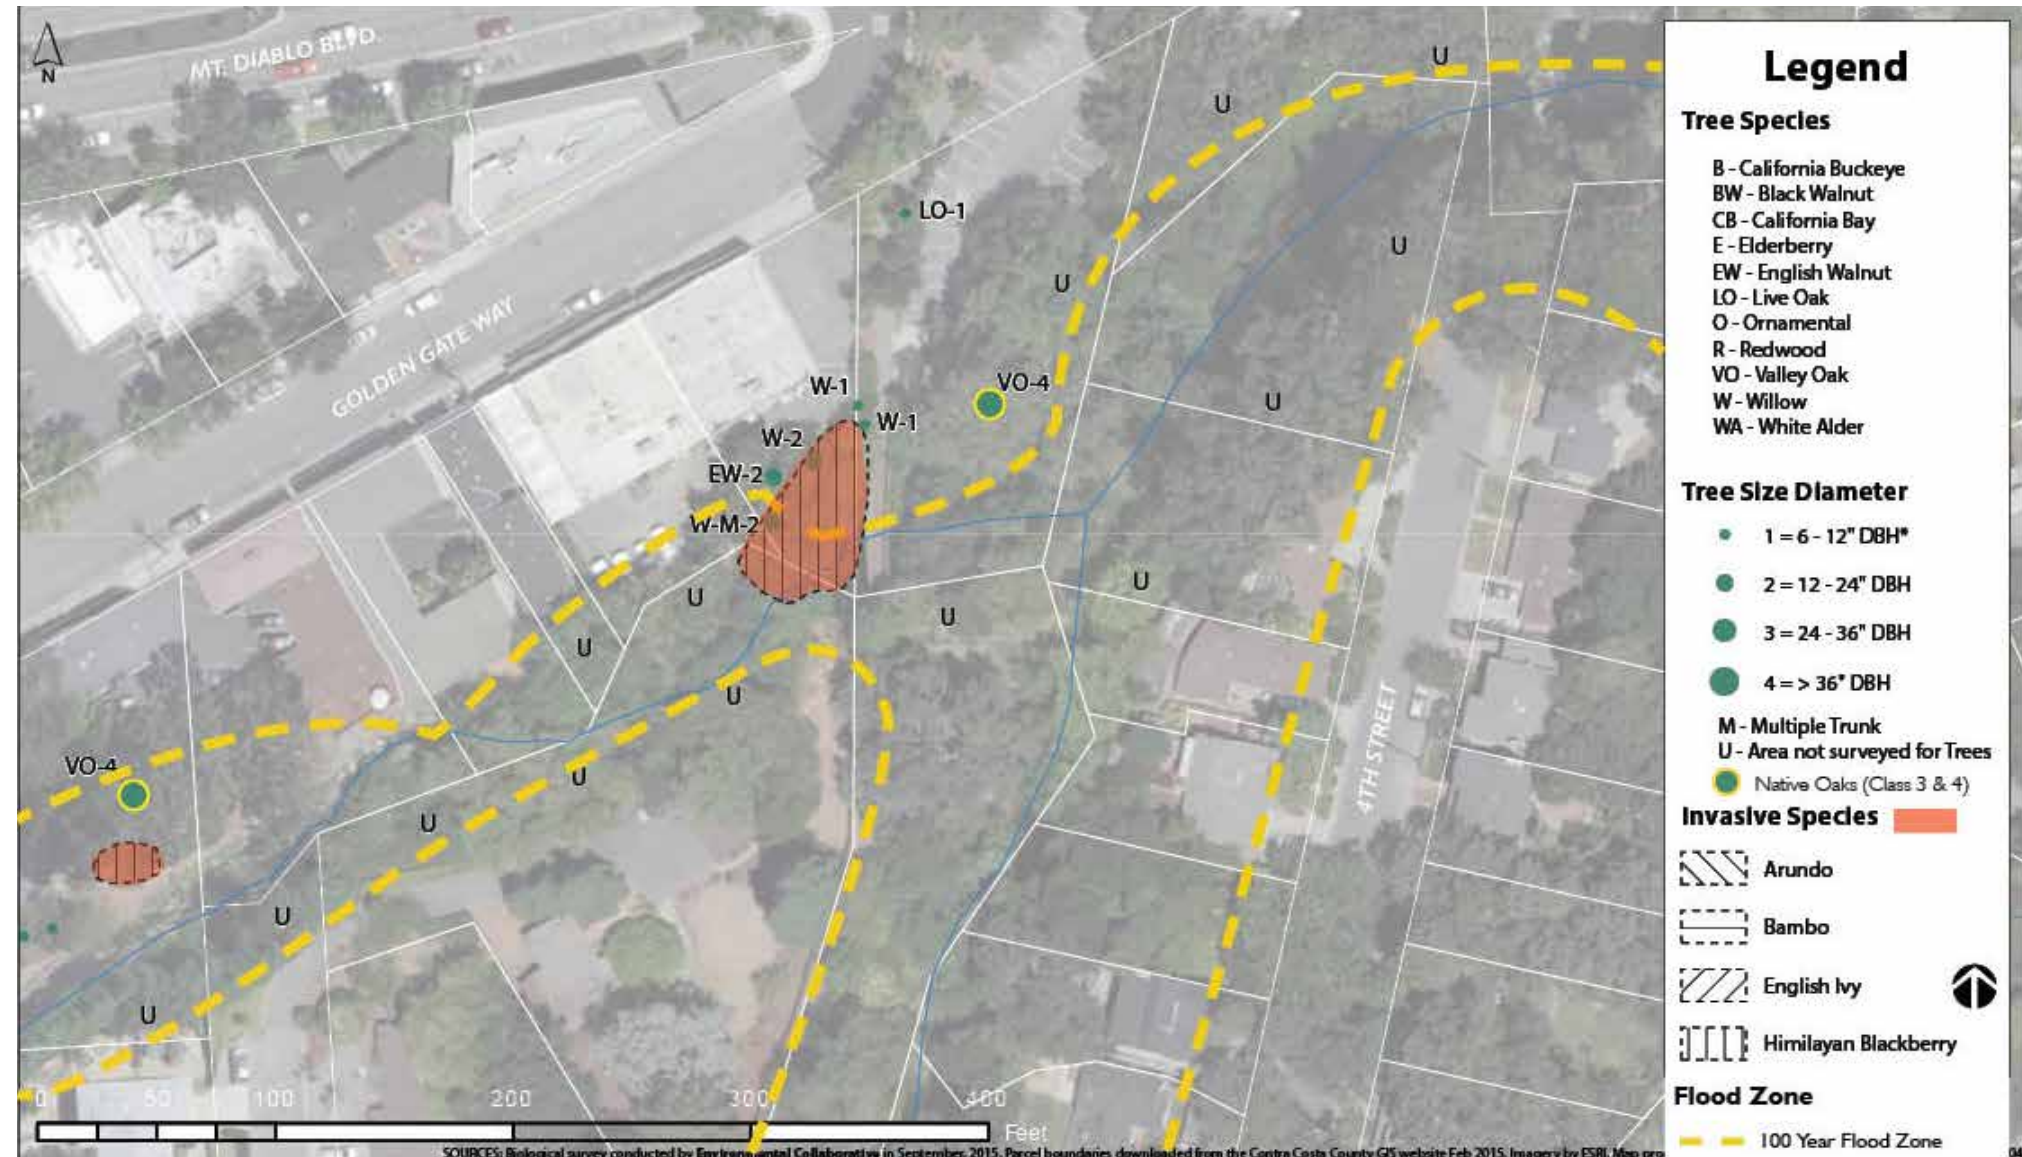
Figure 3-20: East Reach 3 Biological Conditions.

Several significant oak trees are located in this area; trees in this segment of the creek include willow (*Salix lasiolepis*), valley oak (*Quercus lobata*), live oak (*Quercus agrifolia*), and English walnut (*Juglans regia*).

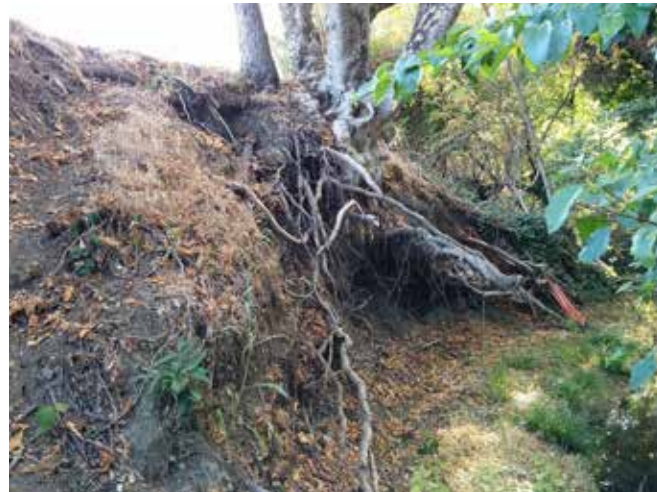
Exposed tree roots at West Reach

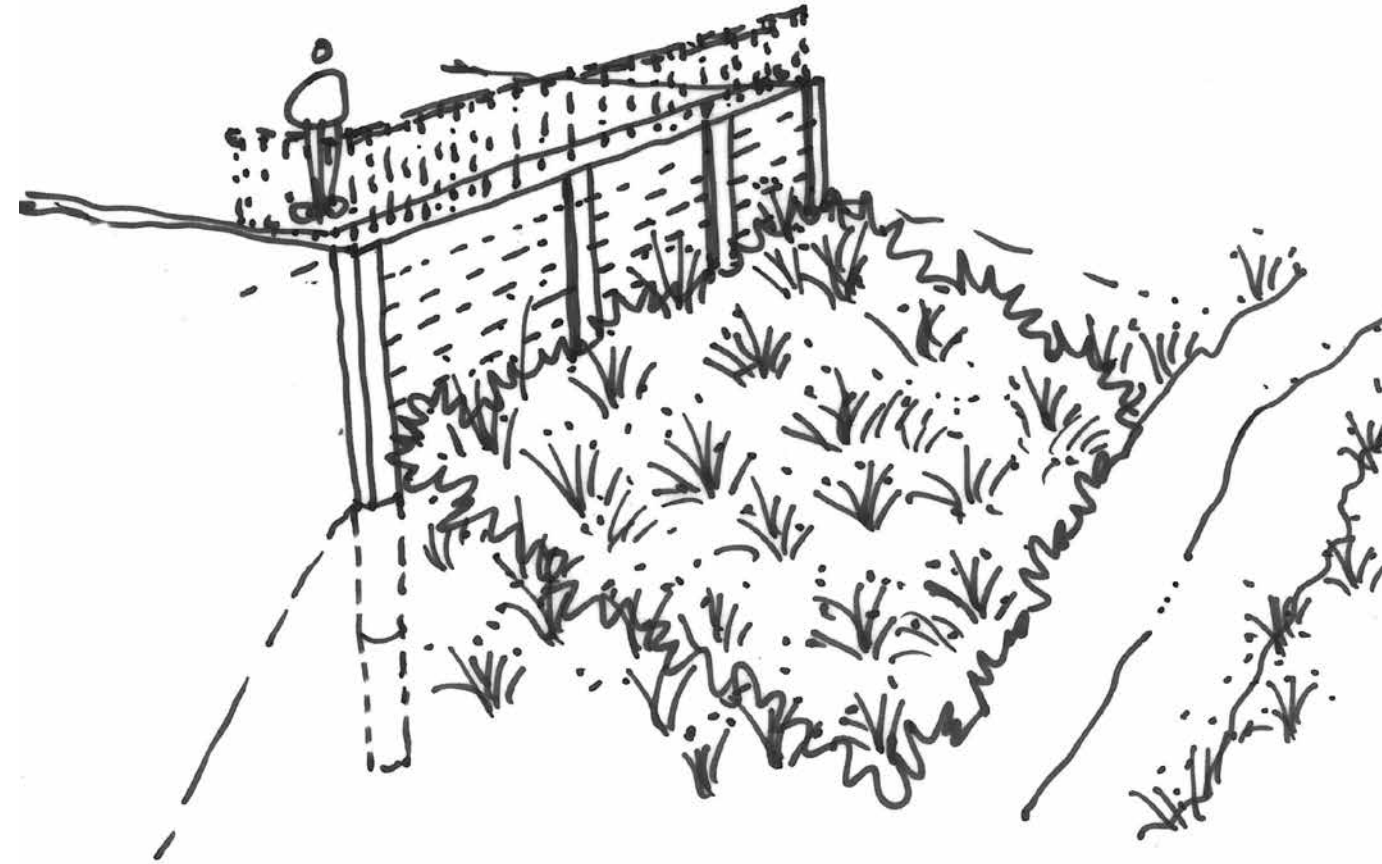
Figure A-1: Illustrative Example of Pile Wall

- **Below Grade Pile Wall** – Pile walls are walls with the supporting structure driven or bored into the ground. They may be made of a variety of materials, including steel, concrete, wood, and vinyl. There are multiple types of pile walls, such as soldier, sheet, contiguous and secant pile walls. Typically, they are embedded within competent soil or bedrock, and can be worked into tight areas. Figure A-1 illustrates the concept for a soldier pile wall. It is unlikely that any type of pile wall will be able to be constructed without damaging the eroded tree.
- **Below Grade Buried Rip-Rap Fill** – This solution is a rip-rap filled keyway constructed at the top of bank.
