HISTORICAL RESOURCE  
ASSESSMENT REPORT

## Memorandum

Project Lennar Homes

Topic Historical Resource Assessment

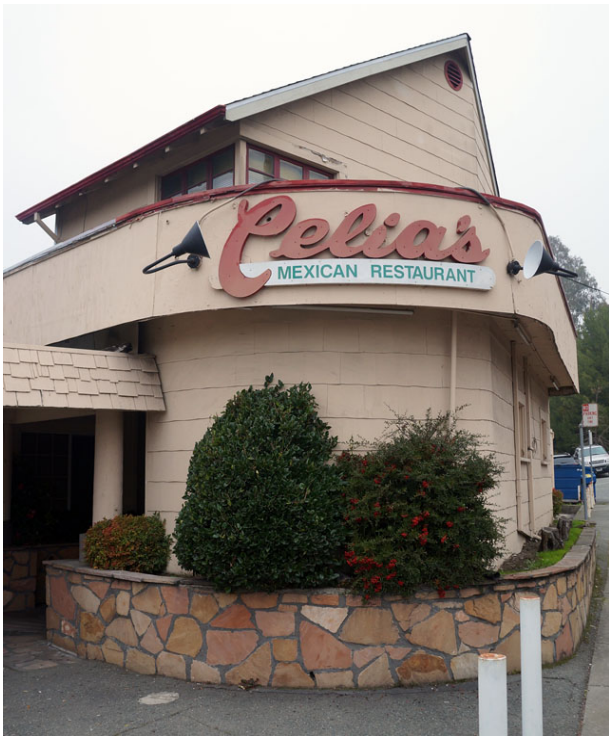
View of the curved fascia at the southeast corner of 3666 Mt. Diablo Boulevard.

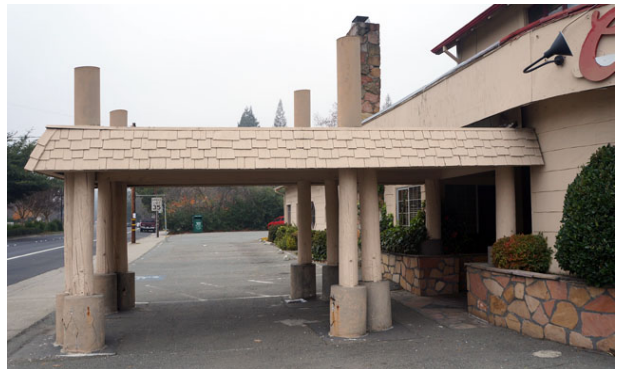
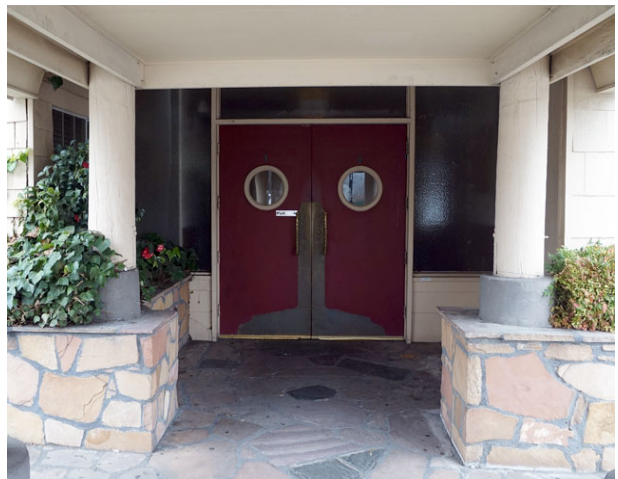
Views of the porte cochere (above) and entrance doors (below).

Feeling	The property conveys character and overall qualities it originally had although the additions on the building including the porte cochere and exterior finishes somewhat diminish the historical feeling.
Association	The property retains the relationships it originally had to its significance, as a leisure establishment along Mt. Diablo Boulevard and example of roadside design.
Materials	The property retains integrity of materials but is somewhat diminished with the replacement of exterior finishes.
Design	The property retains its original historic design traits despite its additions. One of the most prominent additions, the pier-like porte cochere, illustrates a pared-down Tiki style; although this does not relate directly to the style sources in the earlier portions of the building it was used for many well-known buildings on thoroughfares during the heyday of Roadside design, so this change does not diminish the ability of the building to convey its association with historical trends that make it significant.

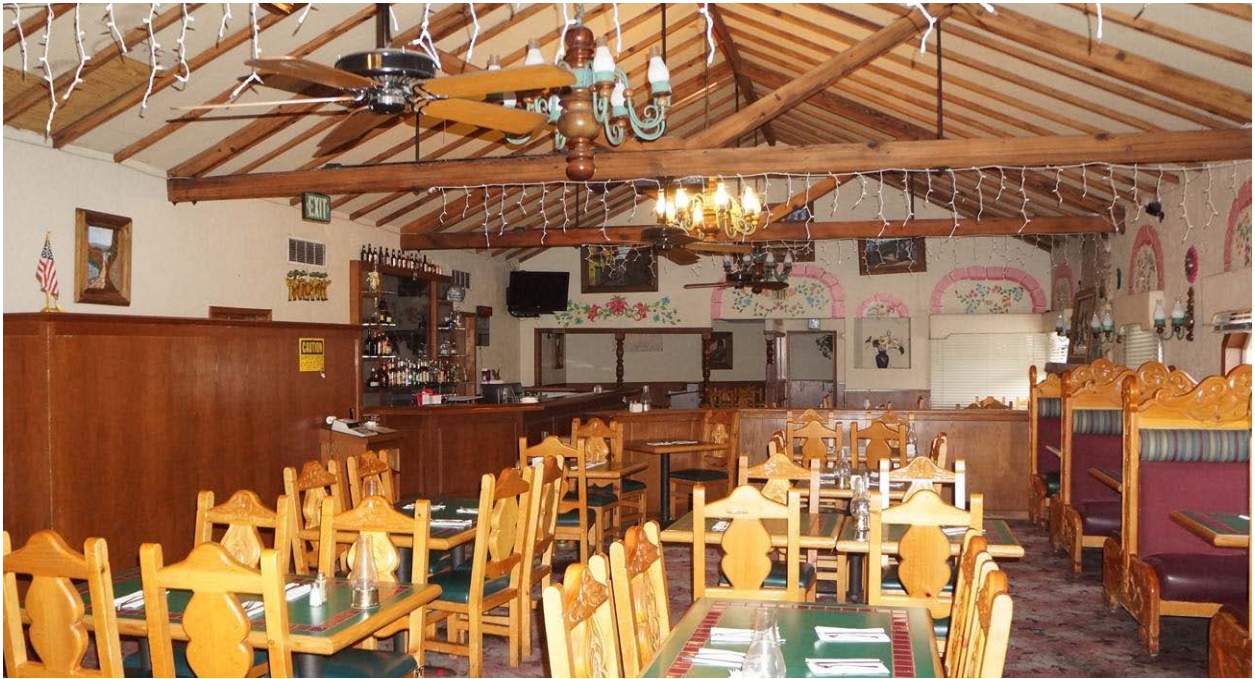
View of the dining room of 3666 Mt. Diablo Boulevard, looking east. The early bar is at the left in the background and the early masonry fireplace is at the right.

The interior of the bar/dining space is composed of carpeted floors, flat wood wainscot with projecting cap and base, painted rustic plaster walls with decorative painting, heavy timber trusses supporting the roof with wood trim which resembles rafters at the ceiling with acoustical tile between the rafters. There is a large fireplace at the east end of the south wall of the dining space with stone chimney, mantle, hearth, and raised base. The bar is located across from the fireplace and is composed of a wooden bar partition with stainless steel bar top. The wall behind the bar has a large wooden shelf assembly with central mirror. The wood is finished with a golden colored stain. The entry and lounge areas at the southeast have dropped gypsum board ceilings, plaster walls, wood wainscot, and carpeted floors. The front pair of doors are metal with one round port hole at head height at each door and glazed transom and sidelights in a wood frame. The west kitchen has plaster walls and ceilings and red tile floors. The other support spaces were not observed.

The physical condition of Structure 1 is good. There is minor exterior wood deterioration at the base of the rear additions and exterior side of windows. The interior appears intact with some patching of ceilings with plywood at the bar/dining area.

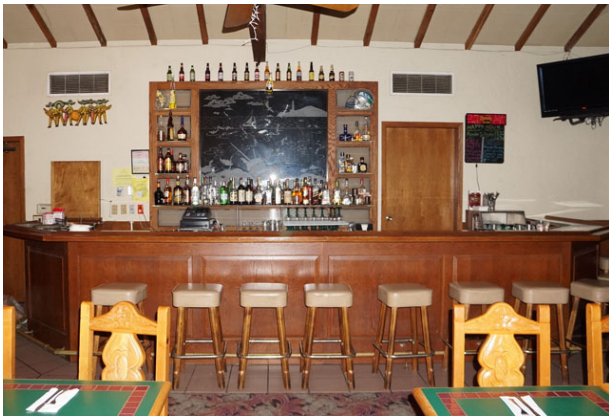
View of the existing bar, possibly in its original location.

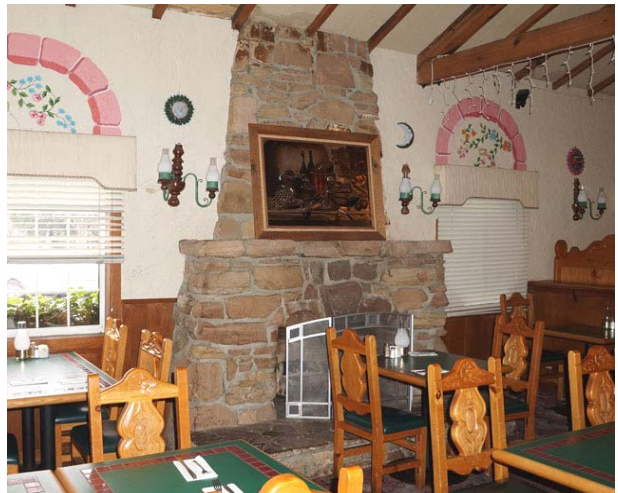
View of the early fireplace.

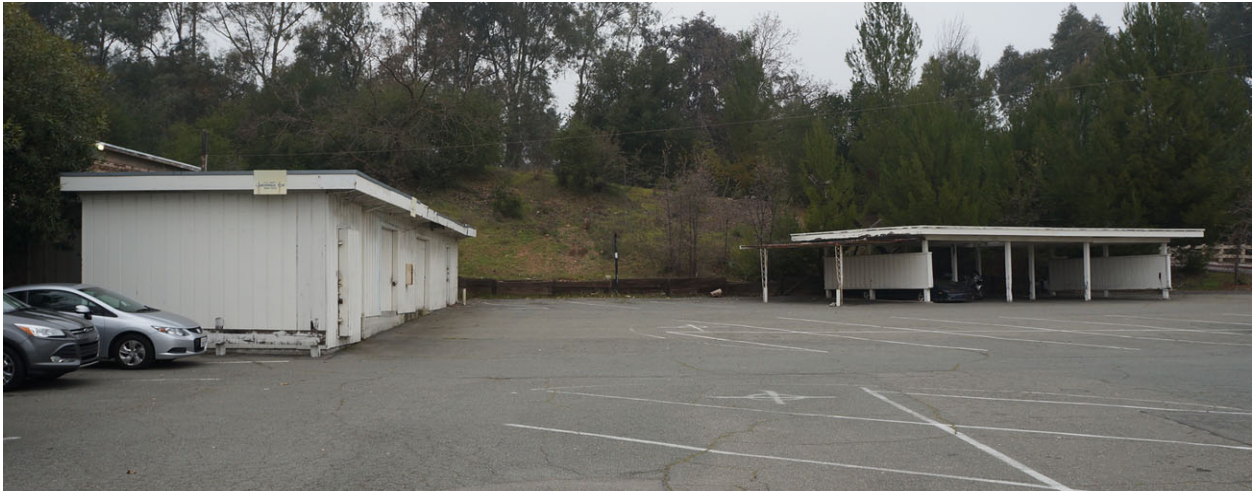
View of the northern portion of the parcel numbered 3666, showing the storage building (Structure 2) at the left and the carport (Structure 3) at the right.

The storage building is a simple one-story, wood frame structure, measuring overall about 52 feet long by 30 feet in depth. It has a sloped roof, exposed rafter tails at the eaves, vertical board siding and doors made up of vertical boards. There is a locker and toilet room at the north end of the structure and a cold storage room, added in 1967, at the south end. The interior was not observed. The condition is fair with wood deterioration at the base of siding and eave, and poor roof drainage.

The carport is composed of two sections; one is trapezoidal, measuring 33 by 18 feet, and the other is rectilinear mass, measuring 10 by 20 feet. The main body of the carport was built from wood posts supporting a flat wood-frame roof. Two panels composed of vertical wood boards over wood framing provide some shear strength to two of the column lines. The bay at the west is covered by a lower roof, attached to the main roof framing, and supported by metal filigree posts. The condition is fair to poor; it appears unstable with some wood deterioration.

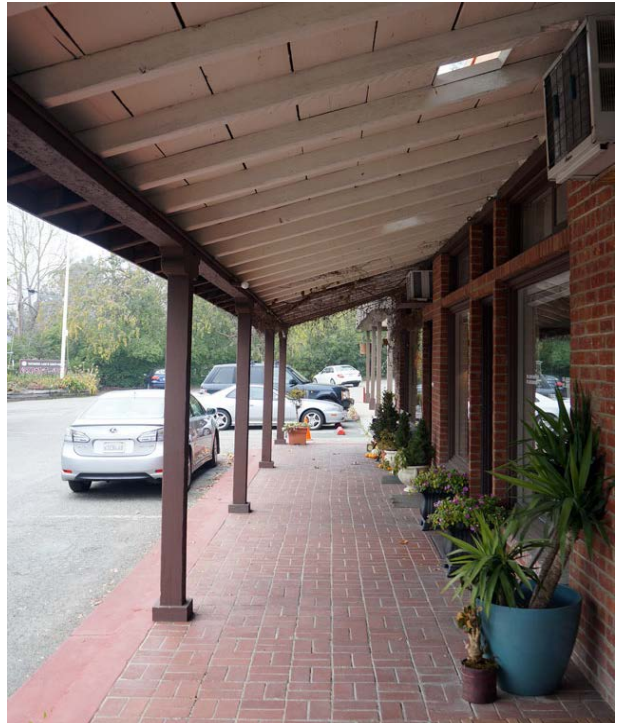
View of the front porch of 3674-78 Mt. Diablo Boulevard.

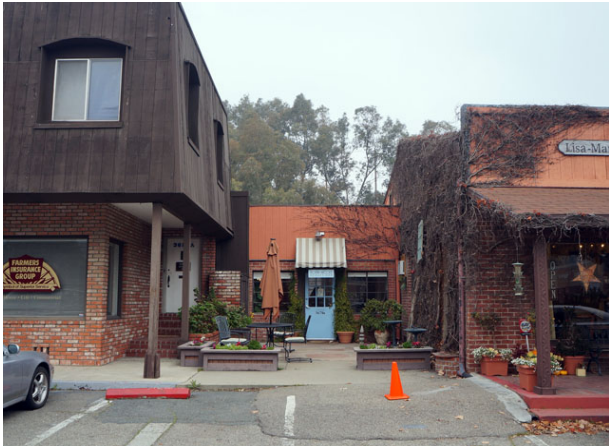
View of 3678a (second section of Building 1) which is recessed from back between 3674-78 (first section at the right) and 3680 Mt. Diablo Boulevard (third section at the left).

The condition of Building 2 is good. The ivy growing on the first and second section of the building is likely bringing moisture to the surface and deteriorating the face of the brick and upper wood siding. The upper section of the rear concrete block wall at the second section appears to suffer from water infiltration. This might indicate a roof leak. According to tenants, Building 2 has experienced flooding in the past from the rear hillside and may not have adequate drainage surrounding the building.

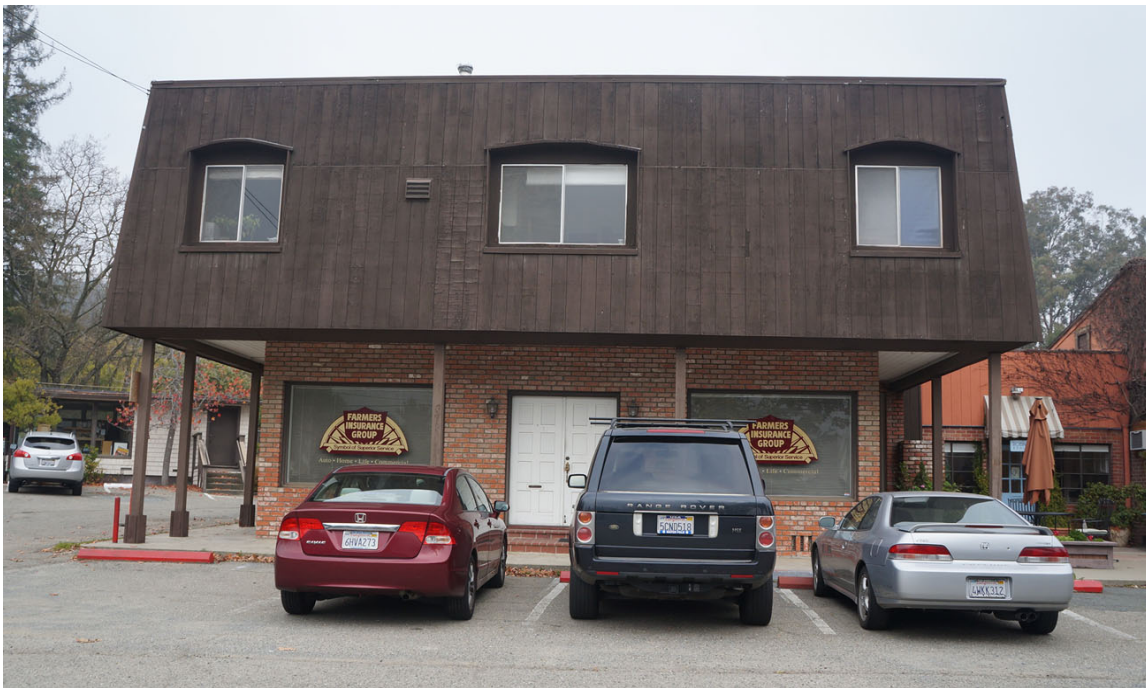
View of the south exterior wall of 3680 Mt. Diablo Boulevard, with 3678a at right.

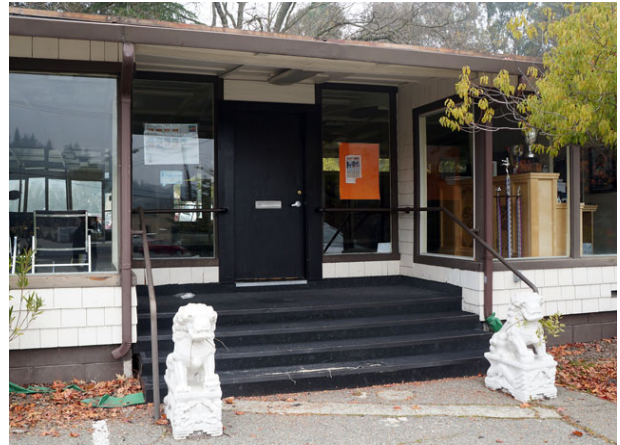
Detail of the recessed entrance porch of Building 3.

The physical condition of Building 3 is good. Deterioration of roofing and gutters is visible at the north side. Shingles have been replaced at the northwest corner of the building.

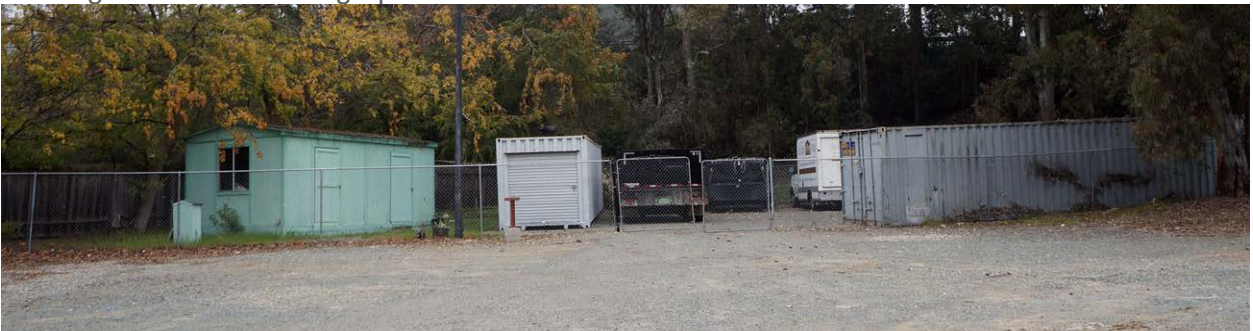
View showing the temporary storage building (left) and containers on this parcel. East Bay Municipal Utility District property is in the foreground.

Because this structure does not appear to have a foundation, it appears to be temporary,
