Pacific Gas and Electric Company

Tree Root Interference Assessment

February 19, 2014

Dynamic Risk Assessment Systems, Inc.

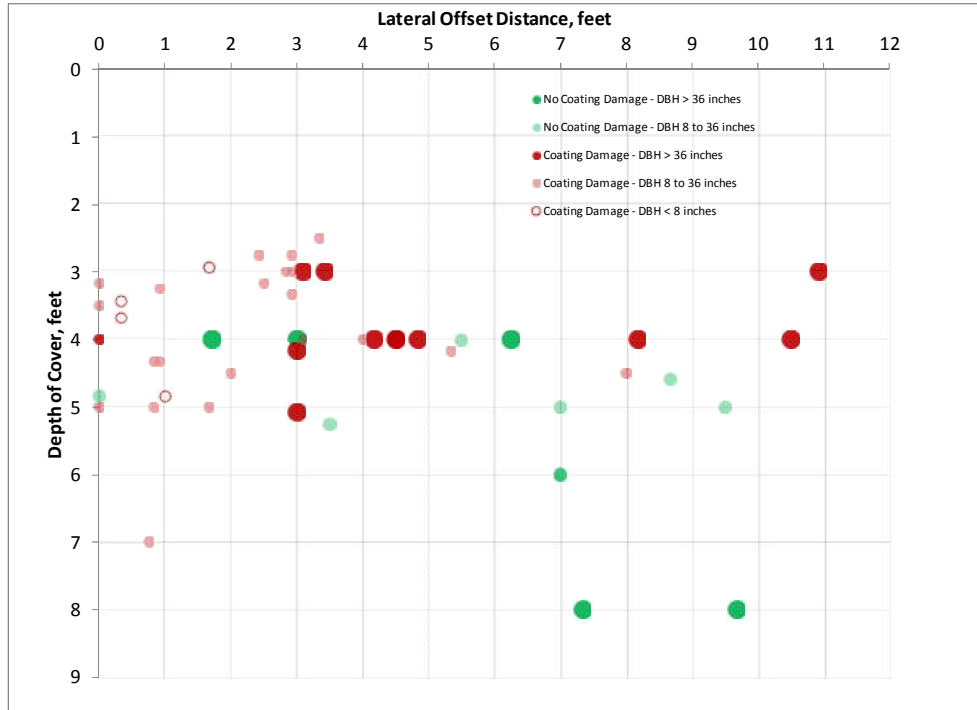
Figure 5. Depth of Cover versus Lateral Offset Distance^s.

In evaluating the results from the 53 sites, a comparison between the lateral offset distance and depth of cover was produced and is presented in Figure 5. The legend provided in this figure discriminates the data based upon the tree diameter (DBH) and whether or not coating damage was evident.

As is evident from Figure 5, there is no obvious trend from these results. This is likely due to the number of attributes that influence the results. However, it is evident that tree size (DBH), offset distance, and depth of cover may be indicators as to whether or not coating damage has occurred.
