FINAL REPORT
VOLUME I
R-PG&E-20150427

Pacific Gas and Electric Company

Tree Root Interference Assessment

April 27, 2015

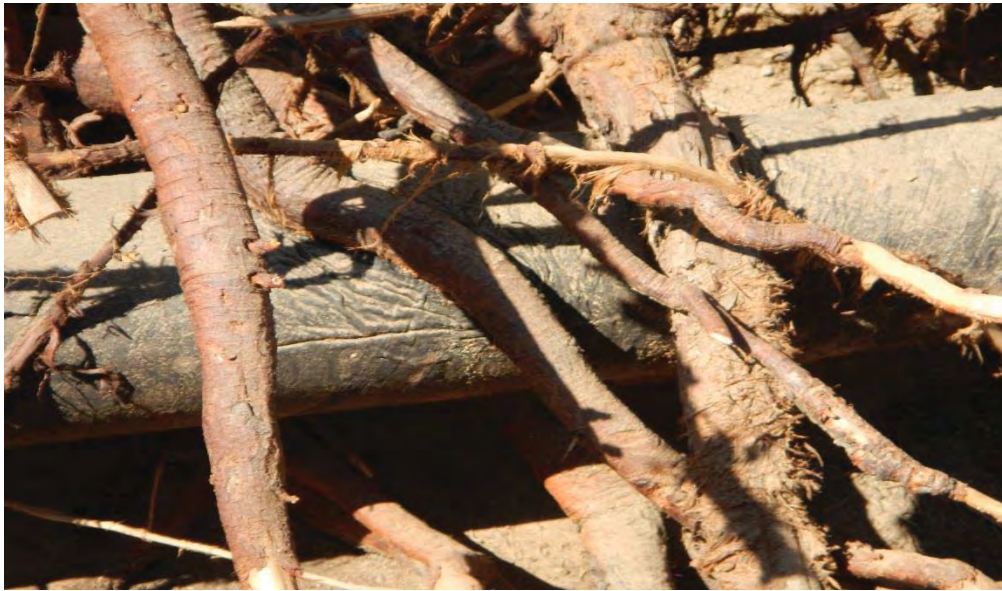
**Figure 3. RWVIM-107-13 (Weber Lane)
(CTE coating damage)**

The distribution of damage as a function of external coating type is summarized in Table 2. These results show that for the excavations performed, over 85% of the sites with CTE or HAA coating types^m had coating damage attributed to the tree root system. Examples of CTE and HAA coating damage caused by tree roots are presented in Figure 3 (RWVIM-107-13, Weber Lane) and Figure 4 (RWVIM-74-13, Atascadero), respectively. Since none of the excavations sites within this study contained pipe with fusion bonded epoxy (FBE) and there are limited results for pipe with polyethylene tape coating, there is insufficient information within the results to understand whether or not these coatings are less susceptible to damage from tree roots.

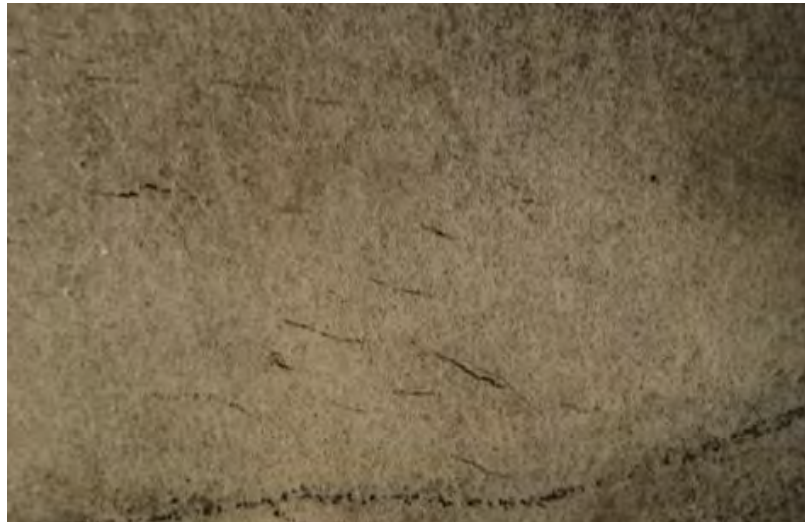
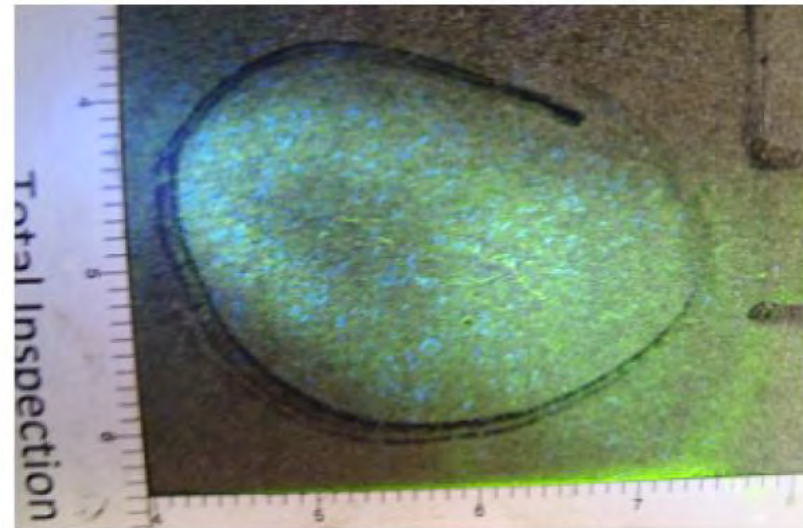
Per the excavation reports, none of the linear indications found on any of the 13 pipe segments were attributed to SCC. GE Energy performed the inspections on 11⁹ of the 13 pipe segments and concluded that these segments did not contain SCC. In general, SCC occurs in colonies, consisting of several to thousands of cracks. SCC cracks are usually oriented in the longitudinal direction¹⁰ and tend to interlink to form long shallow flaws. Figure 8 and Figure 9 contain representative photographs showing the linear indications identified by GE Energy. Photographs of representative linear indications identified for Dig RWVIM 89-13 are shown in Figure 8. As seen in the photographs, the indications were relatively long, straight, and were not associated with colonies. Based on the morphology, these indications were likely not due to SCC. In contrast, the representative indications shown in Figure 9 appear to occur in colonies. It is not clear from the photographs whether the indications are associated with SCC. The inspection crew on-site, however, did not identify these indications as SCC.

Figure 9. Photographs, provided from Digs RWVC 36-13(Left) and RWVIM 101-13 (Right), showing representative colonies of linear indications identified using magnetic particle inspection.

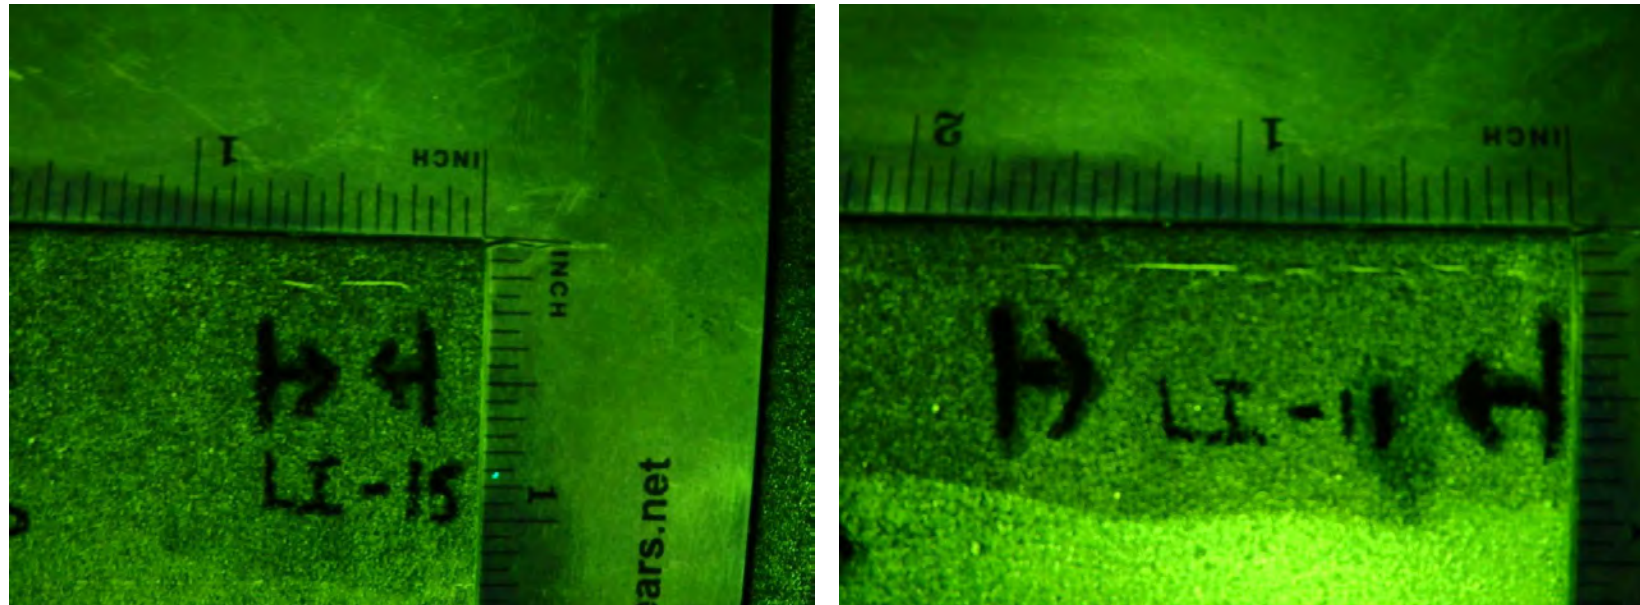
Mears performed the inspections on 2 of the 13 pipe segments¹¹ that contained linear indications. The indications on one of the pipe segments (i.e. RWVIM 160-13) were attributed to manufacturing defects/mill scale (i.e. not SCC), while the likely cause of the indications identified on the second pipe segment (i.e. from Dig 153-12) was not identified. Figure 10 and Figure 11 contain photographs showing representative linear indications that were identified for Digs RWVIM 160-13 and 153-12, respectively. As seen in the photographs, the indications are relatively straight and were not associated with colonies. Based upon the morphology of these indications, they were likely not due to SCC

Figure 10. Photographs, provided from Dig RWVIM 160-13, showing representative linear indications identified using wet fluorescent magnetic particle inspection.

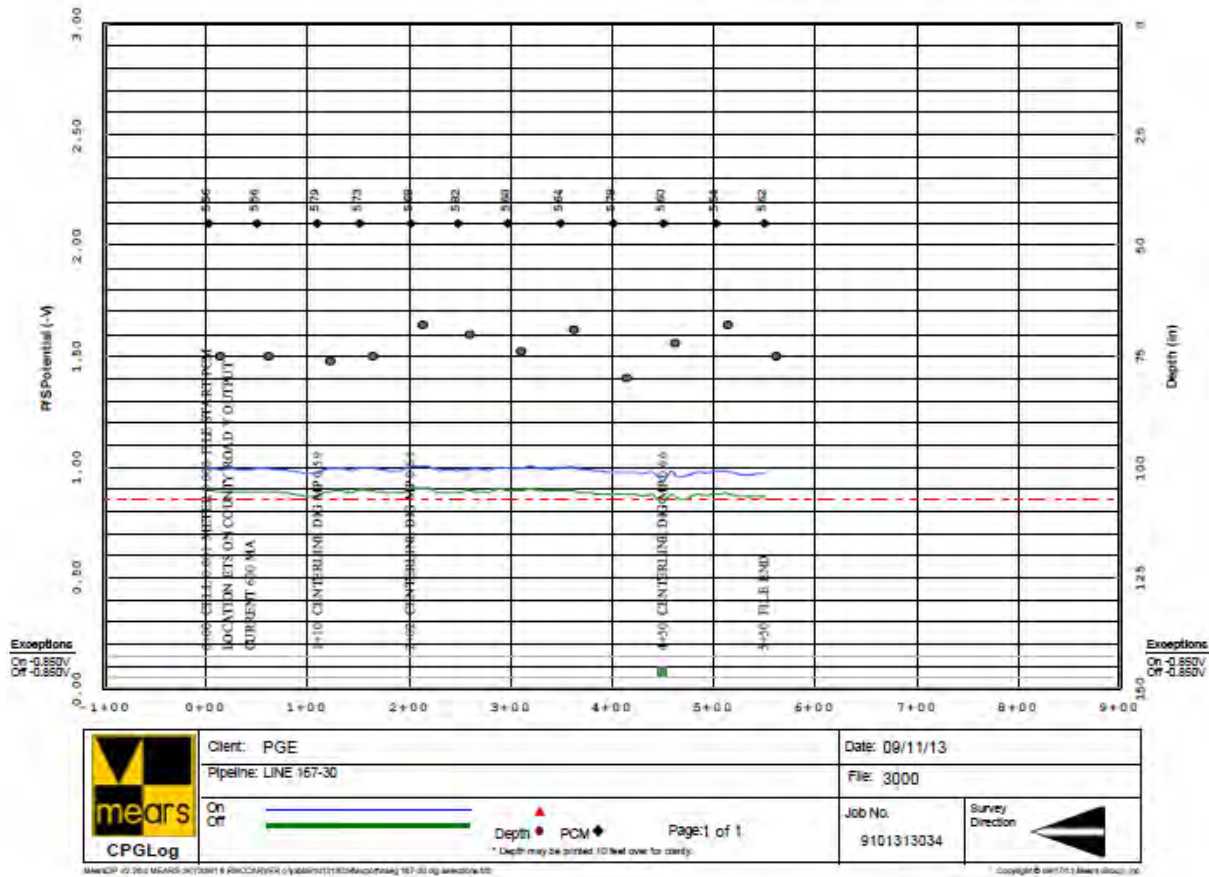
Overall, the results of the surveys were consistent with the presence of coating damage observed during the associated pipe excavations. For example, if the results of a coating survey associated with a particular pipe segment contained no call outs (i.e. no indications of coating holidays), no holidays were generally found on the pipe segment at the time of excavation. If coating holidays were identified for a particular pipe segment during an aboveground coating survey, coating holidays were generally found on the pipe segment at the time of excavation. Figure 13 and Figure 14 are representative plots showing the results of aboveground surveys where: (1) no

Figure 13. Profile, provided by Mears, showing representative results from an aboveground survey where no coating holidays were identified.

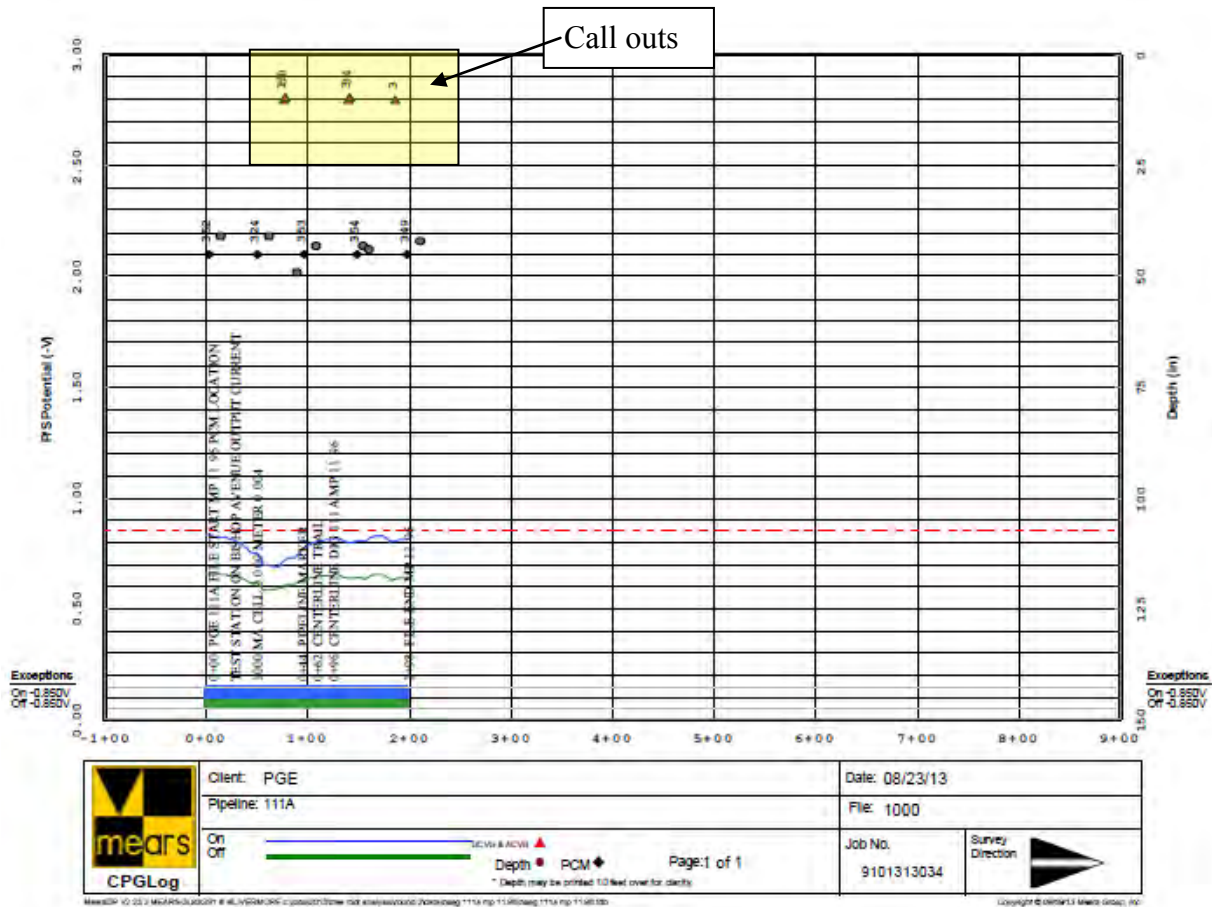
Figure 14. Profile, provided by Mears, showing representative results from an aboveground survey where coating holidays were identified.

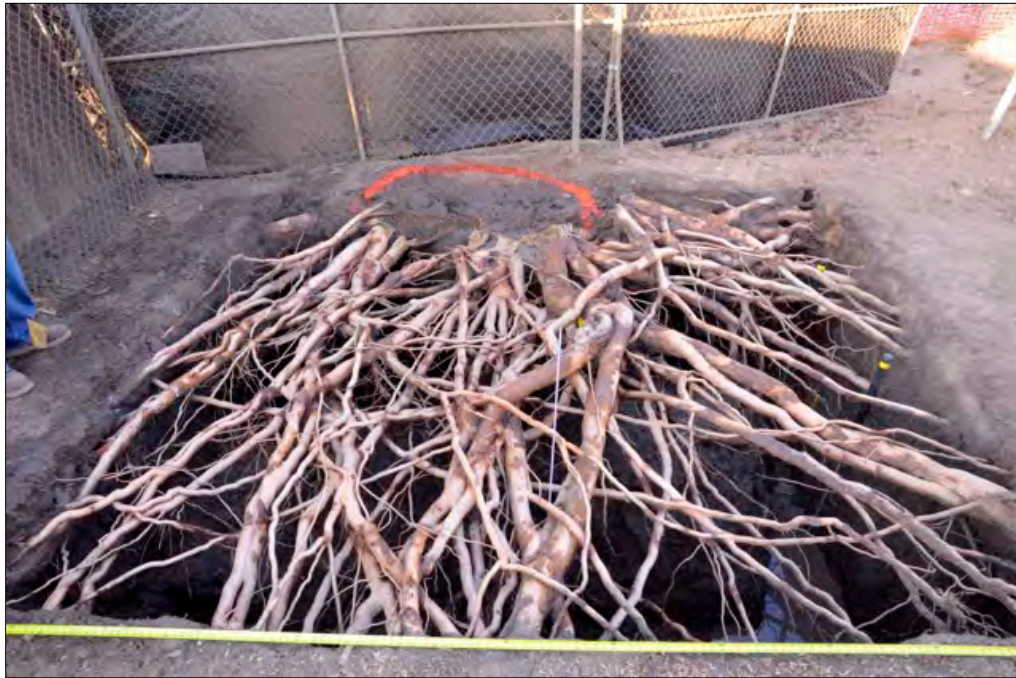
Figure 4. A lateral root system at 153-1.

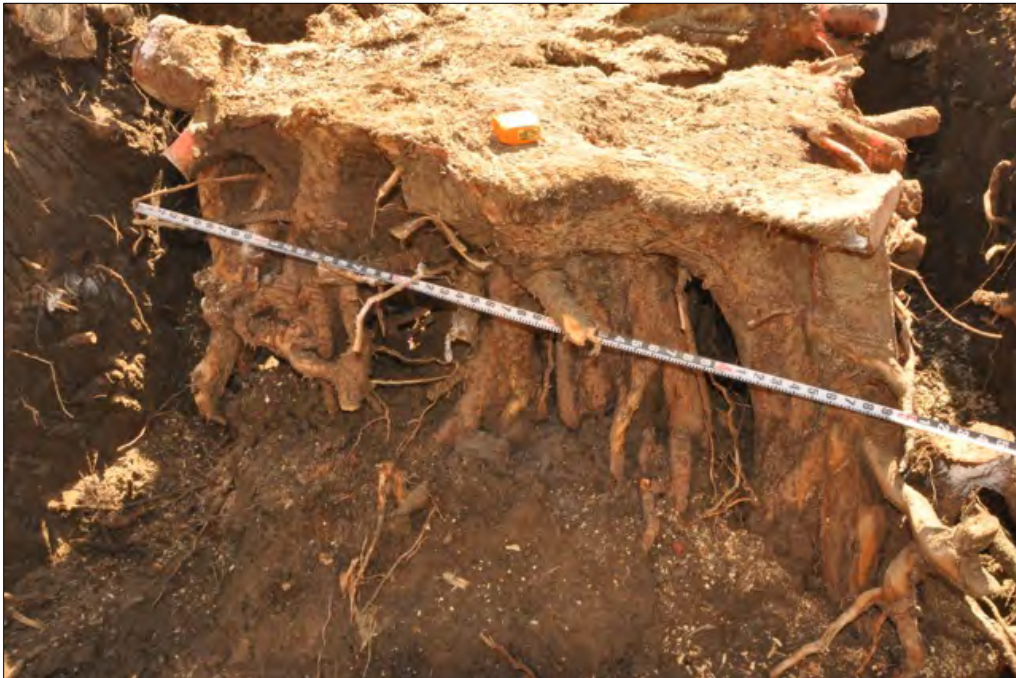
Figure 7. Sinker roots at dig site 153-4.

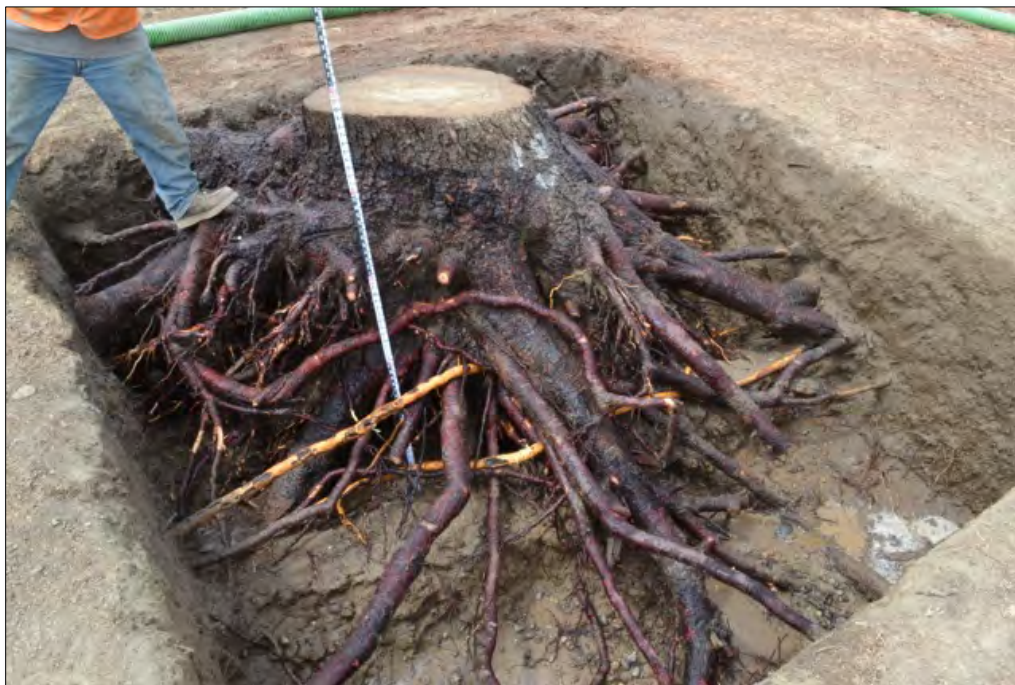
Oblique roots, unlike lateral roots, emerge at a downward angle from the base of the trunk (known as the root collar), or sometimes from lateral roots. It is the oblique and sinker roots that are most likely to interact with gas transmission pipes as they divide and grow to greater depths (Figure 9).

Figure 9. These are oblique roots at dig site 128-13.

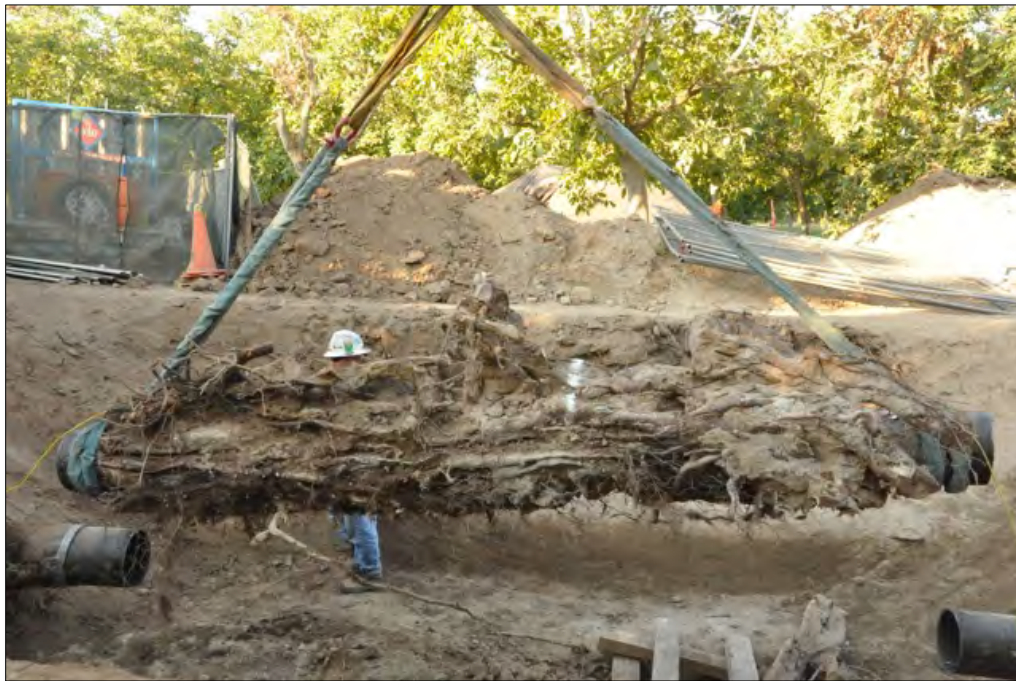
At these five dig sites roots were utilizing the trench to go into and/or below the hardpan layer. In the case of the Valley oak (RWVIM-90-13) the hardpan actually created a confined area that concentrated the growth of the massive root system near the pipe and, as a result, root and pipe/coating interaction was extensive (Figure 20).

Figure 20. Dig site RWVIM-90-13.

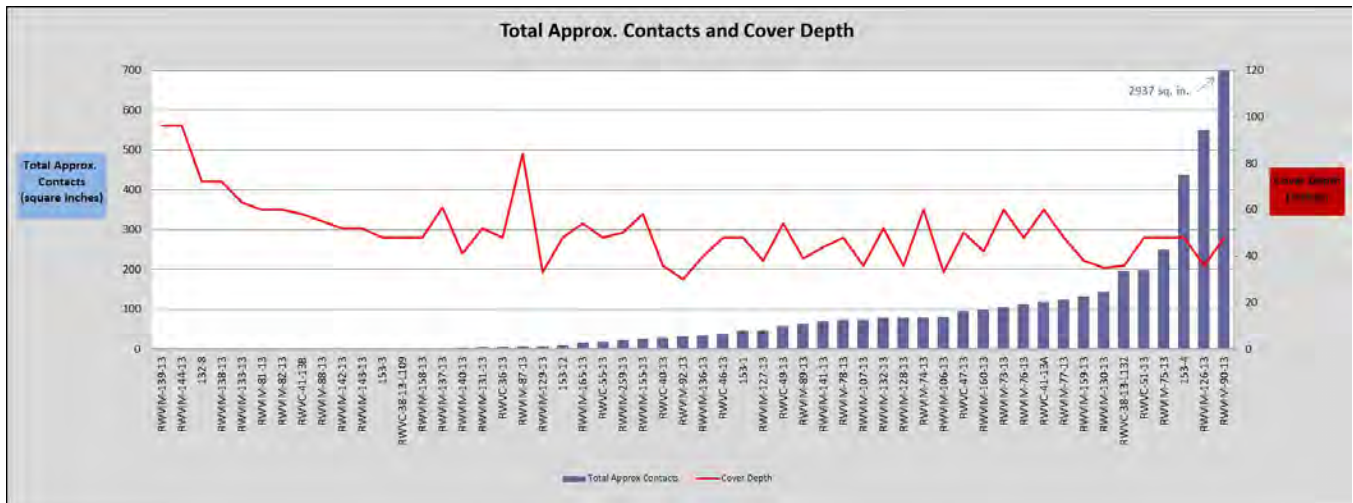
Figure 28

The following chart illustrates the unpredictable relationship between root-pipe interactions and cover depth. The chart depicts a general trend that deeper cover depth corresponds with less root/pipe interactions. However, it is important to note that there are many exceptions, as the red line indicates, which make the ability to predict these interactions difficult (Figure 28):

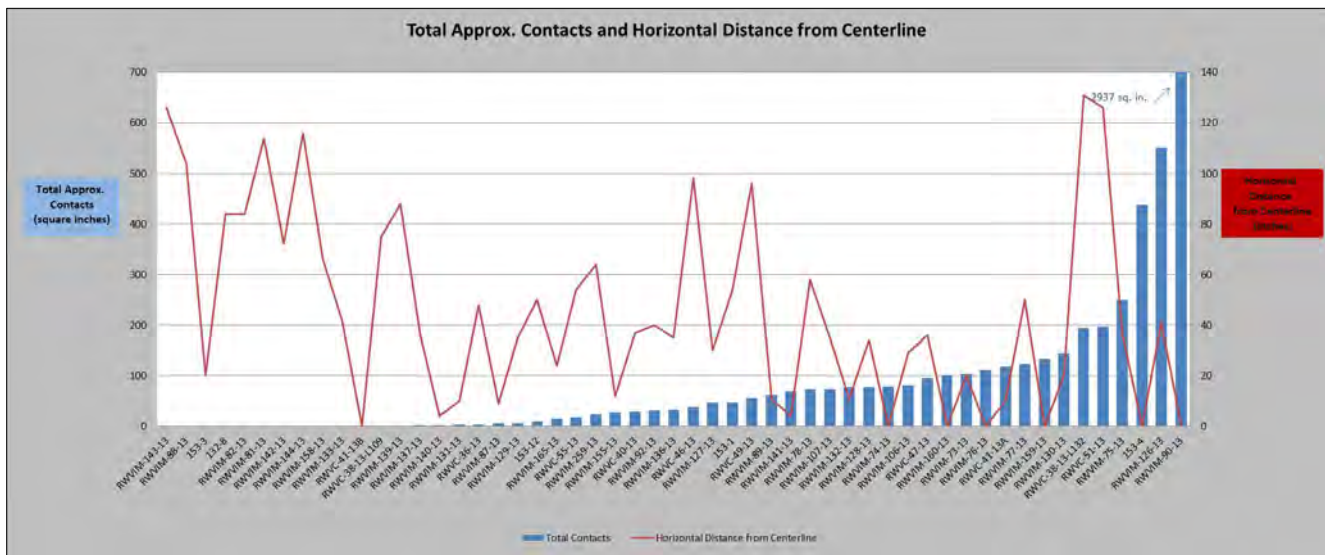
Figure 29

The following chart illustrates the unpredictable relationship between root/pipe interactions and horizontal distance from tree to pipe. The chart below indicates a trend or relationship between interactions and distance from tree to pipe centerline. Other factors, such as species, size of tree, and soil type affect interactions as much or more than distances between trees and pipe centerlines (Figure 29).

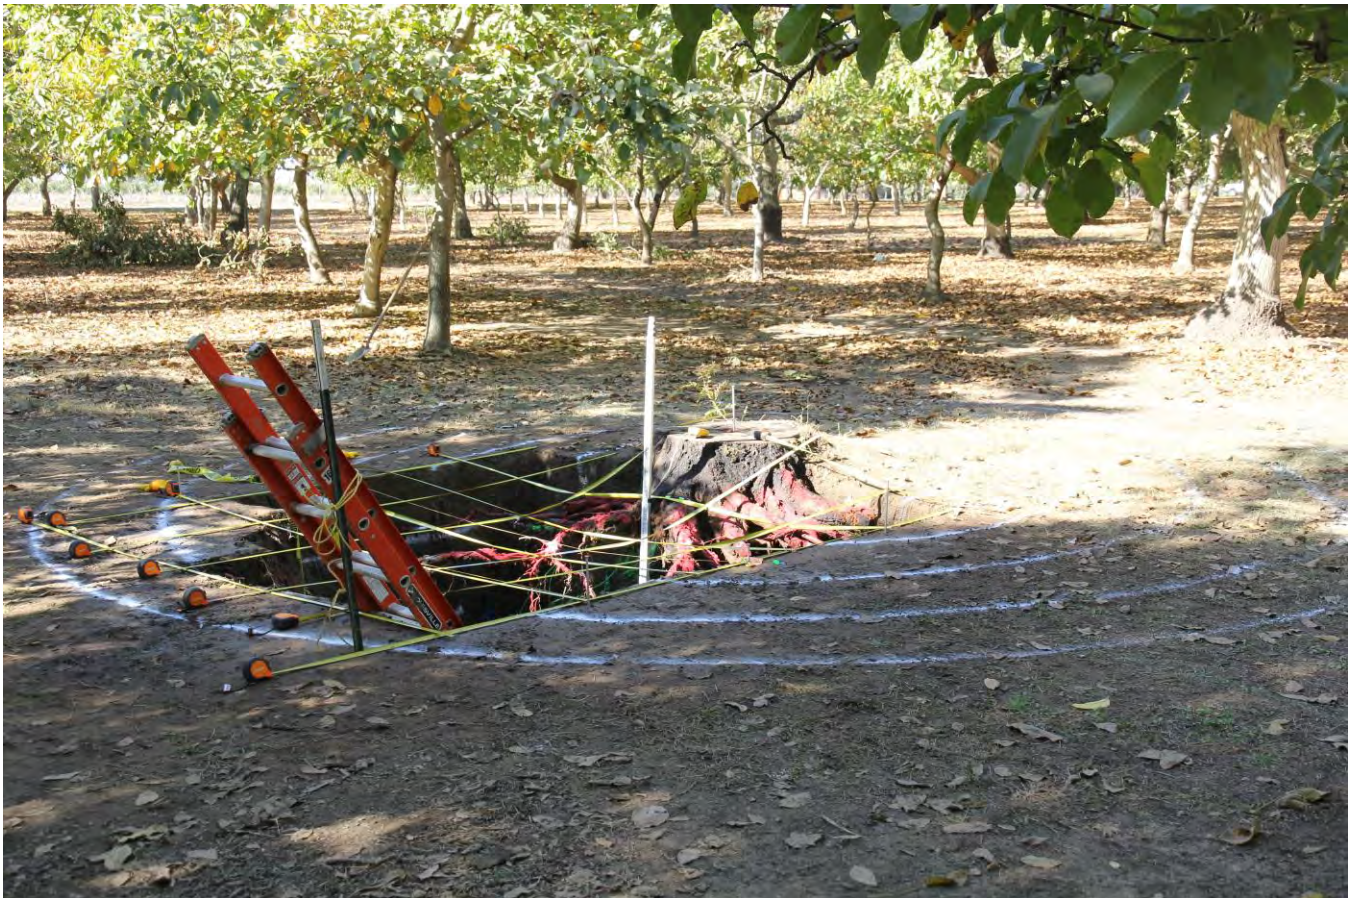
Figure 6. The walnut tree stump at Lockeford. The circular lines were scanned with GPR to map the entire root system. The trees in the orchard were of varying ages and sizes. The excavated tree stump was similar in size to the largest tree in the background of the photo.

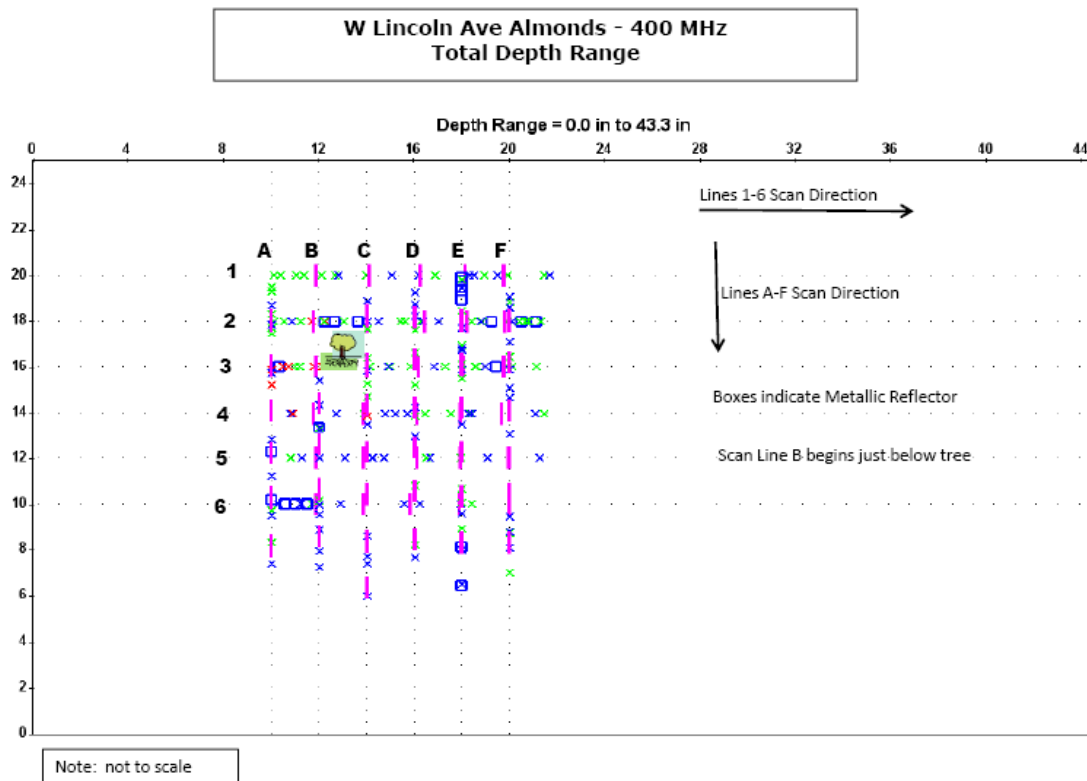
The data from the initial almond orchard in Fresno County was encouraging in that it did predict the root system of the tree quite well. Figure 7 shows the roots detected by the GPR within the grid of the 10' x 10' excavated pit. Figure 8 is a photo of the pit with the tree roots below the 12" depth still in place. The pipeline was not yet exposed at the time the photo was taken but it ran from the corner of the pit at the upper right in the photo, under the tree and across to the left edge of the pit. The trunk of the tree, the root crown and the root system visible in Figure 8 had to be removed prior to further excavation to reach the pipeline.

Figure 7. The scan grid for the almond tree at W. Lincoln Ave. illustrating the labeled scan lines with the roots detected by the GPR on each line.

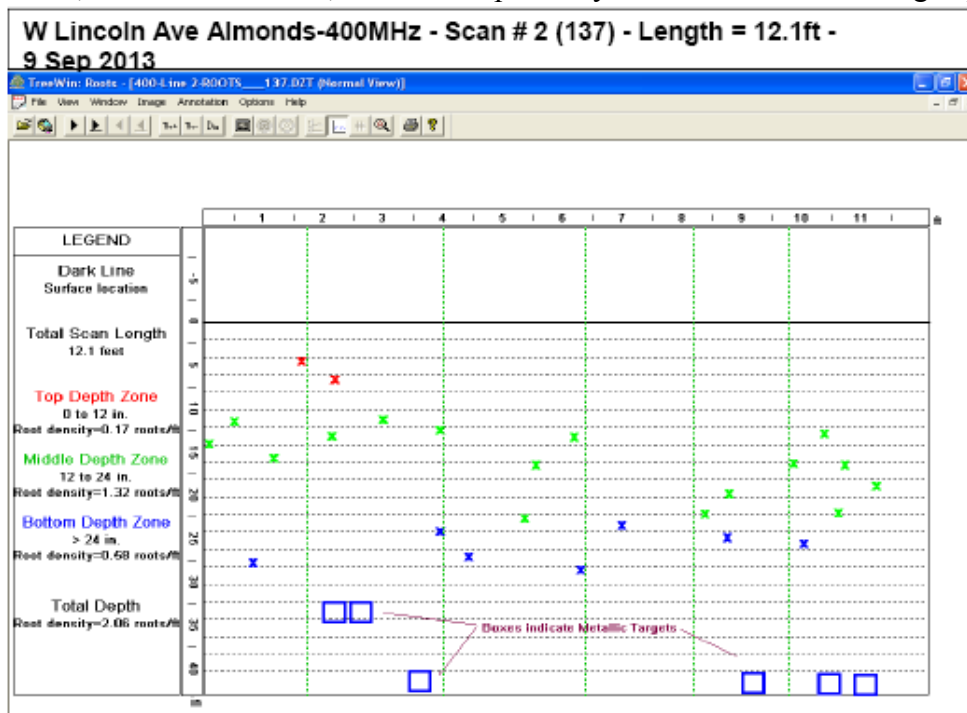
Examples of the scan profiles are shown in Figure 9 (line 2 in Fig. 7) and Figure 10 (line B in Fig. 7). In both scans, the roots are almost exclusively above the top of the duripan layer (28”) except for the area just under the tree in Fig. 10 where there are some roots down at the pipeline depth but not in the pipeline trench. The long roots, seen extending from the tree across to the left side of the photo in Fig. 8, show up well as the green (12-24” depth zone) roots in Fig. 9.

Figure 9. Profile 2 from the scan grid in Fig. 7 showing roots detected. The pipeline is the double box at 36” at the 2.5 point of the scan. The boxes at the bottom are voids or openings in the soil structure from cracks, fissures, animal burrows or, in this case probably remnants of an old tillage operation.

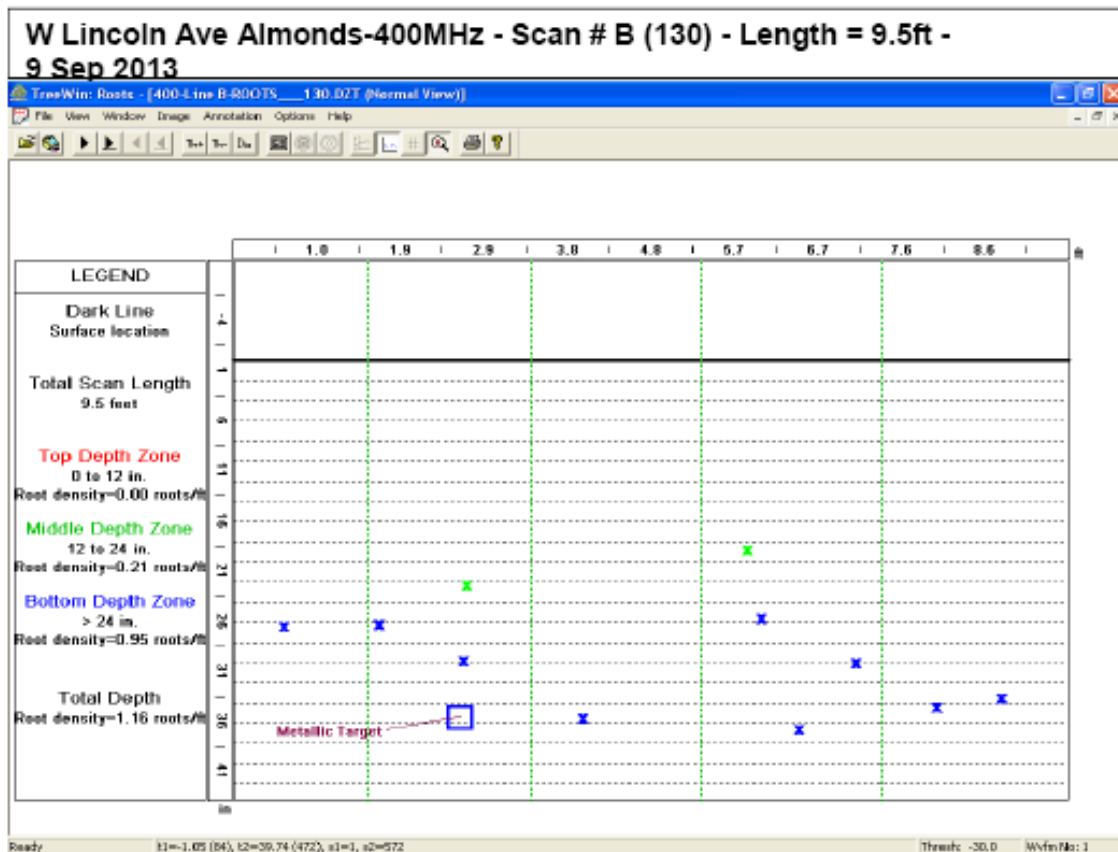
Figure 10. Profile B from the scan grid in Fig. 7 showing roots detected. The pipeline is indicated by the box at 36”

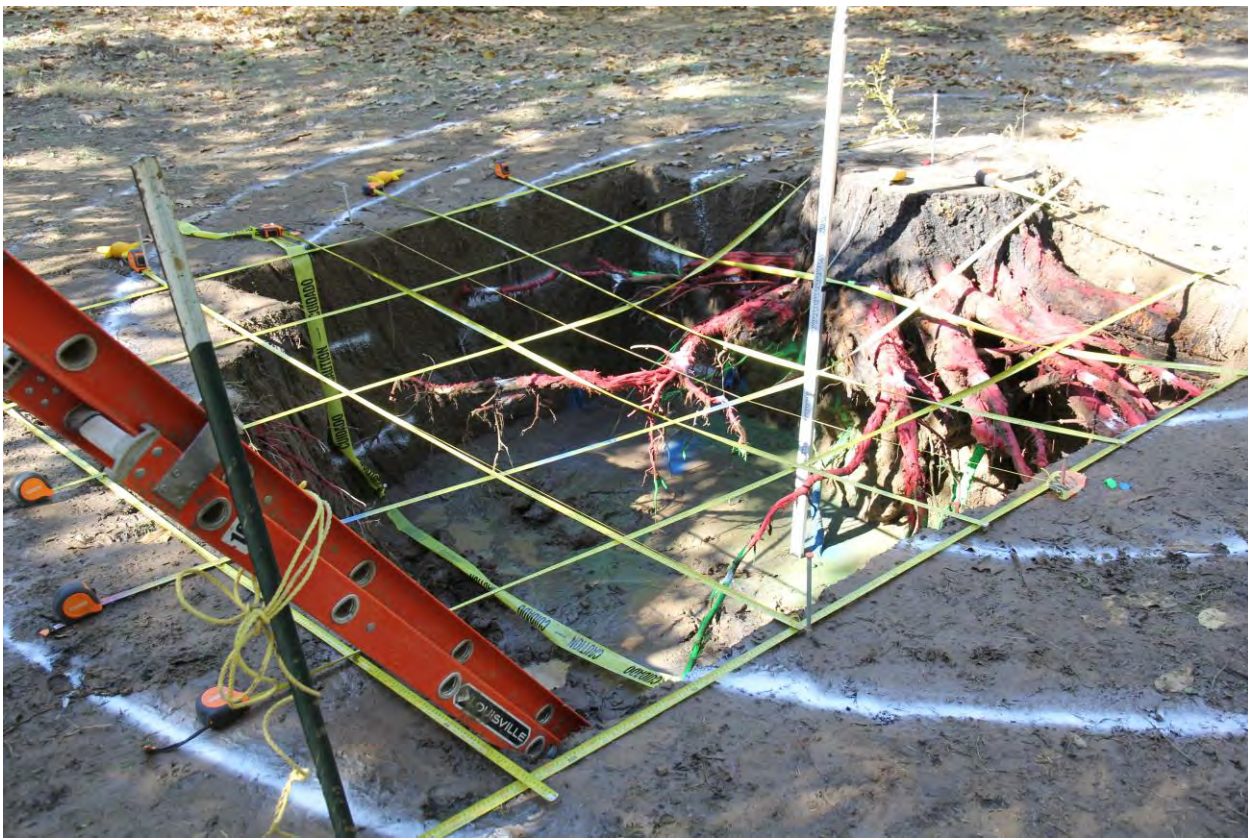
tree roots proliferated vertically instead of continuing to grow laterally as they did where the pipeline trench was not a factor. The photo in Figure 11 and the 3d root map in Figure 14 do show some indications of more vertical root growth over the pipeline compared to the roots in the native soil. Most of the roots detected in the GPR scans were well above the pipeline depth but Figure 12, the scan at the 12' radius from the tree shows some evidence of roots at the pipeline depth. The scan is a circle beginning north of the tree. The roots at the pipeline depth are concentrated to the left of the left pipeline box and to the right of the right pipeline box. Those areas are between the pipe and the tree. The space in the center of this graph of the 12" circle would show the soil between the pipe and the 12' radial arc beyond it. The roots in blue are at the pipeline depth, between the pipe and the tree. It would appear from Figure 12 that some roots grew near the pipeline at its depth of 50" and few other roots reached that depth in the native soil. An even more subtle indication of pipeline influence on the root system of this tree can be seen in the 3d root map, Figure 14. The pipeline runs between the 15 and 20 lines of the "Y" axis of the figure. The second, color coded version shows several roots that grow down as they reach the pipeline trench and then grow back toward the surface as they cross it. The significance of these indications was only apparent to us when we knew the location of the pipe and were looking for the influence of the pipe and the trench on the root development of the walnut tree. It appears to us that it would take a knowledgeable GPR operator with considerable experience in orchard tree growth to routinely deduce the effect of the pipeline on the root development of a tree from this evidence. Both the field GPR consultant from Tree Associates and the data processing consultant, Dr. Mucciardi from TreeRadar, suggested that this level of interpretation of the GPR data is possible but only with the experience that comes from the evaluation of numerous examples

Figure 11. The walnut tree stump at Lockeford excavated to a depth of 4'. The pipeline is below the yellow "caution" tape on the bottom of the pit.

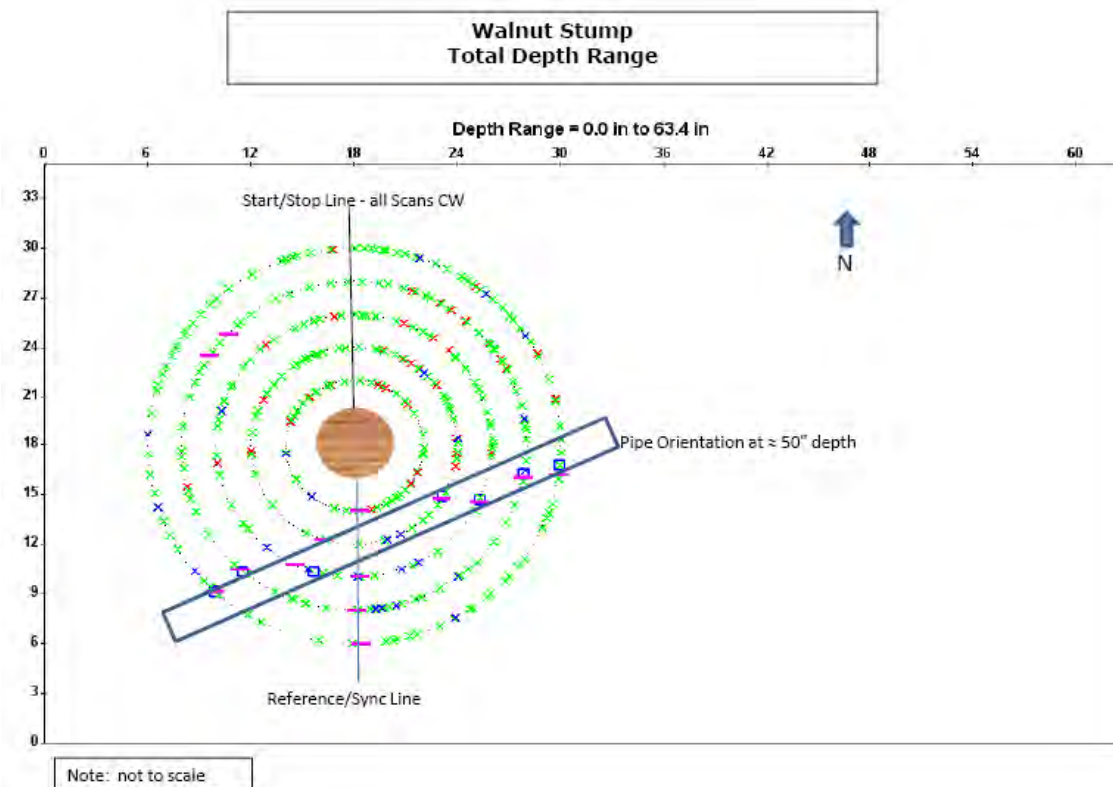
Figure 14. A 3d representation of the root system of the Lockeford walnut tree. The pipeline runs between the 15 and 20 values on the “Y” axis. The lower figure is color coded for depth. The top 1/3 is shown in red, the middle 1/3 in green and the deepest roots in blue.

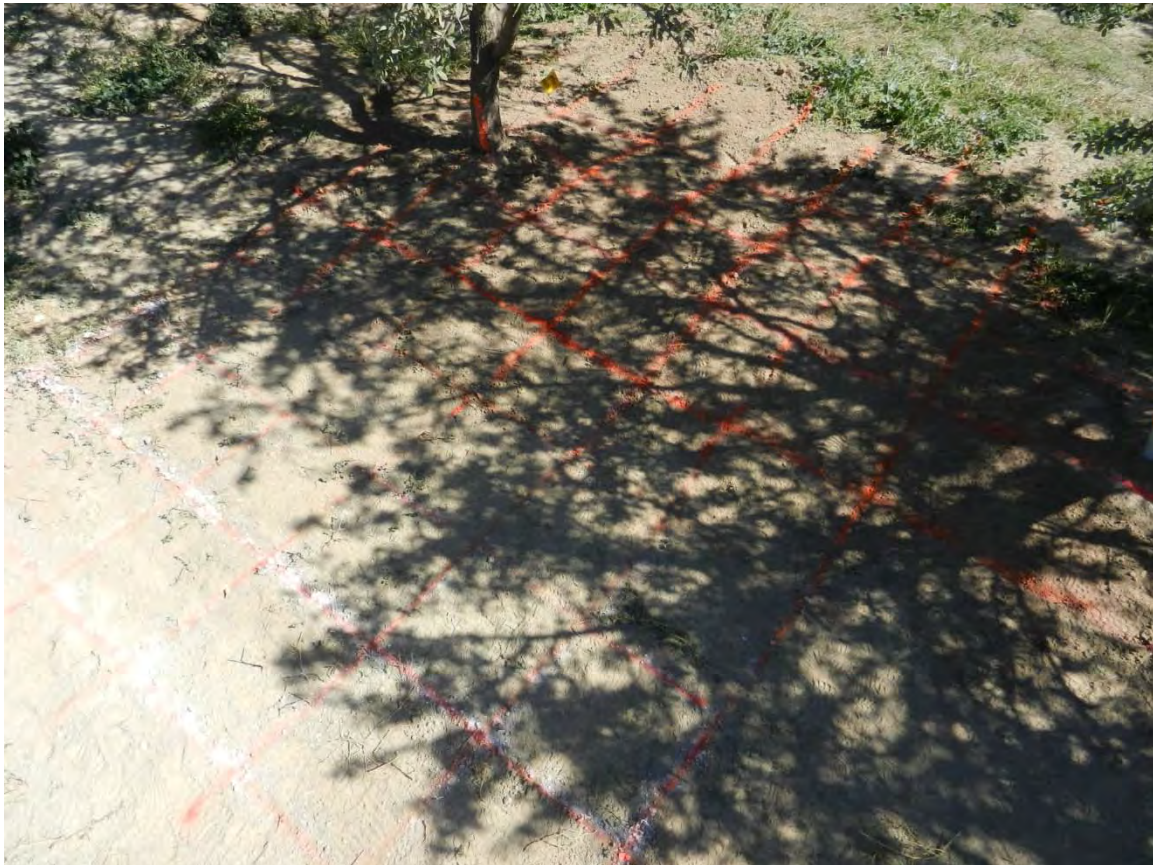
Figure 1. View of plot showing gridlines and tree near north corner of plot.

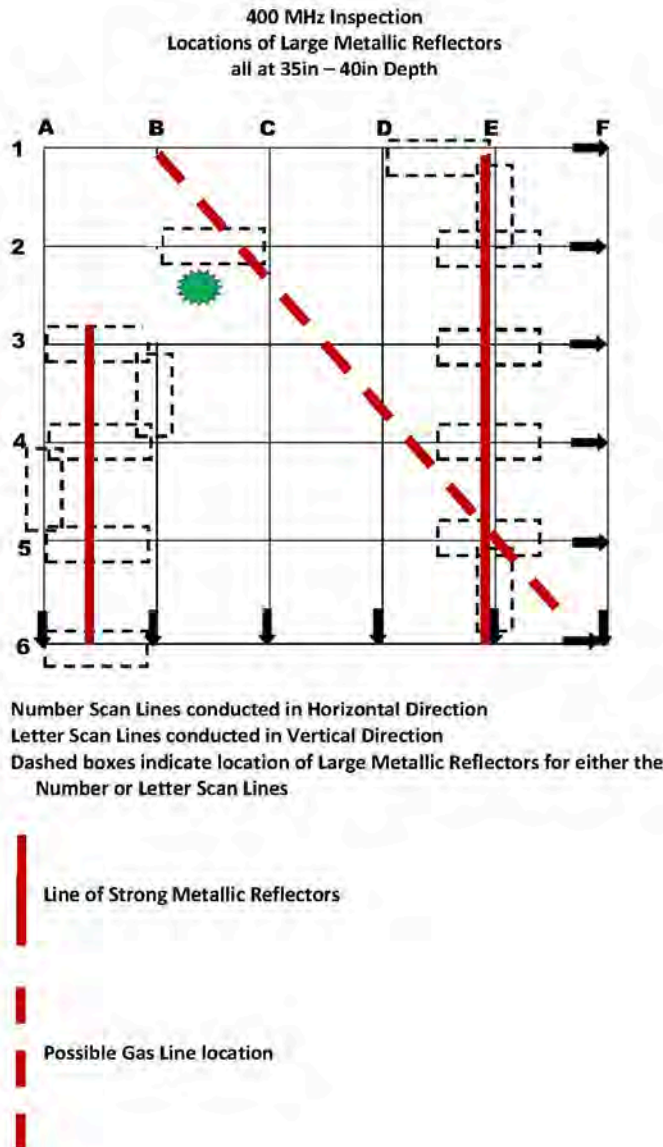
Location of Metallic Reflectors: The location of metallic reflectors and the possible location of the gas pipeline (fitted to two of the reflectors) are depicted on the plot with scan lines indicated as well as scan directions (see below) and the location of the tree trunk. Setting the TRU to a more appropriate deeper depth setting may have modified the predicted location of the metallic reflectors. The deeper depth setting – down to about 70 inches will be used in future inspections.

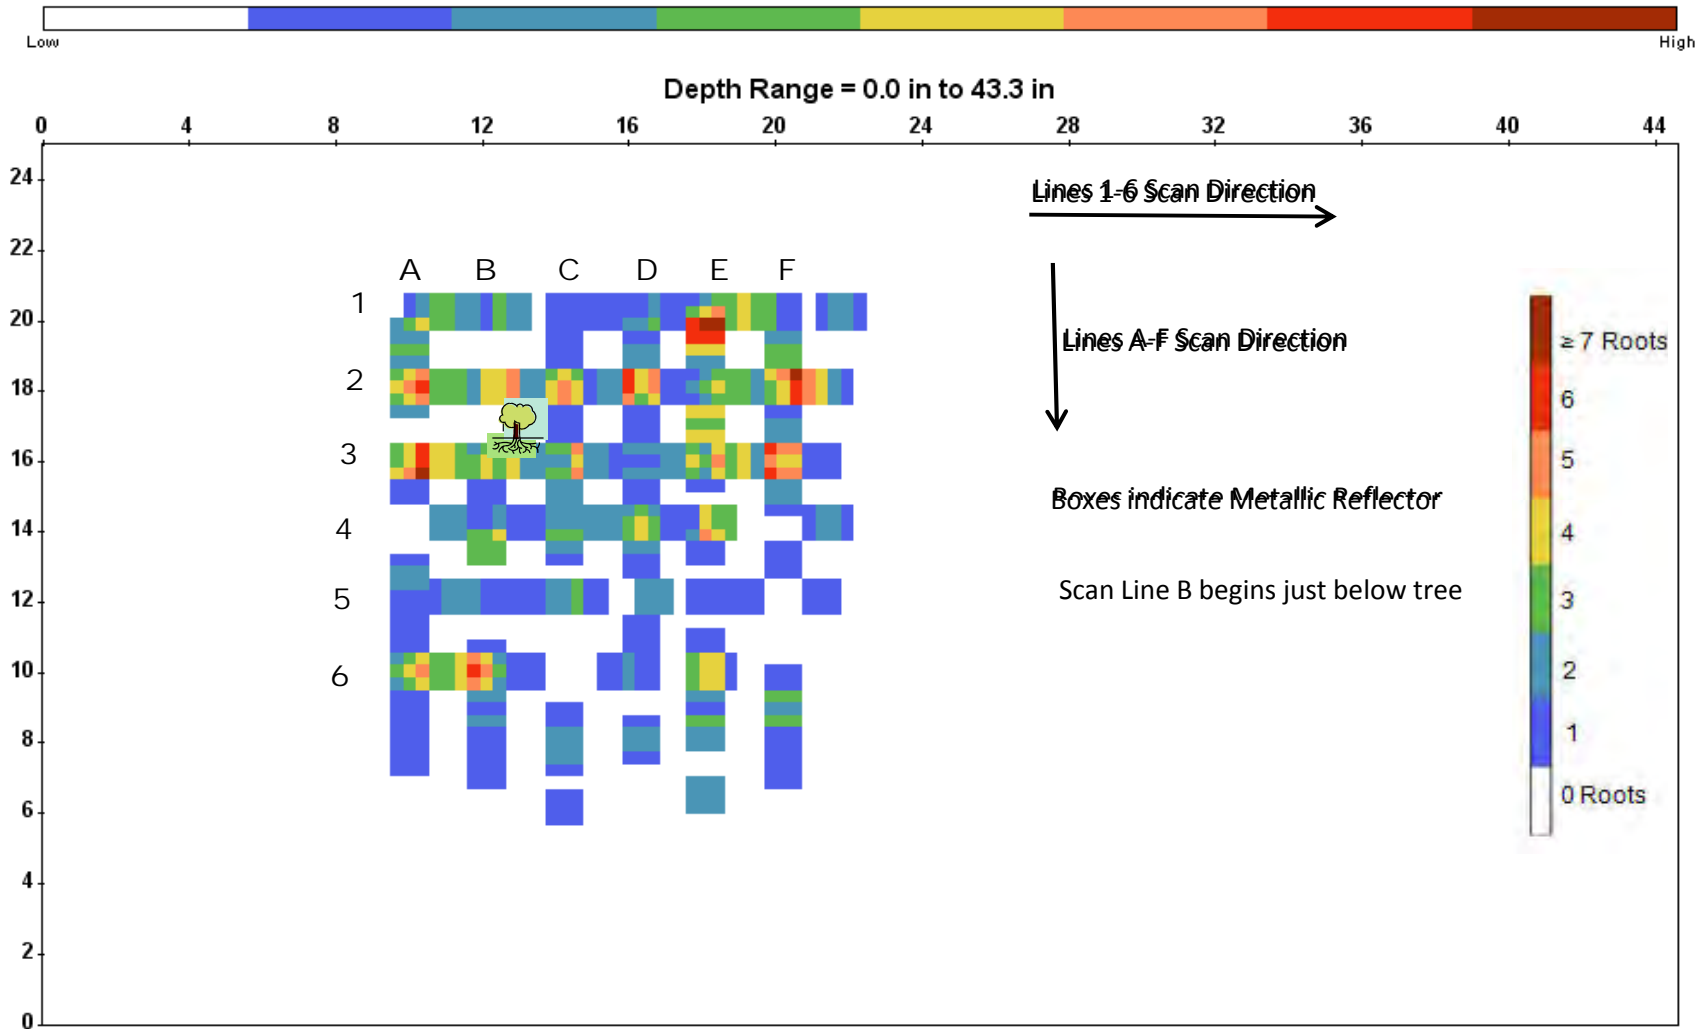
**W Lincoln Ave Almonds - 400 MHz
Root Density**
(all detected roots projected to surface)

A root density map is also attached which superimposes the density of roots along scan lines for the entire depth range. Note that the overall root density is greater for the 900 MHz scans due to the antenna's lower minimum root diameter detection capability. The root density map for both antennas reveals the greater density of roots closer to the tree on the plot and the tree adjacent to the plot (berm area). Note that the root density on scan line 6 looks high but this is influenced by the presence of metallic reflectors.

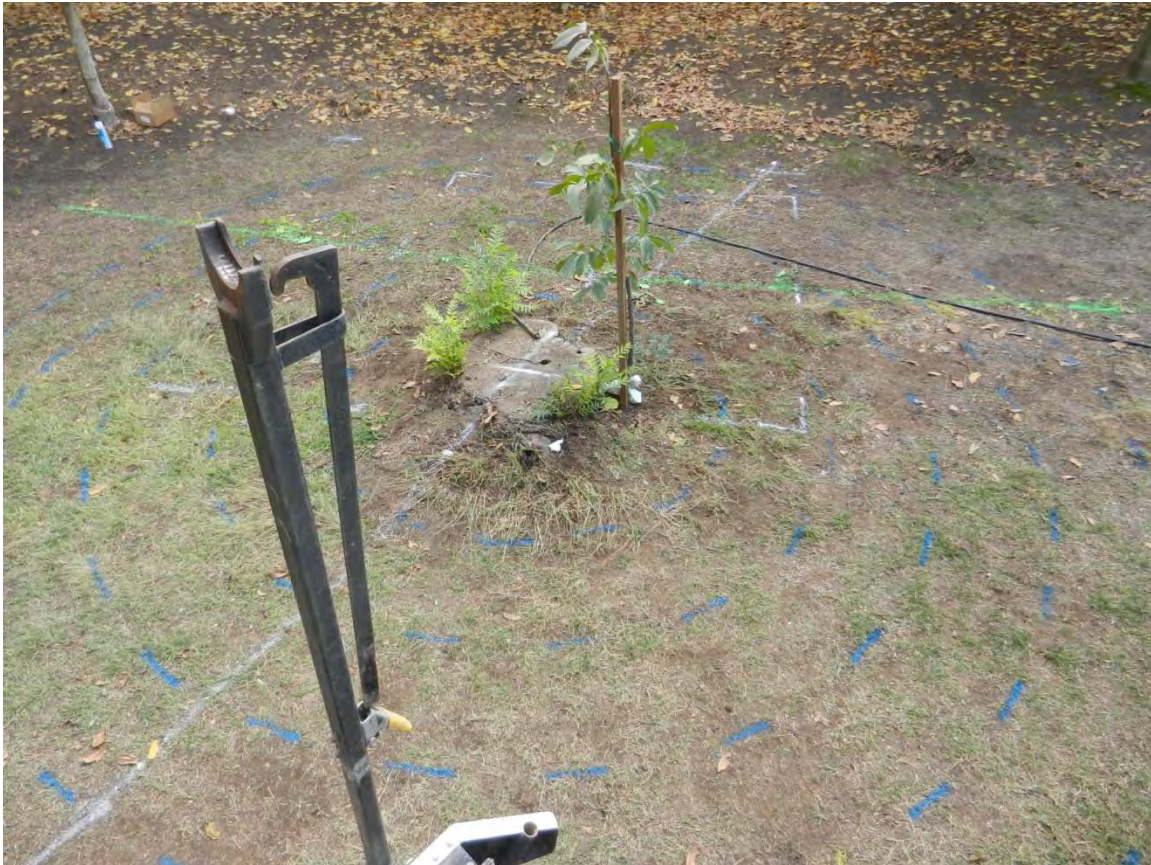
Figure 1. Looking downward and toward the south southwest at walnut stump and plot. Note white line bisecting trunk which was start stop line. Blue lines are scan lines. White box is excavation location and green line is predicted pipe location.
