FINAL REPORT
VOLUME I
R-PG&E-20150427

Pacific Gas and Electric Company

Tree Root Interference Assessment

April 27, 2015

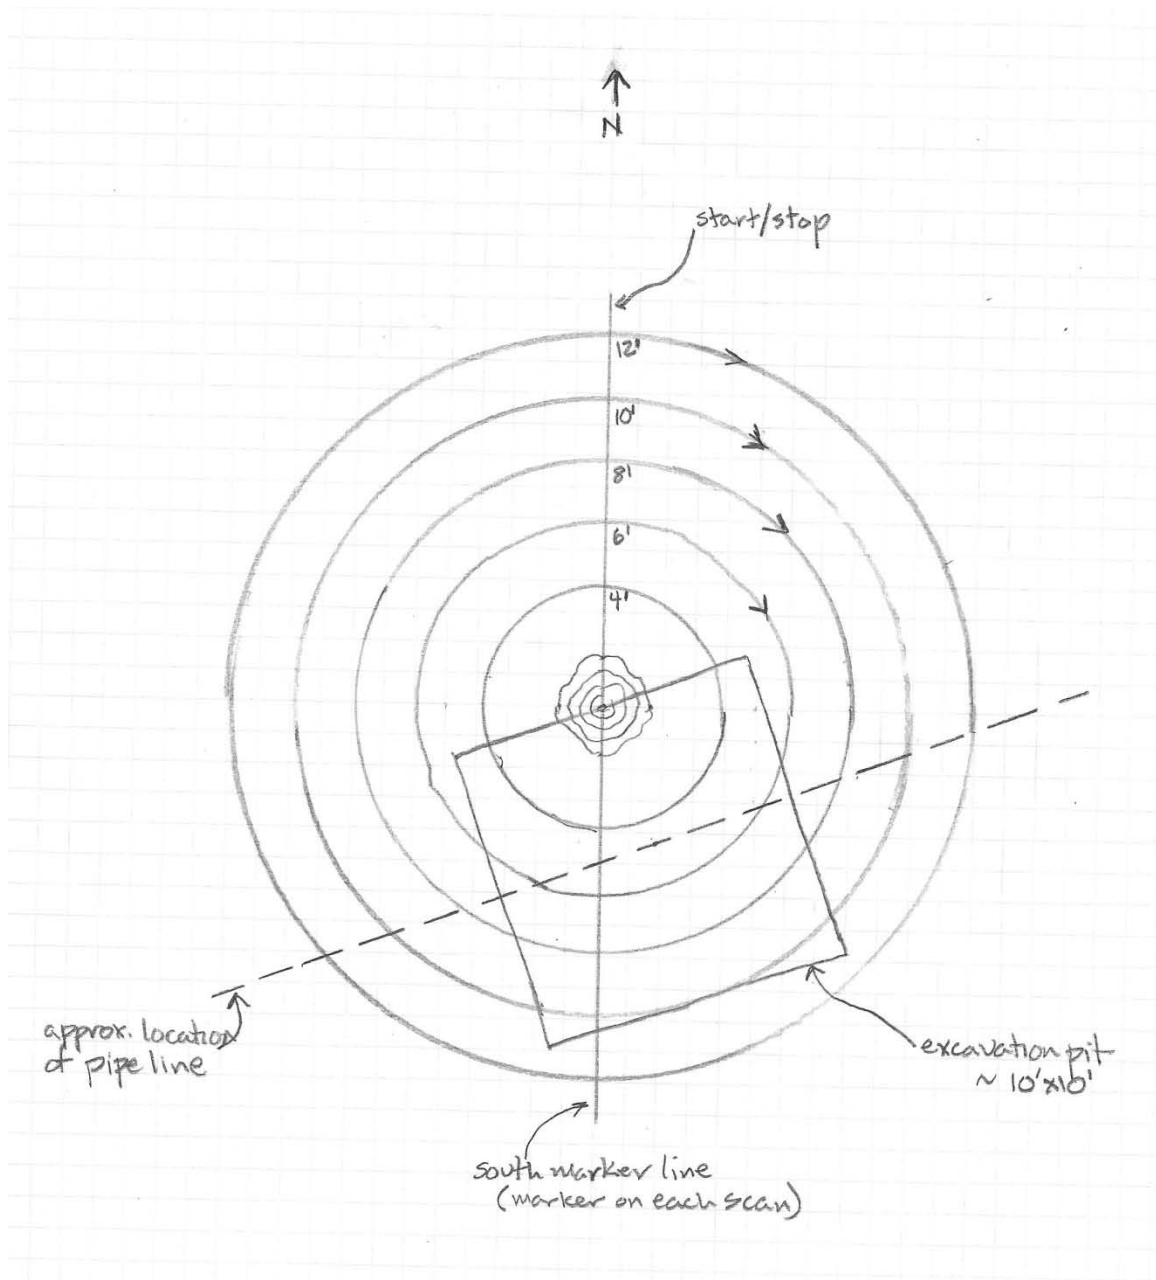
Figure 2. Sketch of stump, scan lines, excavation pit and approximate pipe location from potholing.

No "pipe reflection" was found on the first (4 ft.) scan as the scan did not run over the pipe as shown in Fig. 2 above. Only one such reflection was found on the second (6 ft.) scan as the scan ran more or less tangential to the pipe. In the remaining scans, two pipe reflections were found as the scan crossed the pipe twice.

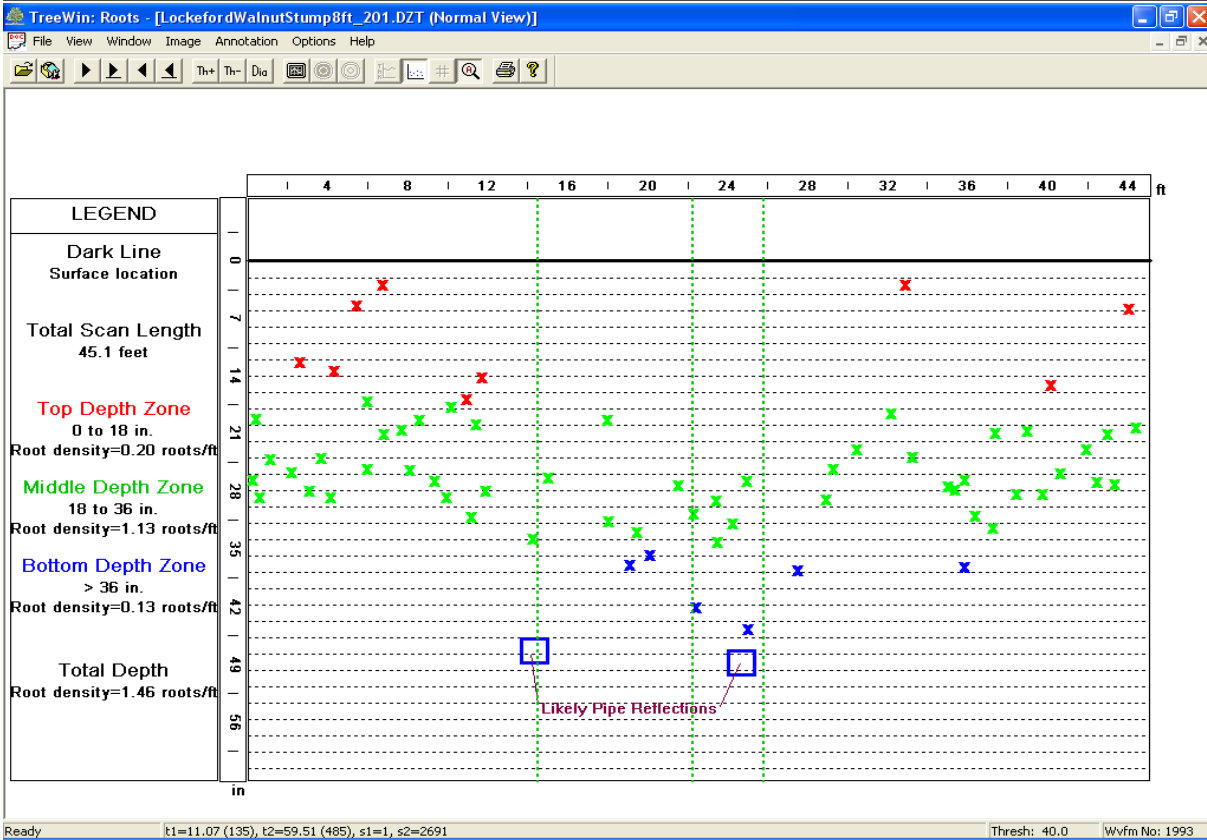
Walnut Stump - Scan # 8ft (201) - Length = 45.1ft - 29 Oct 2013

Roots were found above and relatively close to the pipe in the 8 and 12 foot scans.

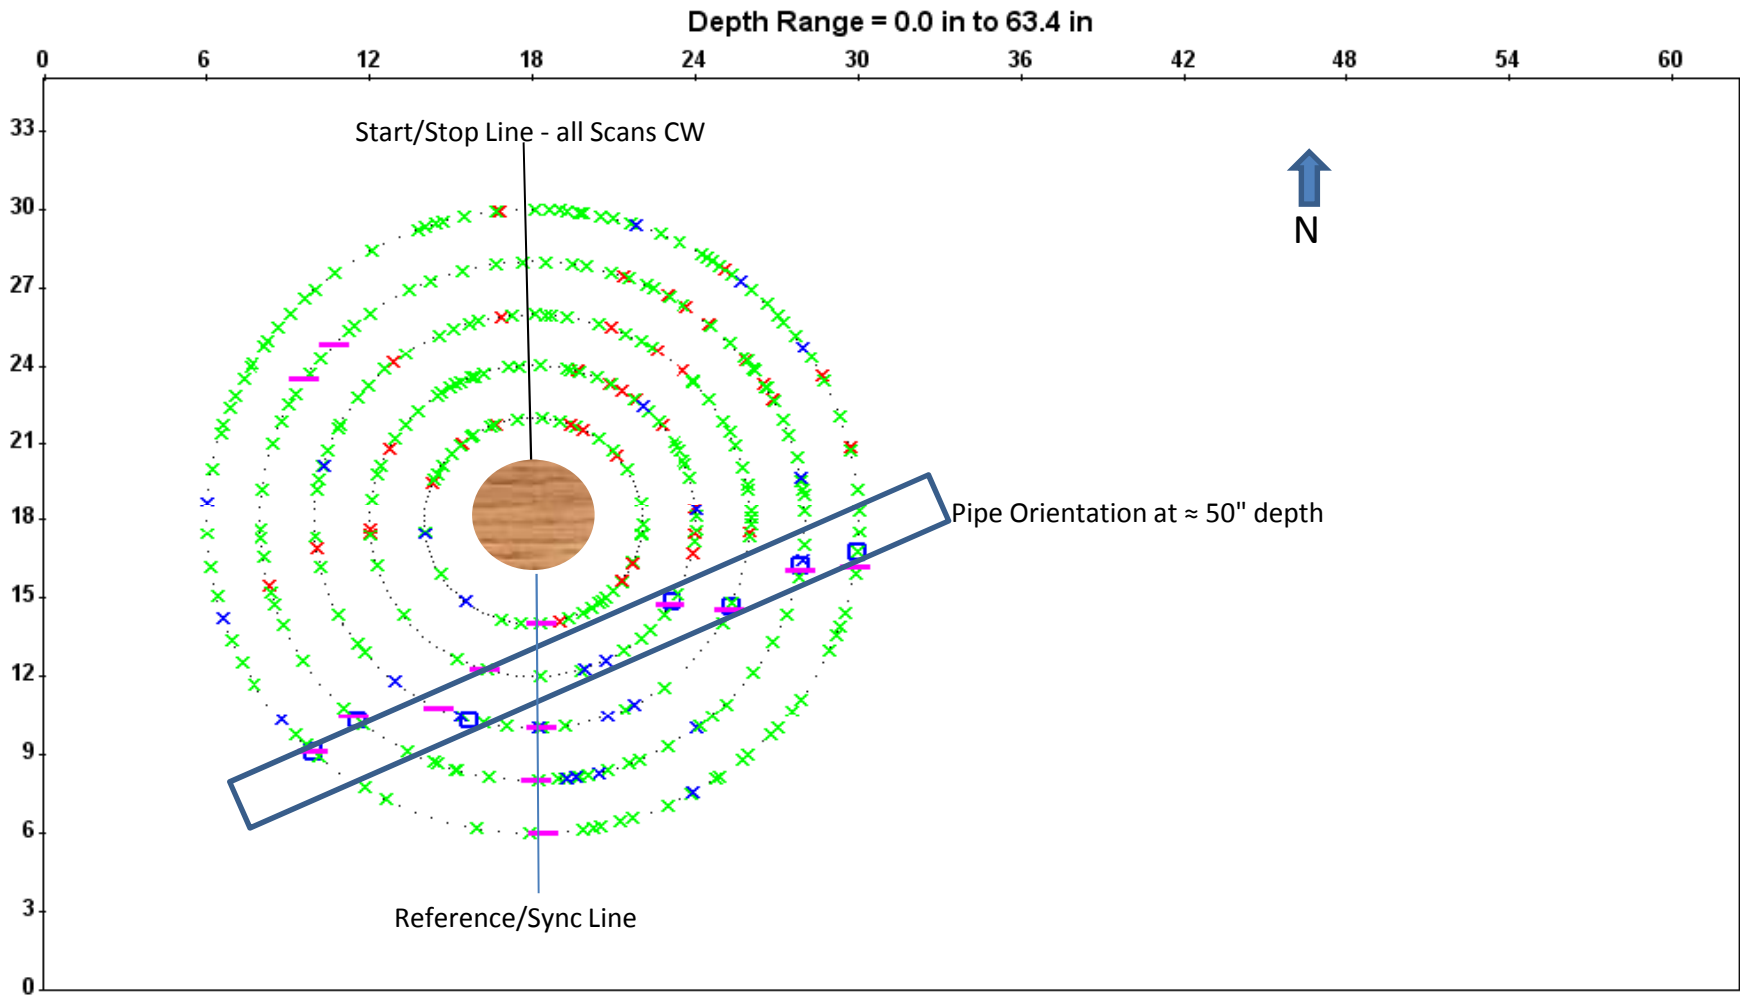
**Walnut Stump
Total Depth Range**

Looking at the top down view for the total depth range, one can see that roots were found across the entire plot. However, there was a lower density of roots found in the southwest quadrant and the greatest density appears to be in the northeast quadrant. The majority of roots in the 0-18 inch range were found in the northeast quadrant and there were few roots in this depth range in the southern half of the plot. The vast majority of roots were found in the middle depth range. Looking at the 36 to 63 inch depth range, the majority of roots were found in the southern half of the plot and four roots were found more or less over the pipe.
