**FINAL REPORT
VOLUME II
R-PGE-20150427**

Pacific Gas and Electric Company

**Tree Root Interference Assessment
Attachments**

April 27, 2015

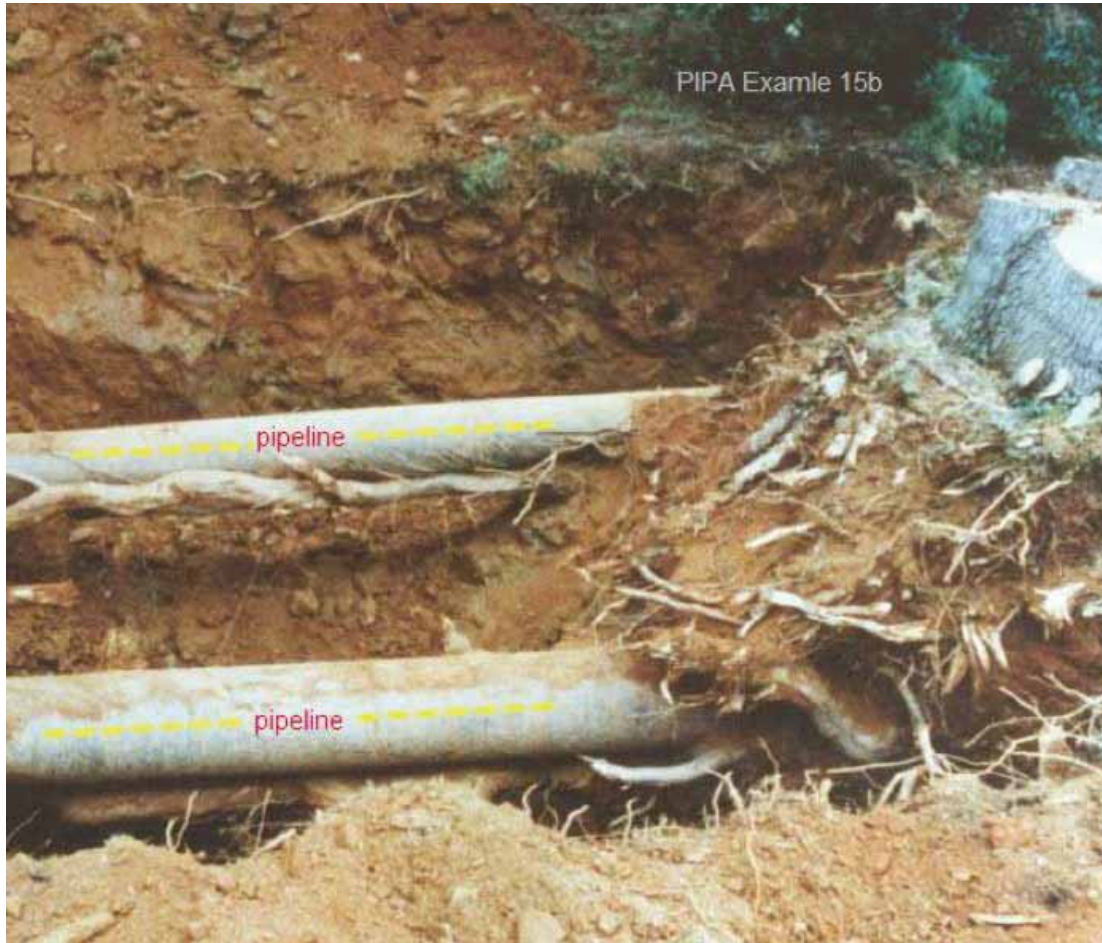
In some cases, larger woody roots develop in proximity to buried pipelines (Figures 3 and 4), although we are not aware of any research that documents the frequency or extent of large root growth along pipelines. One case has been reported in which tree roots grew under and in contact with a natural gas pipeline, and the movement of the roots caused cracks to form in the pipeline (Mattheck and Breloer 1994, Mattheck and Bethge 2000). The diameter of the pipeline was not provided in either document, and it is unclear whether it was a transmission or service line. This incident is described in more detail in the section “Pipe Damage from Roots on Windward Side of Tree.”

Figure 4. Roots in proximity to buried utility lines (note proximity of trunk to pipes). Pipe diameter is unknown, but appears to be approximately 6 inches. Photo from PIPA (2010).

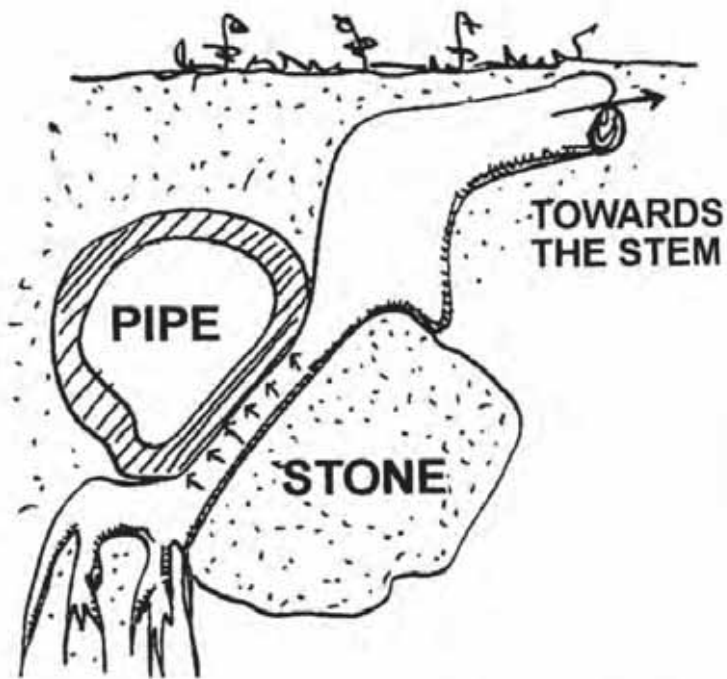
Figure 5. A plastic or thin-walled pipe may be compressed if radial growth occurs in a root supported by a large object, such as a rock. From Mattheck and Bethge (2000), used with permission.

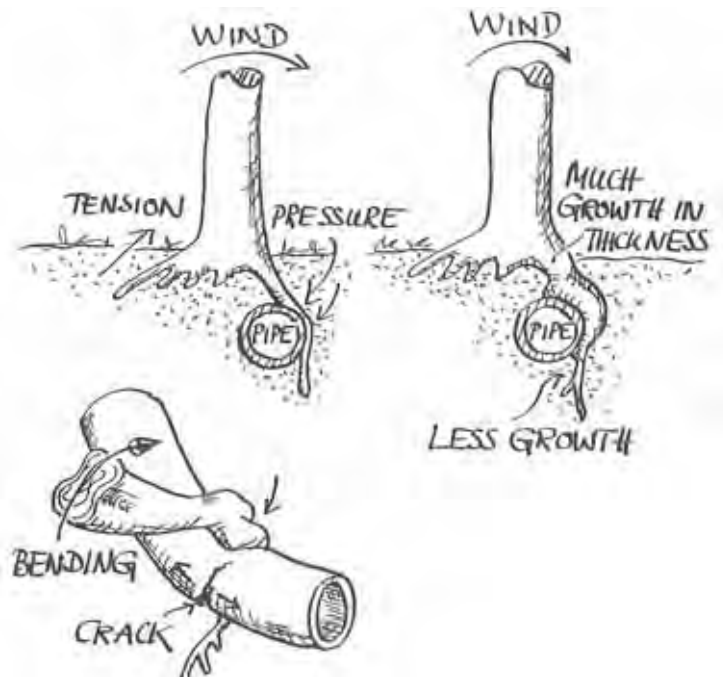
Brennan et al. (1997) state that some sewer and pipe displacement may occur as a result of root movement with wind load. When roots on the leeward (compression) side of a tree contact a pipe, root growth will spread out over the pipe, forming a “pressure cushion” (Figure 6). In this scenario, compressive forces may be transferred to a pipeline, which could possibly lead to cracks on the lower surface of the pipe (Mattheck and Bethge 2000). However, the movement created by compressive forces may not be great. Coutts (1986) found that the soil was depressed only 0.4 inches on the compression side of 35-year-old Sitka spruce (*Picea sitchensis*) trees that had been pulled over with a winch. Mattheck and Bethge (2000) calculate that a root on the compression side of a tree must have a radius five times greater than that of a root on the tension side to create the same hazard potential for a pipeline. We were unable to find any reported cases of pipeline damage fitting this scenario.

Figure 6. A root in contact with a pipe on the lee (compression) side of a tree may form a "pressure cushion" over the pipe. The risk of damage to the pipe in this scenario is considerably less than if the roots were located under the pipe on the windward (tension) side of the tree. From Mattheck and Breloer (1994), used with permission.

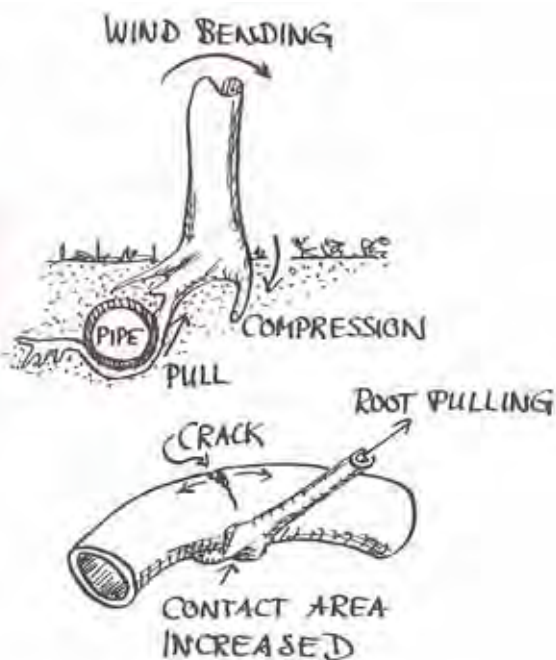
Mattheck and Bethge (2000) indicate that within the root plate, mechanical fatigue damage to pipes can be caused by roots alternately sagging and tightening with the force of the wind. Cracks can then start on the upper side of the pipe at “notches, inhomogeneities, welds or surface defects.” In trees that lean, the roots may introduce an additional torsional force, which could result in a bending load applied to a pipe. In addition, tensional and levering transverse forces can damage pipes if root wedges or knots form between pipes laid on top of one another (Mattheck and Bethge 2000, Roberts et al. 2006) (Figure 9). Significant movement has been observed in roots on the windward side of trees that have been subjected to transverse forces. For example, roots near the trunk on the windward side of trees have been found to rise vertically when force is applied perpendicular to the trunk axis (Lundstrom et al. 2007). Coutts (1986), who used a winch to apply such forces to Sitka spruce (*Picea sitchensis*) trees, reported a 2.5-inch rise in roots at a distance of 30 inches from the trunk.

Figure 7. A root in contact with the underside of a pipe on the windward (tension) side of a tree may cause fatigue damage to the pipe due to alternating tightening and sagging of the root as wind sways the tree. From Mattheck and Breloer (1994), used with permission.

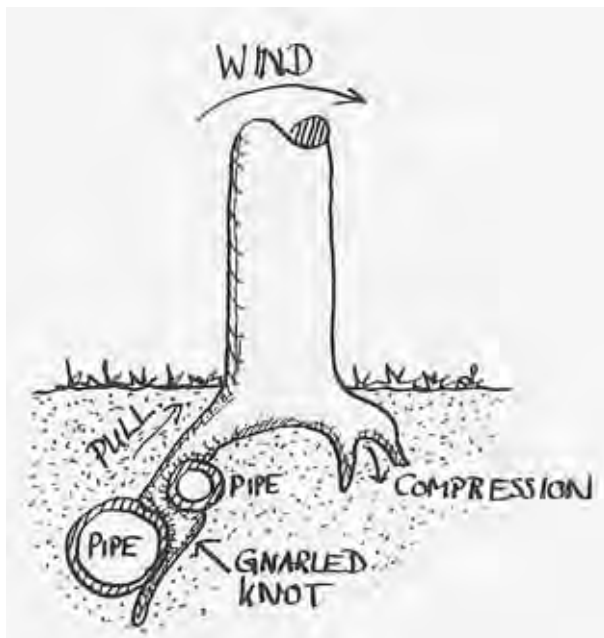
Figure 9. Knots in roots between buried pipelines may act as wedges. From Mattheck and Breloer (1994), used with permission.

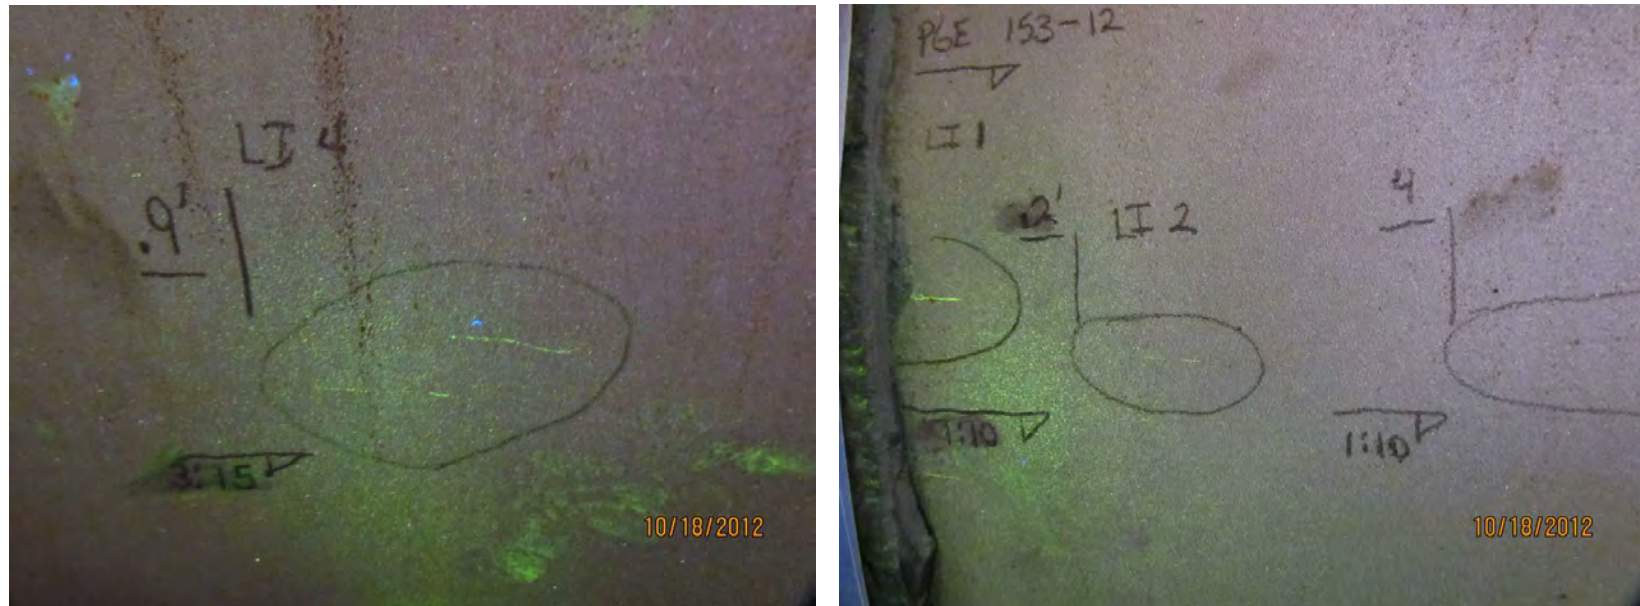
Figure 11. Photographs, provided from Dig 153-12, showing representative linear indications identified using wet fluorescent magnetic particle inspection.

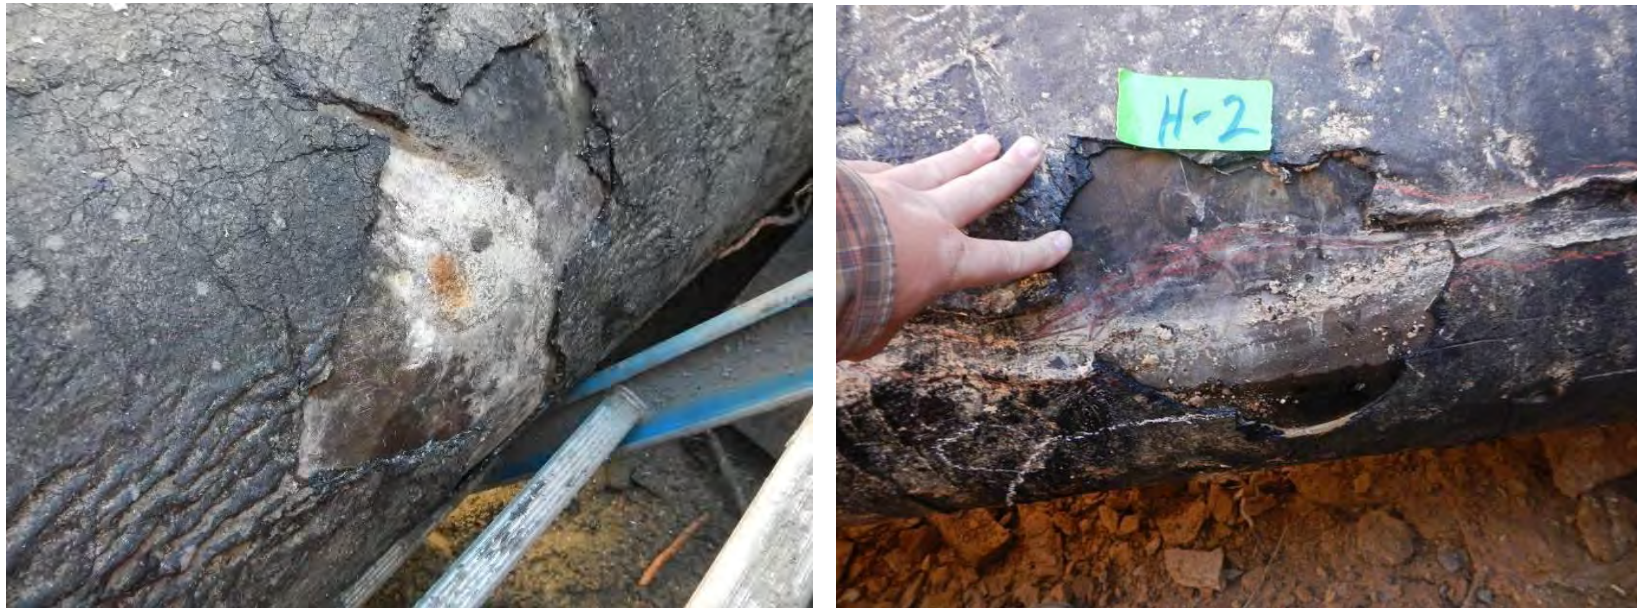
Figure 12. Photographs showing the presence of calcreous deposits in areas where the coating disbonded.

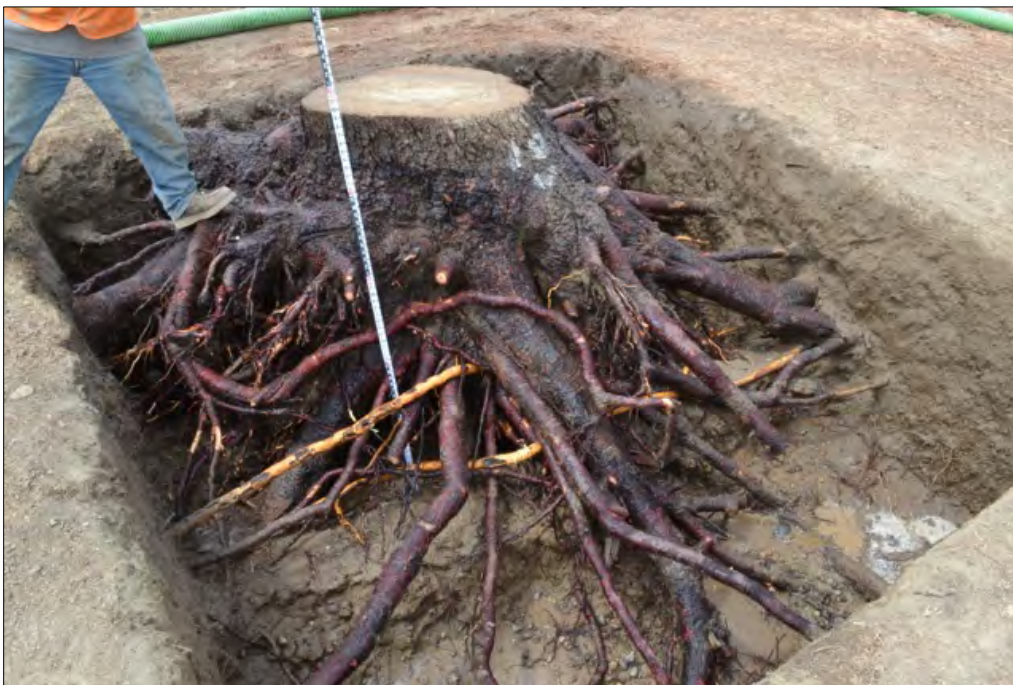
Figure 9. These are oblique roots at dig site 128-13.

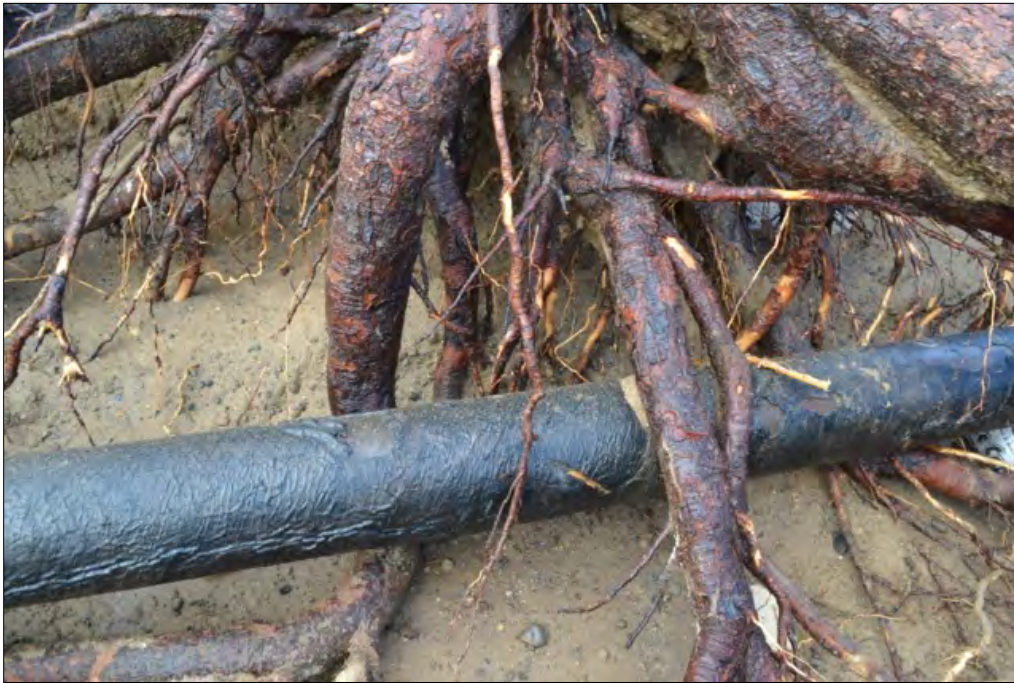
Five trees (Figures 14, 20, 22, 23), all less than 50-years old, had large (>3-inches) roots over, under, and in contact with the pipe. The close proximity of large roots near the pipe, in combination with tall trunks and large tree crowns, which act as levers, was of interest because the trees were relatively young. It is unknown what the implications are for these pipelines as the trees grow to maturity in another 50 to 100 years. The root study did not attempt to measure forces exerted during wind loading from trees in close proximity to pipes.

Figure 22. A young Deodar cedar at dig site RWVIM-92-13 interacting with an 8-inch pipe.

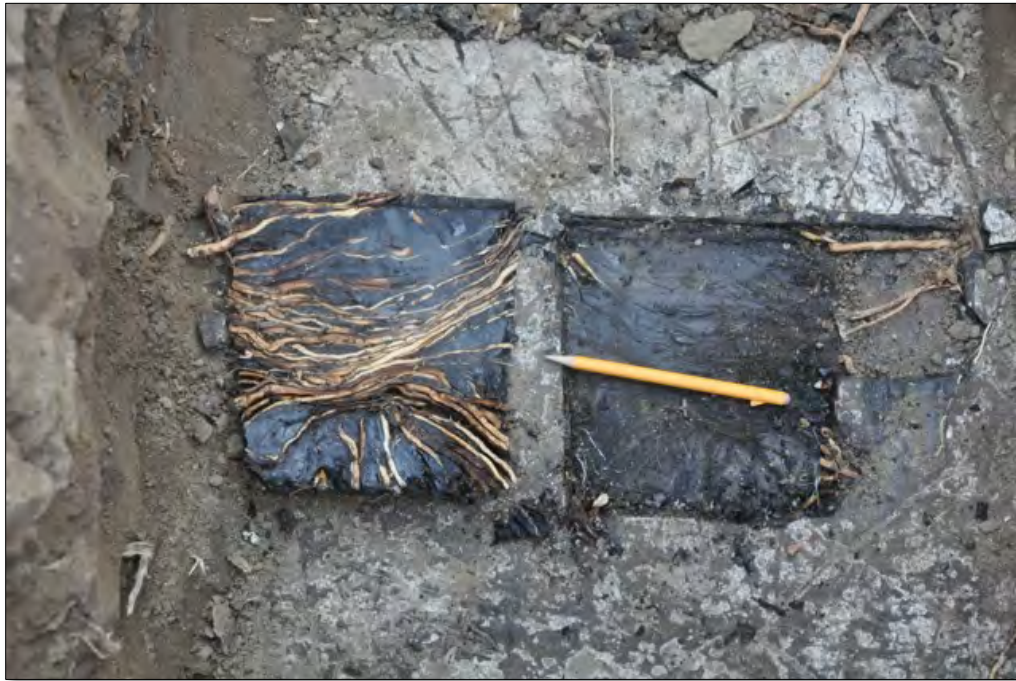
The only palm tree (RWVC-44-13/RWVIM-100-13), a Date palm, in the root study had more contact with the pipe coating than any other tree, even at great distances and depths. This was evident in all three of the small excavation pits on this site. The non-woody palm roots grew into and through the coating and on the pipe. The roots were unlike any other tree in the root study in that they did not impress or displace the coating. At the time, it was not possible to quantify our observations. Palm trees are sometimes planted in rows of multiple trees. If a condition exists where a row of palms is located near the pipeline, significant root-pipe interactions are possible (Figure 30).

Figure 30. At dig site RWVC-44-13 (RWVIM-100-13) (Palm tree) a 6-inch square sample of coating was removed.

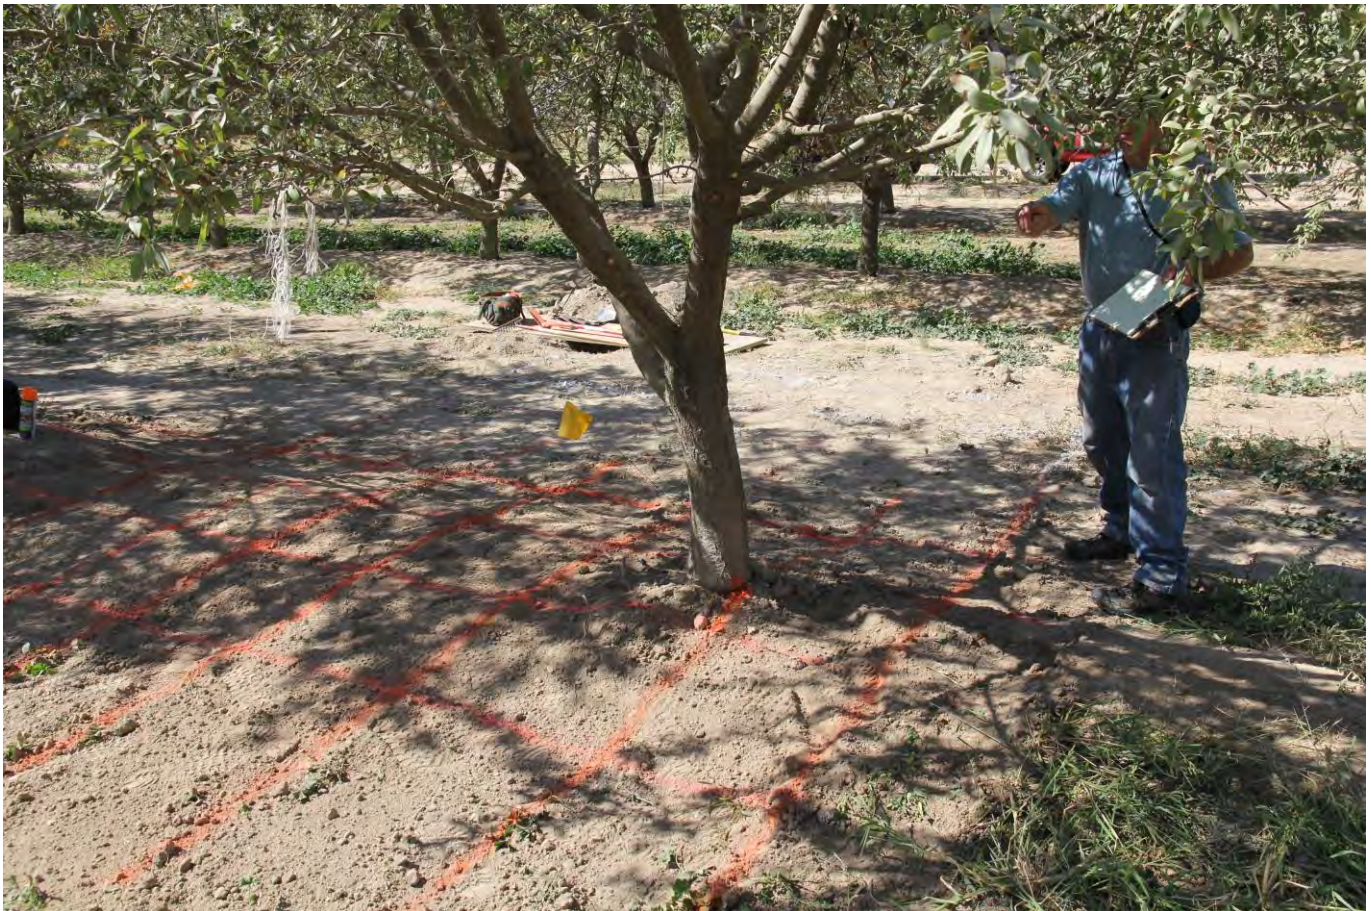
objects such as roots indicated along the line and their approximate depths. By scanning lines on a grid of 2', we expected to be able to map the root system of the tree by matching the points along each scanned profile with the adjacent profiles to map the roots by "connecting the dots". The 10'x 10' pit included the tree trunk/root crown and a portion of the pipeline so we expected to see the root system development altered by the presence of the pipeline trench if the roots were, in fact, influenced by the pipeline. The initial field site was an almond orchard in central Fresno County on West Lincoln Ave. about 10 miles south of Kerman. The trees were 12 years old and were planted on a soil with a very distinct restricting layer or duripan. The restricting layer began at a depth of 24"-28" and the pipeline was about 3' deep so the trench with the pipeline was a significant break in the restricting layer of the native soil. The GPR scans indicated an extensive root system in the upper soil layers above the duripan with no roots detected within it. There was some indication of root growth into the pipeline trench but it was not definitive. Subsequent excavation of that tree and a second site in the orchard found the root system to be completely blocked by the restricting layer with some small roots growing down into the trench and along the pipeline. The roots found near the pipe were smaller than the expected resolution limit of the 400 MHz GPR system.

Figure 5. The almond tree at the W. Lincoln orchard with the GPR grid. The pipeline runs from under the tree, through the center of the photo at a depth of about 3'.

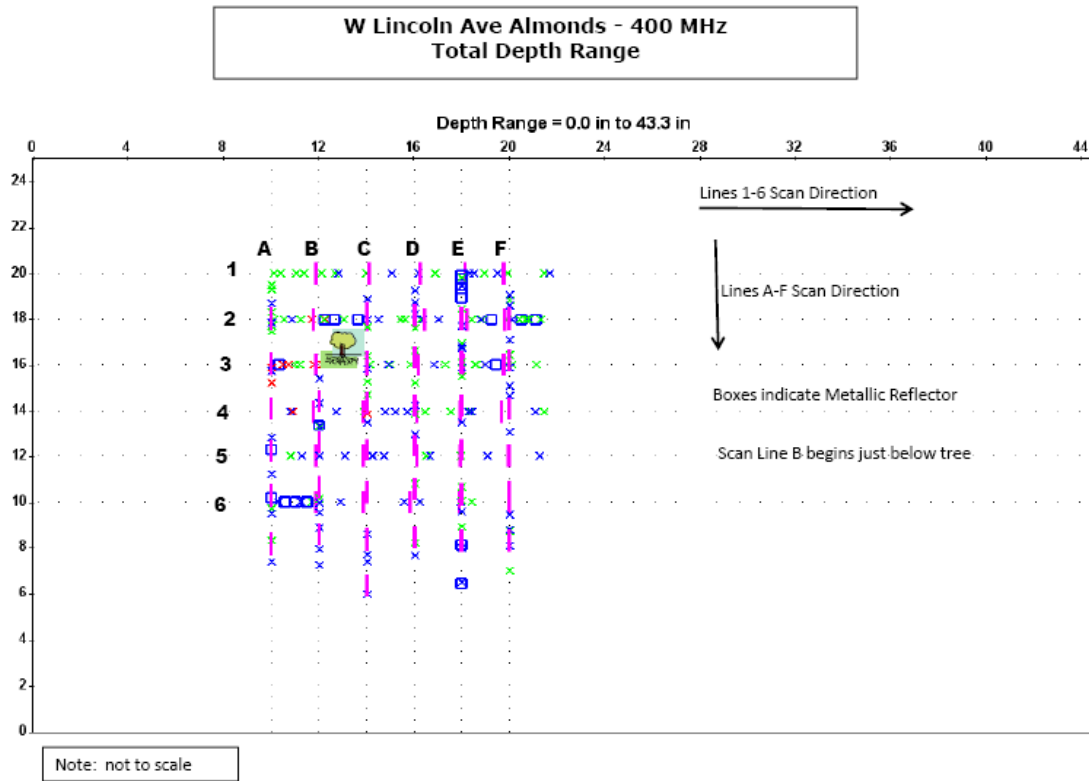
The data from the initial almond orchard in Fresno County was encouraging in that it did predict the root system of the tree quite well. Figure 7 shows the roots detected by the GPR within the grid of the 10' x 10' excavated pit. Figure 8 is a photo of the pit with the tree roots below the 12" depth still in place. The pipeline was not yet exposed at the time the photo was taken but it ran from the corner of the pit at the upper right in the photo, under the tree and across to the left edge of the pit. The trunk of the tree, the root crown and the root system visible in Figure 8 had to be removed prior to further excavation to reach the pipeline.

Figure 7. The scan grid for the almond tree at W. Lincoln Ave. illustrating the labeled scan lines with the roots detected by the GPR on each line.

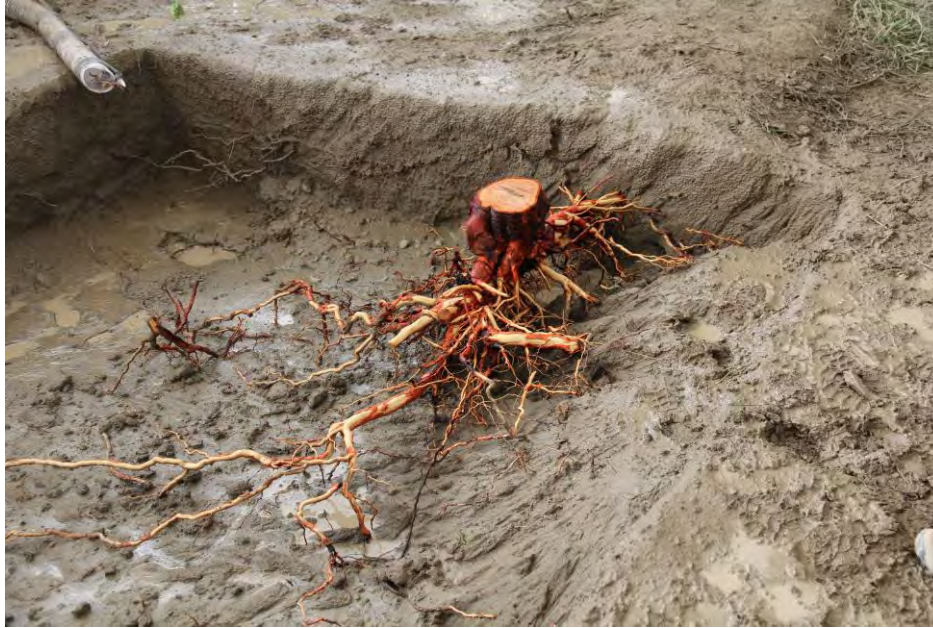
Figure 8. Photo of the almond tree at W Lincoln Ave. excavated to the top of the duripan (approximately 24”). The roots found above 12” have been removed for clarity. The photo was taken from point F1 on the grid shown in Fig. 7.

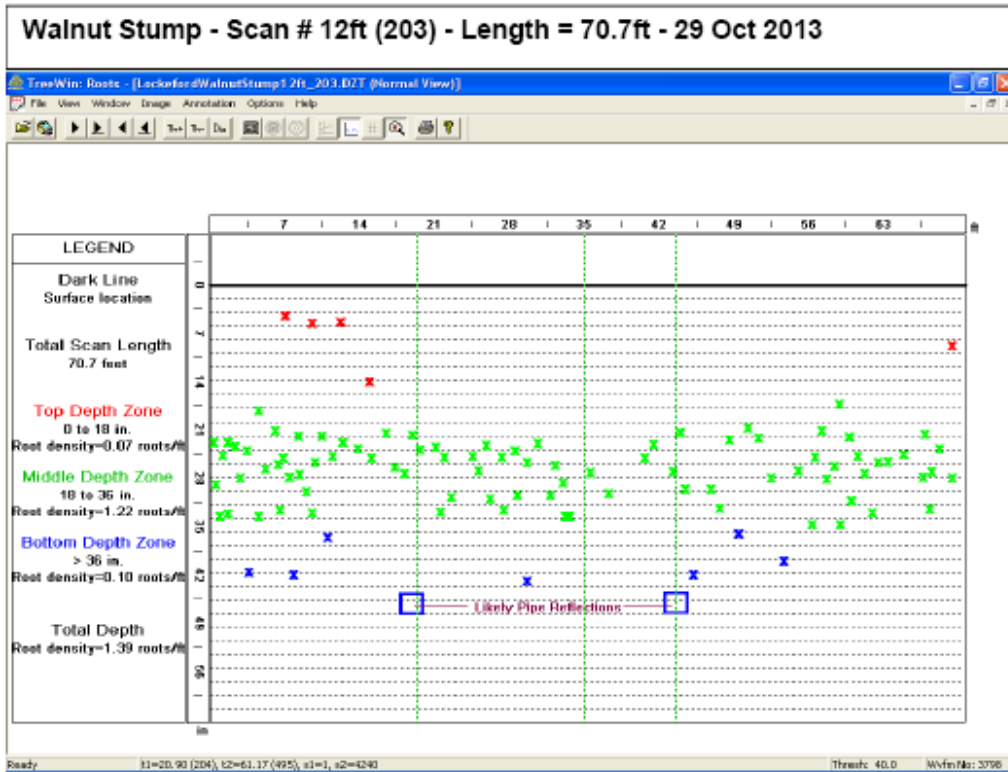
Figure 12. The radial scan 12' from the center of the tree stump. The scan crosses the pipeline in two places, indicated by the boxes.

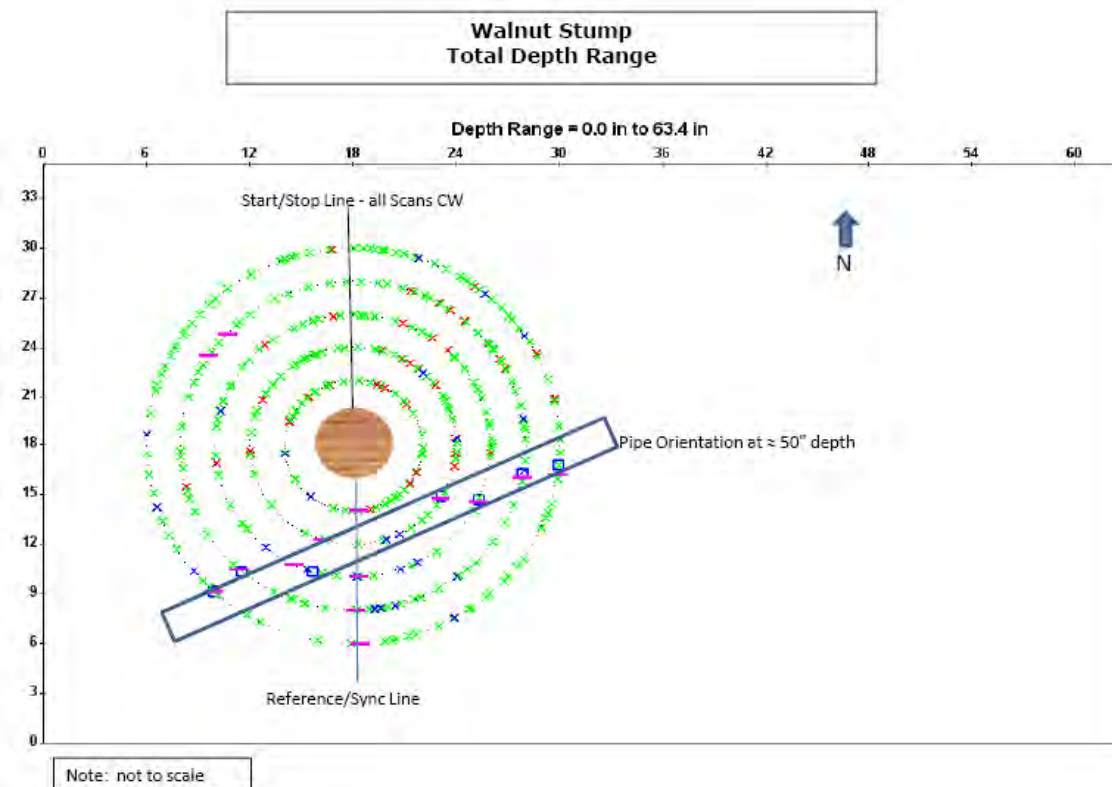
Figure 13. The root map of the Lockeford walnut stump with the roots indicated by the scan at a depth of 0-18" in red, the 18"-36" roots in green and roots deeper than 36" in blue.

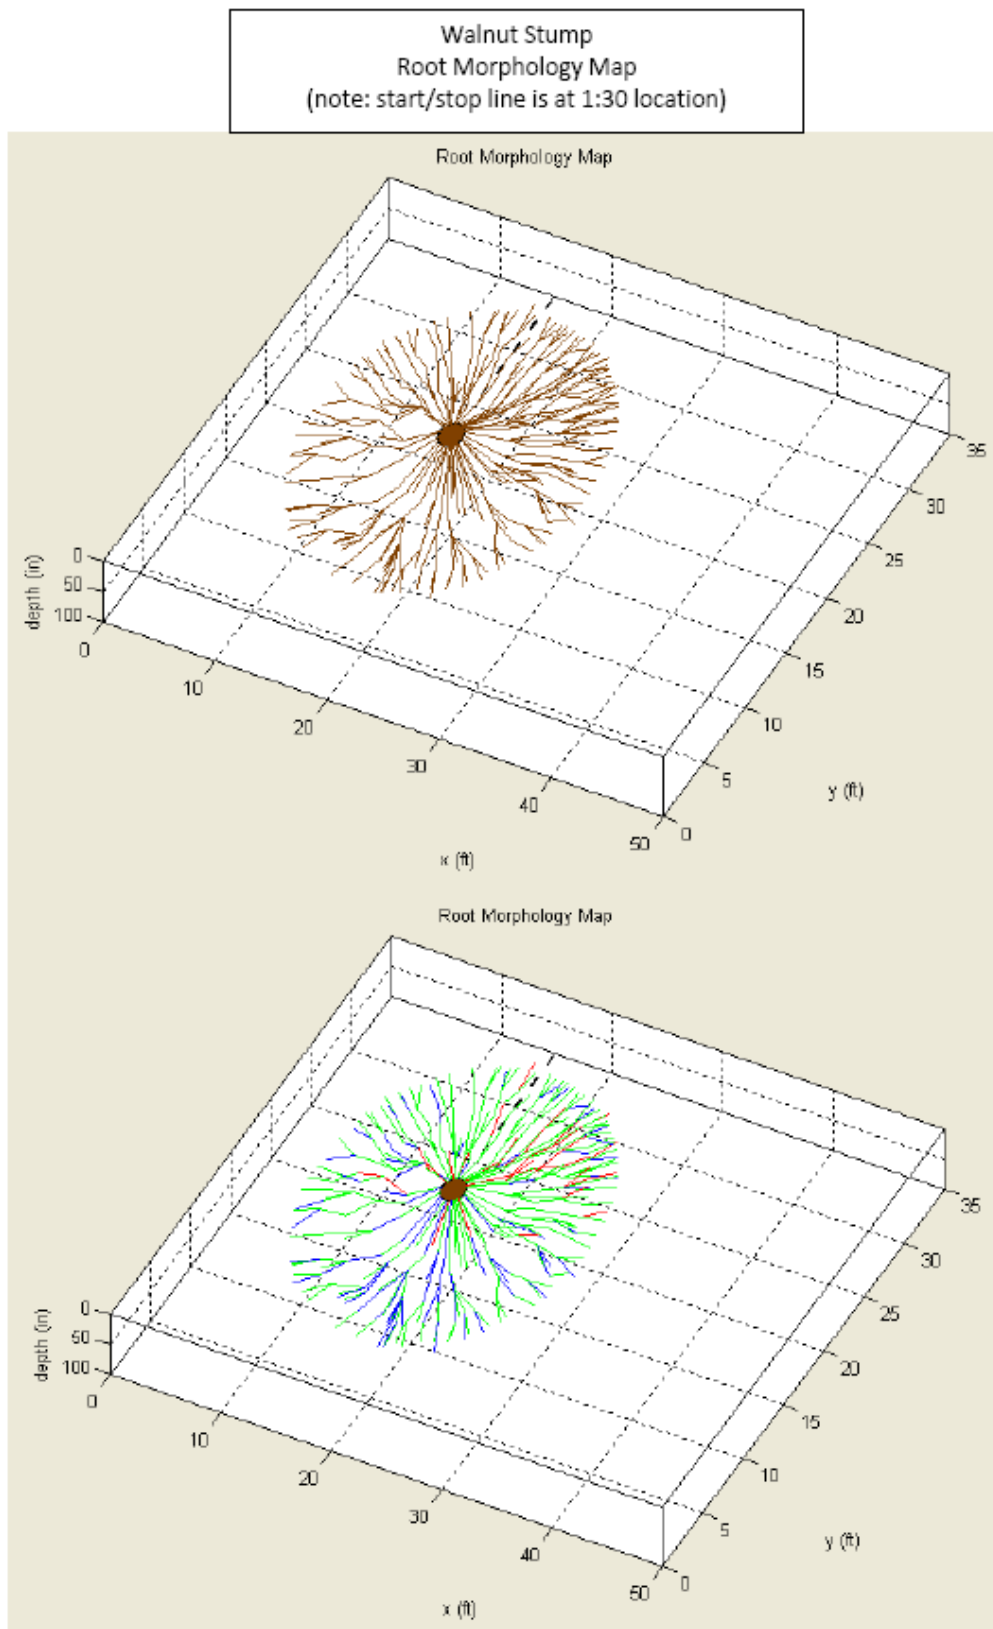
Figure 14. A 3d representation of the root system of the Lockeford walnut tree. The pipeline runs between the 15 and 20 values on the “Y” axis. The lower figure is color coded for depth. The top 1/3 is shown in red, the middle 1/3 in green and the deepest roots in blue.

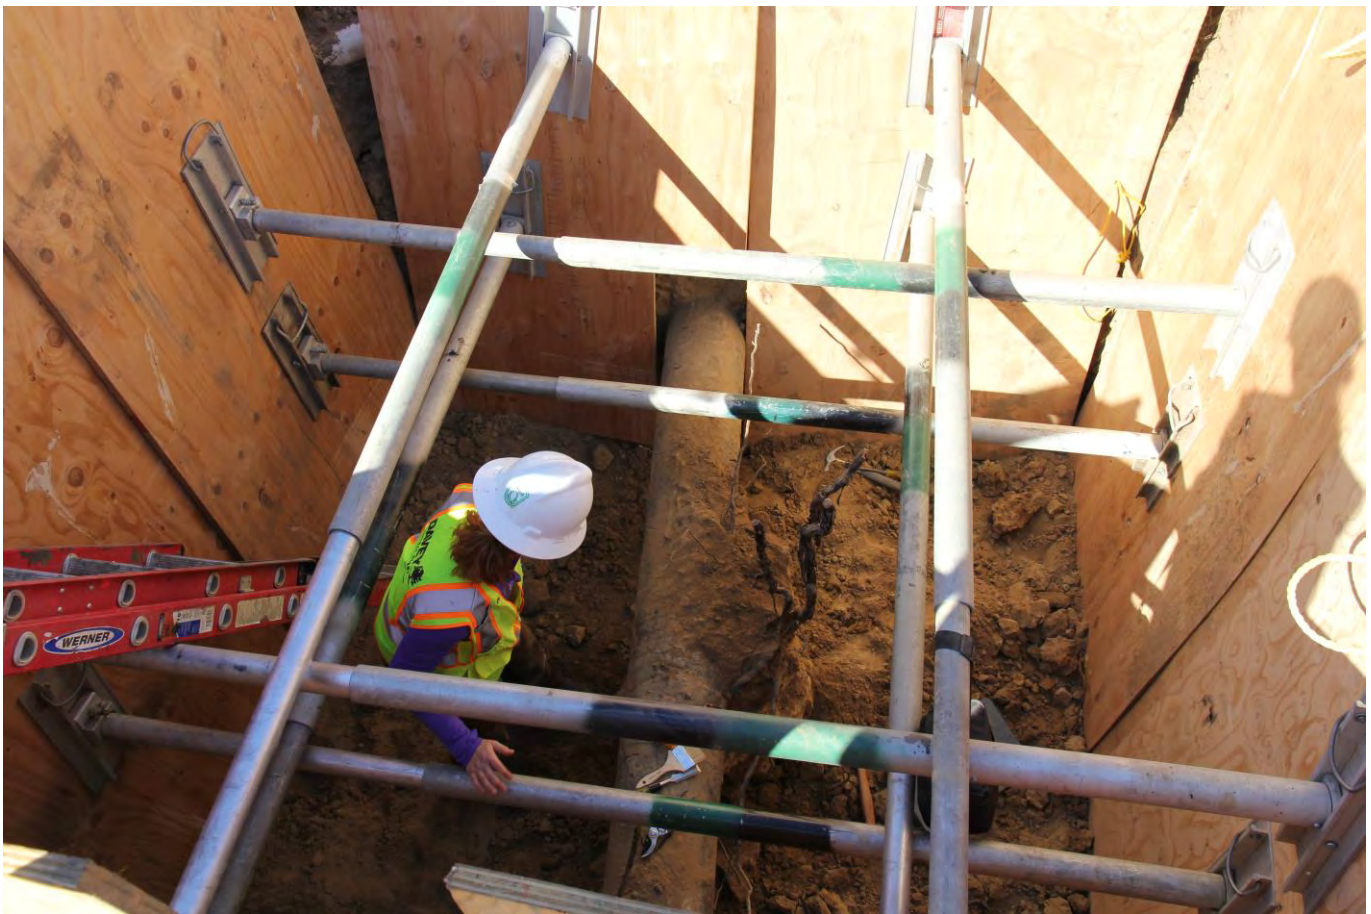
A Zinfandel vine in the wine grape vineyard at Lockeford was also excavated, though not the vine that had been scanned by GPR. The pipeline changed direction slightly as it exited the orchard and entered the vineyard so the vine it actually ran under was the next one in the row. A cursory scan with GPR was not able to find it due to the mistake in the estimated location and fact that the reported depth was only half of the 60" where it was eventually found. The "survey" GPR scan of the vine did not detect any large roots. Grape vines are smaller plants than most orchard trees and, though they may have grown a deep root system if they are old enough, the roots might not be large enough to readily detect with the GPR. The vine over the pipeline was excavated by a dry dig so the root system was not preserved as well as with the hydro-vac excavation. The vine produced several roots that grew straight down into the pipeline trench. No lateral roots of that size were found in the excavation. These roots were probably large enough to detect with the GPR but not in their vertical orientation. Those vine roots did reach the pipeline as shown in Figure 15. Even if the correct vine had been scanned and the pipeline detected by the GPR, it is likely that these roots would not have been seen. Their small size and vertical orientation would make it difficult to detect with a GPR scan.

Figure 15. The roots from the Zinfandel grape vine at the pipeline level.

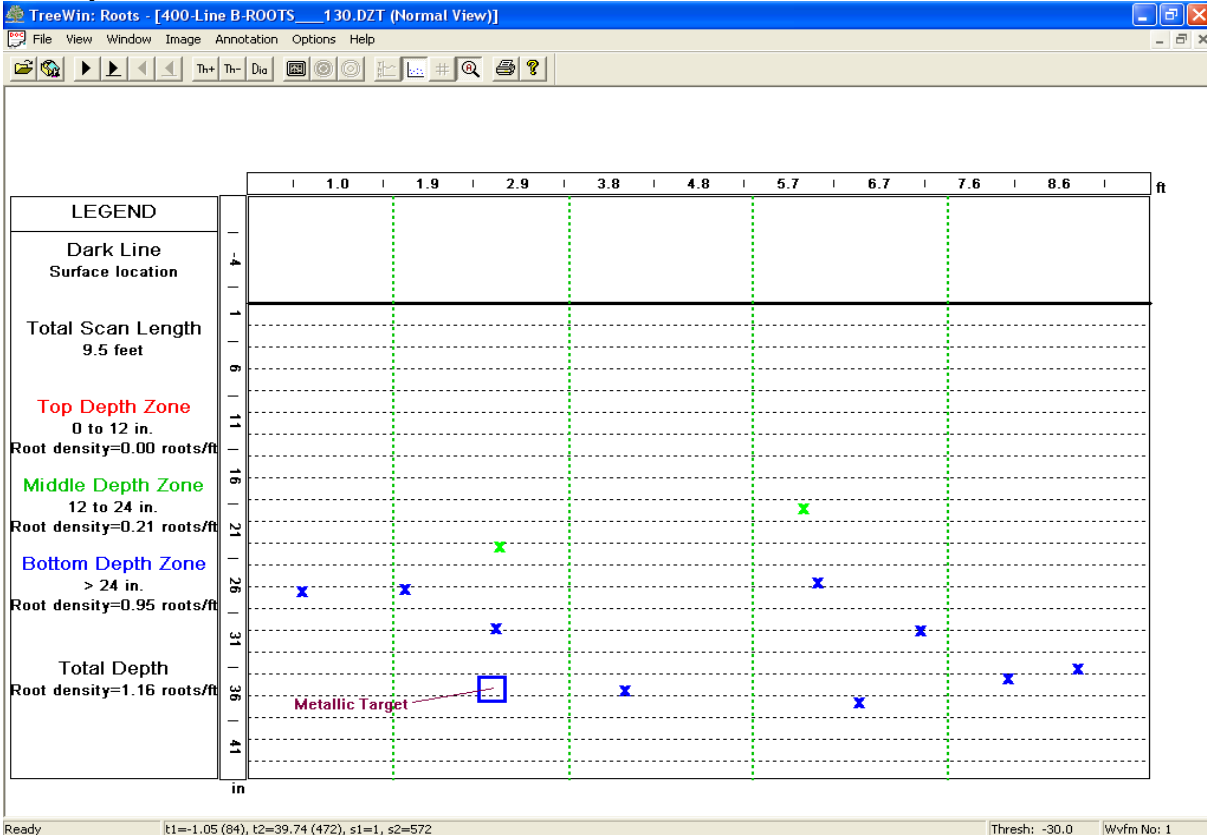
W Lincoln Ave Almonds-400MHz - Scan # B (130) - Length = 9.5ft - 9 Sep 2013

Looking at all the 400 MHz scans, the majority of roots were found between 12 and 35 inches depth. In only one case roots were found to the depth of the metallic reflector (Scan #B). In this same scan, a root was found approximately 6 inches away from the metallic reflector. Roots were 10 or more inches away from the metallic reflectors in other scans (#A,E,2,3,6). The density of roots is least between trees – see density across total depth for scans #C,D and #4,5,6. The 900 MHz scans show a dramatic decrease in root density between scans 3 to 6 (3.22 to 0 roots/ft.).

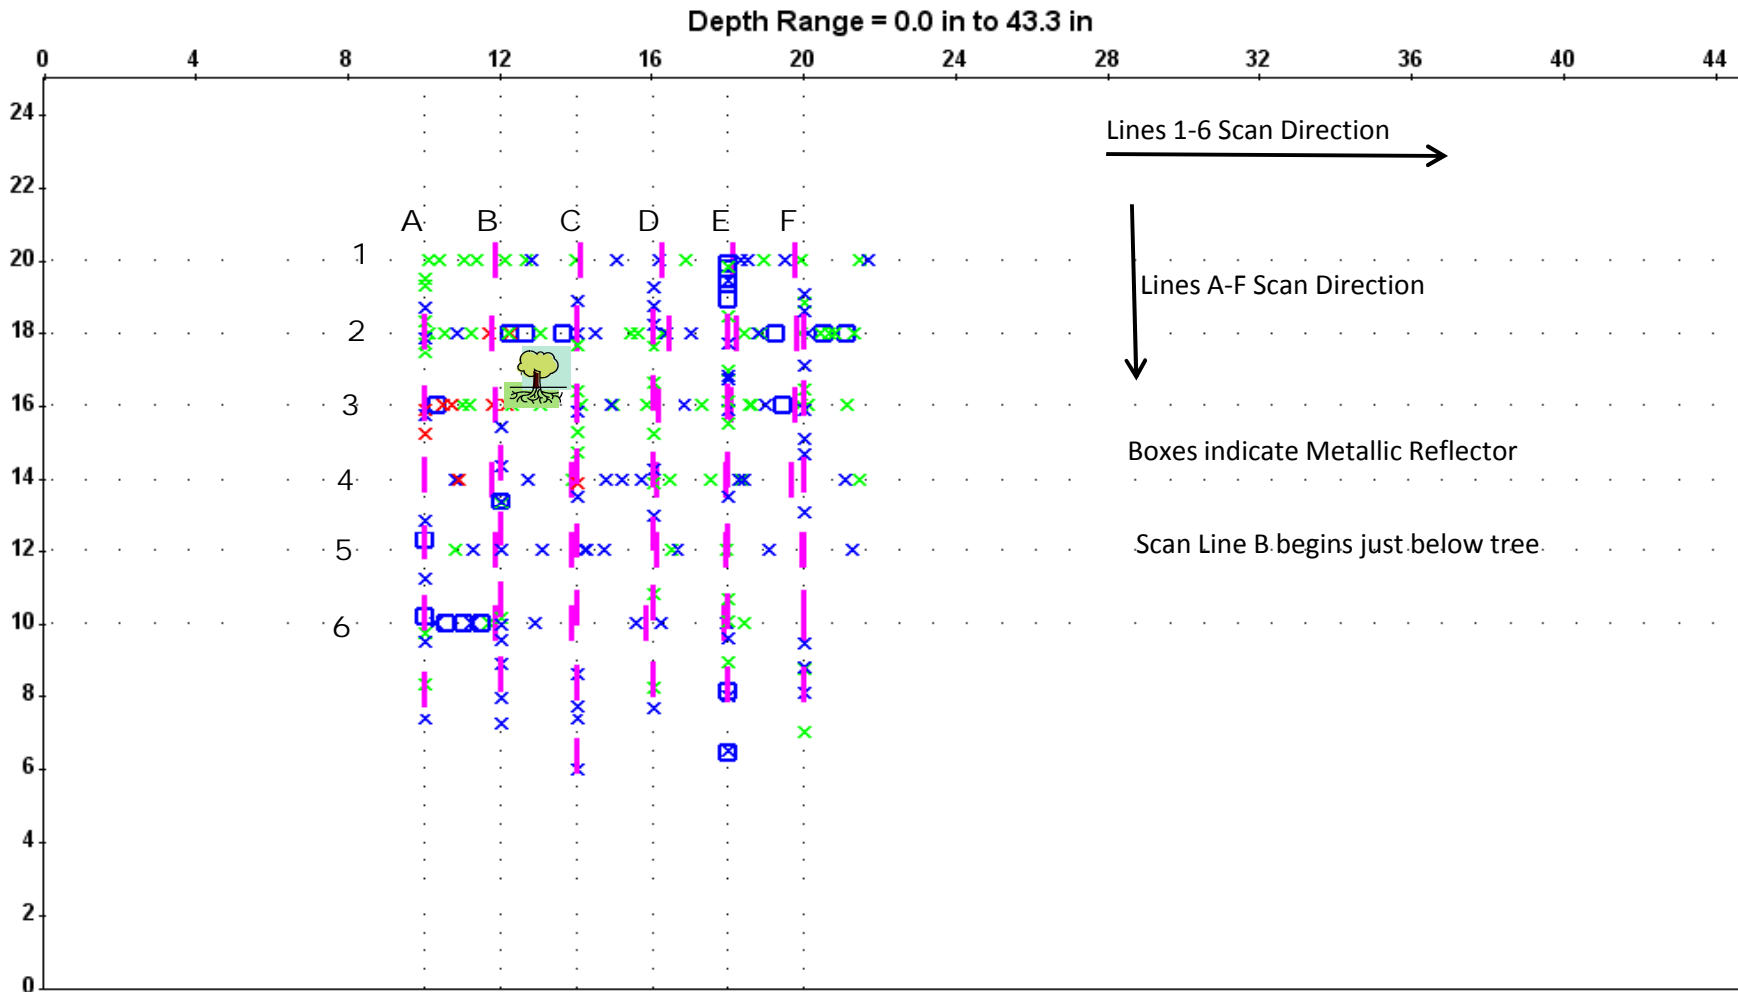
**W Lincoln Ave Almonds - 400 MHz
Total Depth Range**

Looking at the top down view for the total depth range for both antennas, one can see that roots were found across the entire plot. However, there were more roots found within scan lines 1 to 4 and between A and F. More roots were detected with the 900 MHz antenna due to its lower minimum root diameter detection capability. Relatively few roots greater than or equal to 0.8 inches were found in the top foot of soil (see 400 MHz, Top 1/3 Depth Range). Roots were found to the lowest depth range of the scans as seen in the 400 MHz, Bottom 1/3 Depth Range plot. Note that for the 900 MHz results, the bottom 1/3 of the depth range was a 4" depth slice due to the maximum depth of 30 inches for the 900 MHz antenna. The metallic reflectors were below this depth range as well so they were not detected in the 900 MHz scans.

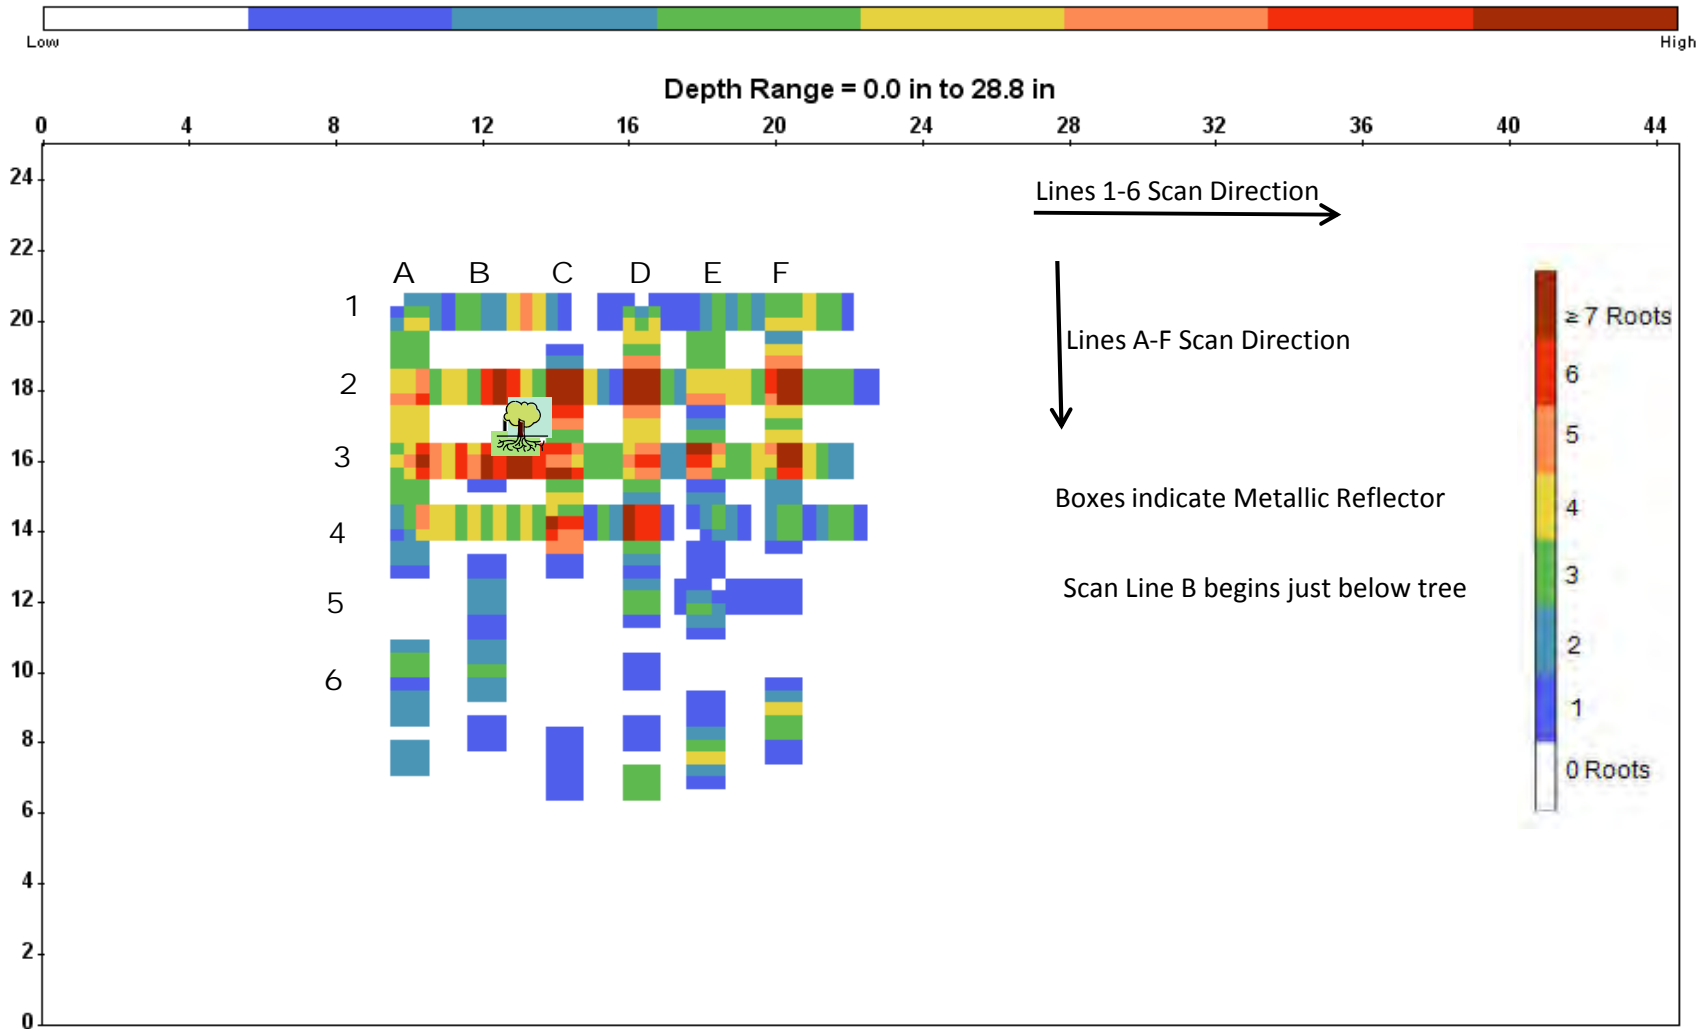
A root density map is also attached which superimposes the density of roots along scan lines for the entire depth range. Note that the overall root density is greater for the 900 MHz scans due to the antenna's lower minimum root diameter detection capability. The root density map for both antennas reveals the greater density of roots closer to the tree on the plot and the tree adjacent to the plot (berm area). Note that the root density on scan line 6 looks high but this is influenced by the presence of metallic reflectors.
