**FINAL REPORT
VOLUME II
R-PGE-20150427**

Pacific Gas and Electric Company

**Tree Root Interference Assessment
Attachments**

April 27, 2015

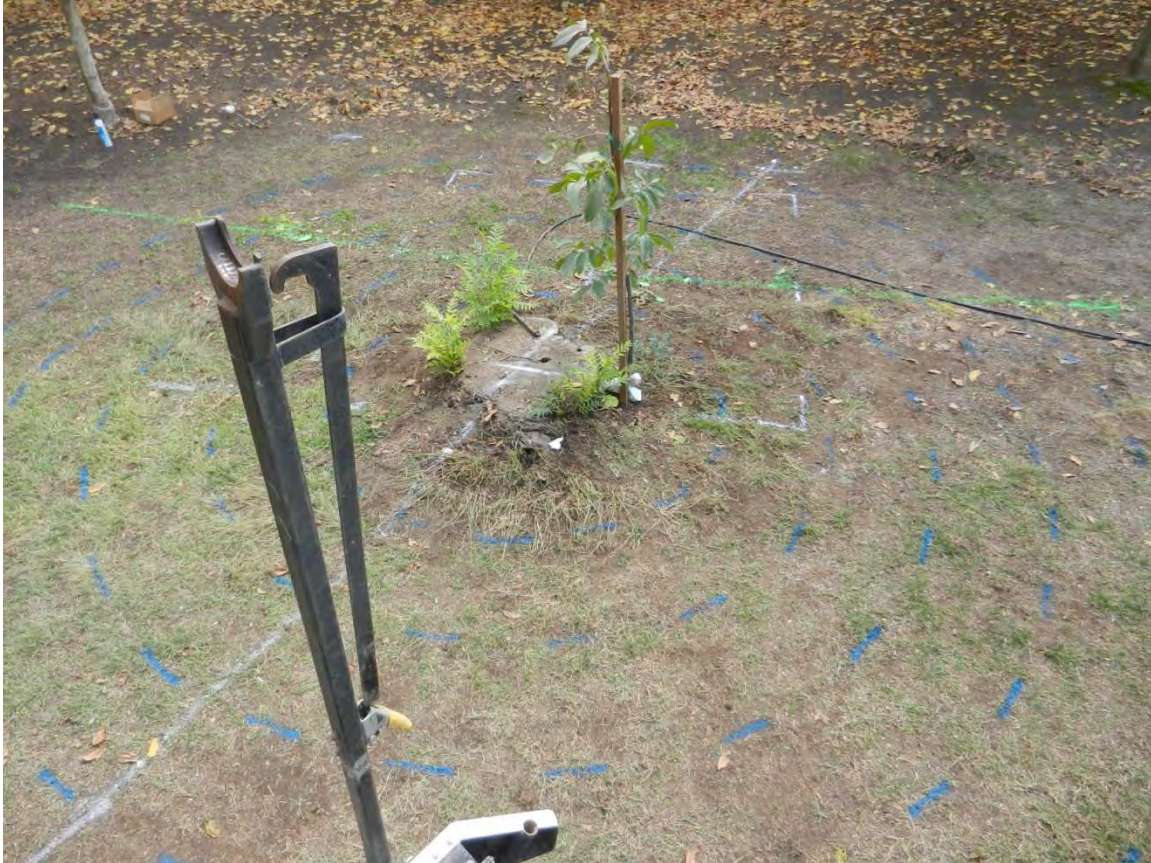
Figure 1. Looking downward and toward the south southwest at walnut stump and plot. Note white line bisecting trunk which was start stop line. Blue lines are scan lines. White box is excavation location and green line is predicted pipe location.

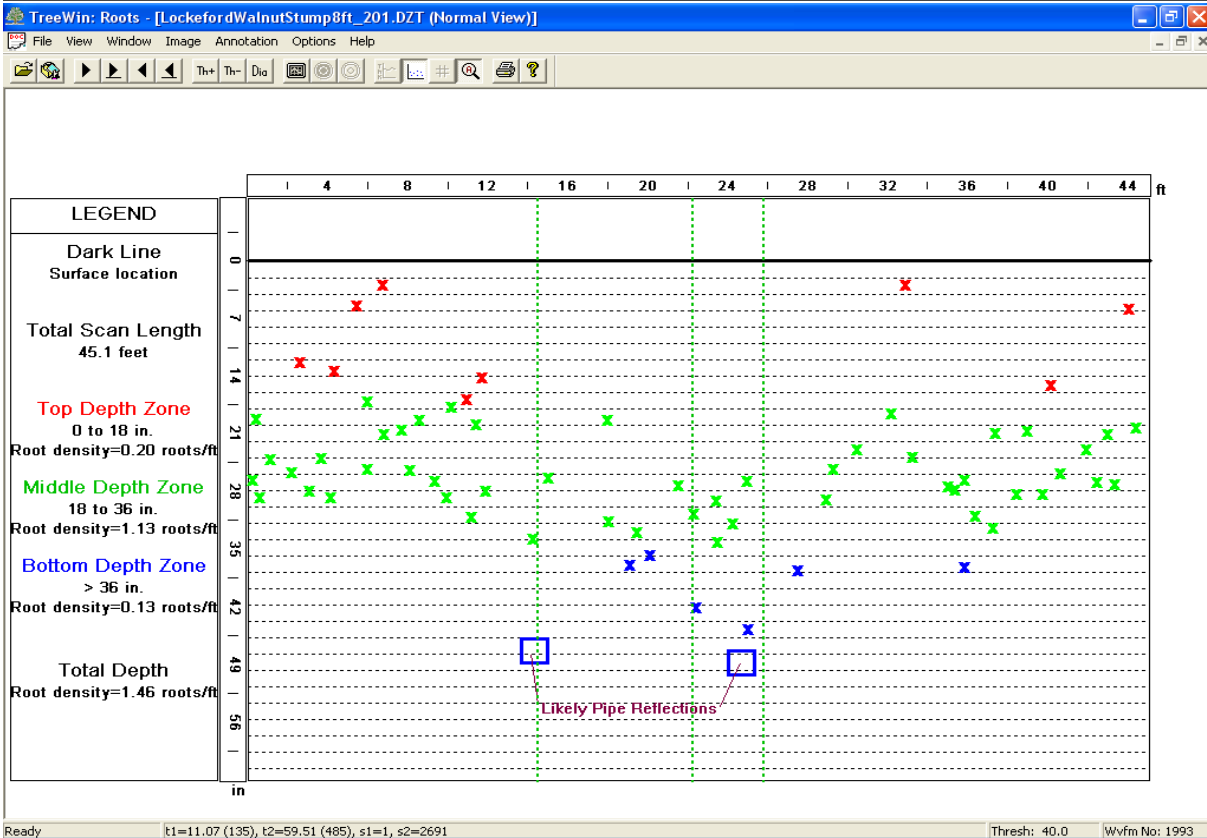
Walnut Stump - Scan # 8ft (201) - Length = 45.1ft - 29 Oct 2013

Roots were found above and relatively close to the pipe in the 8 and 12 foot scans.

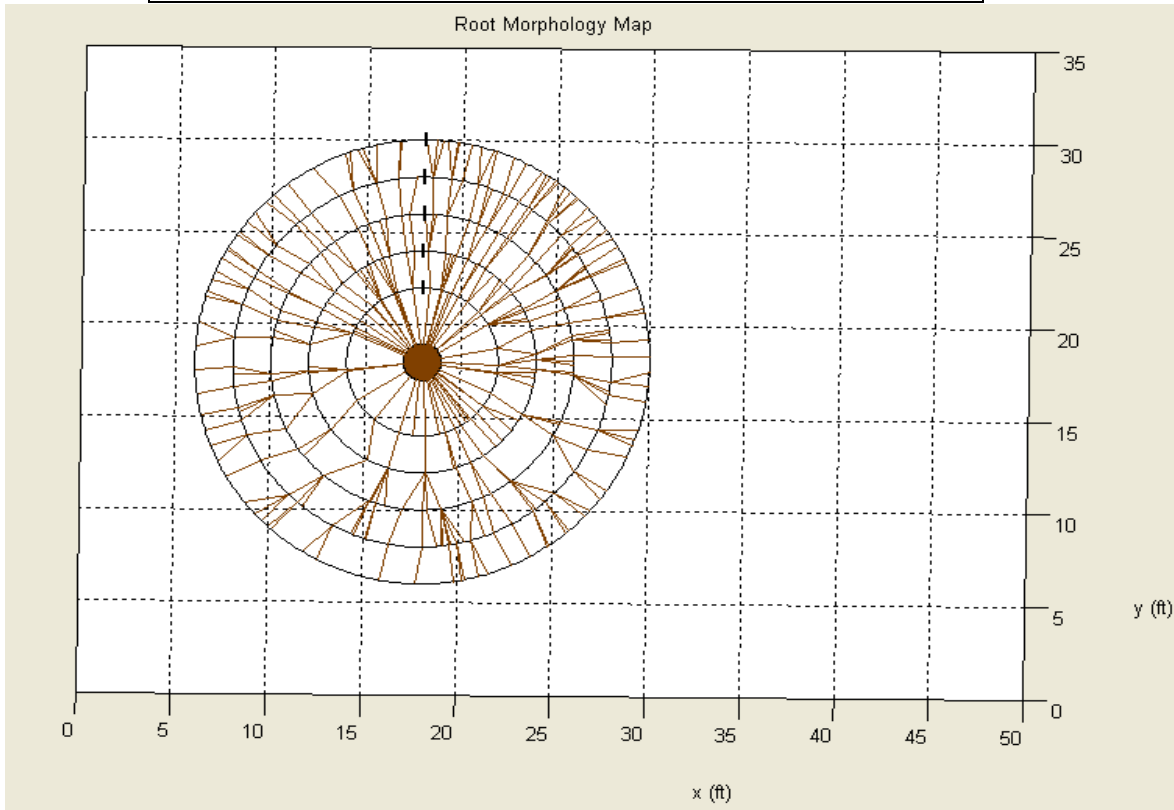
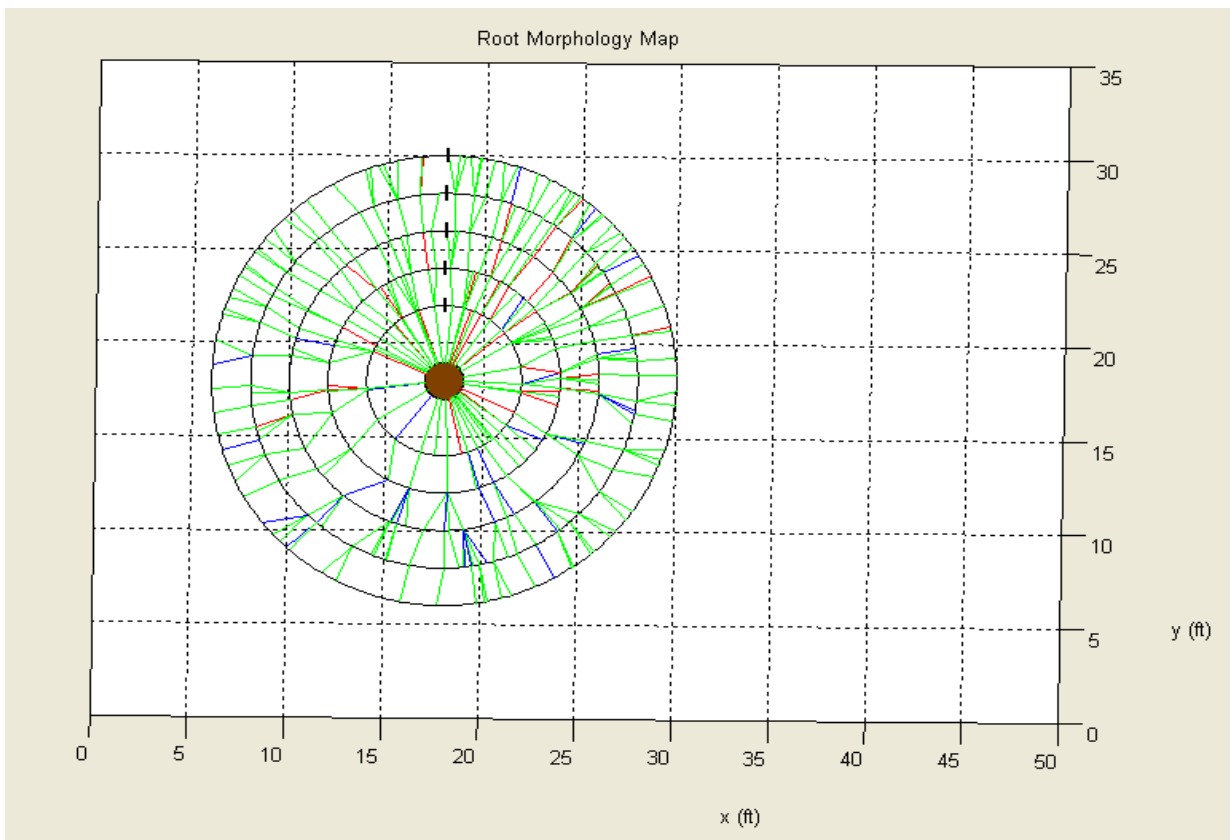
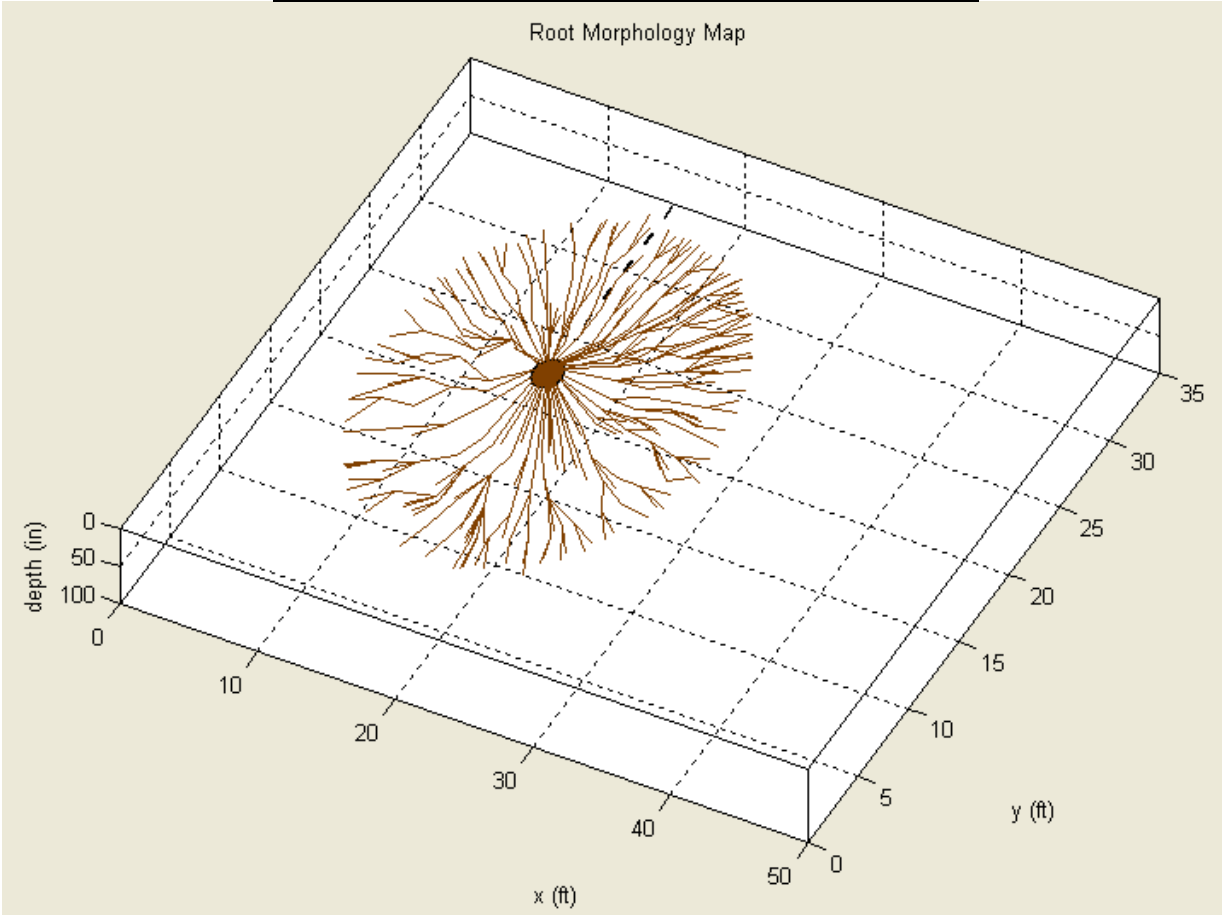
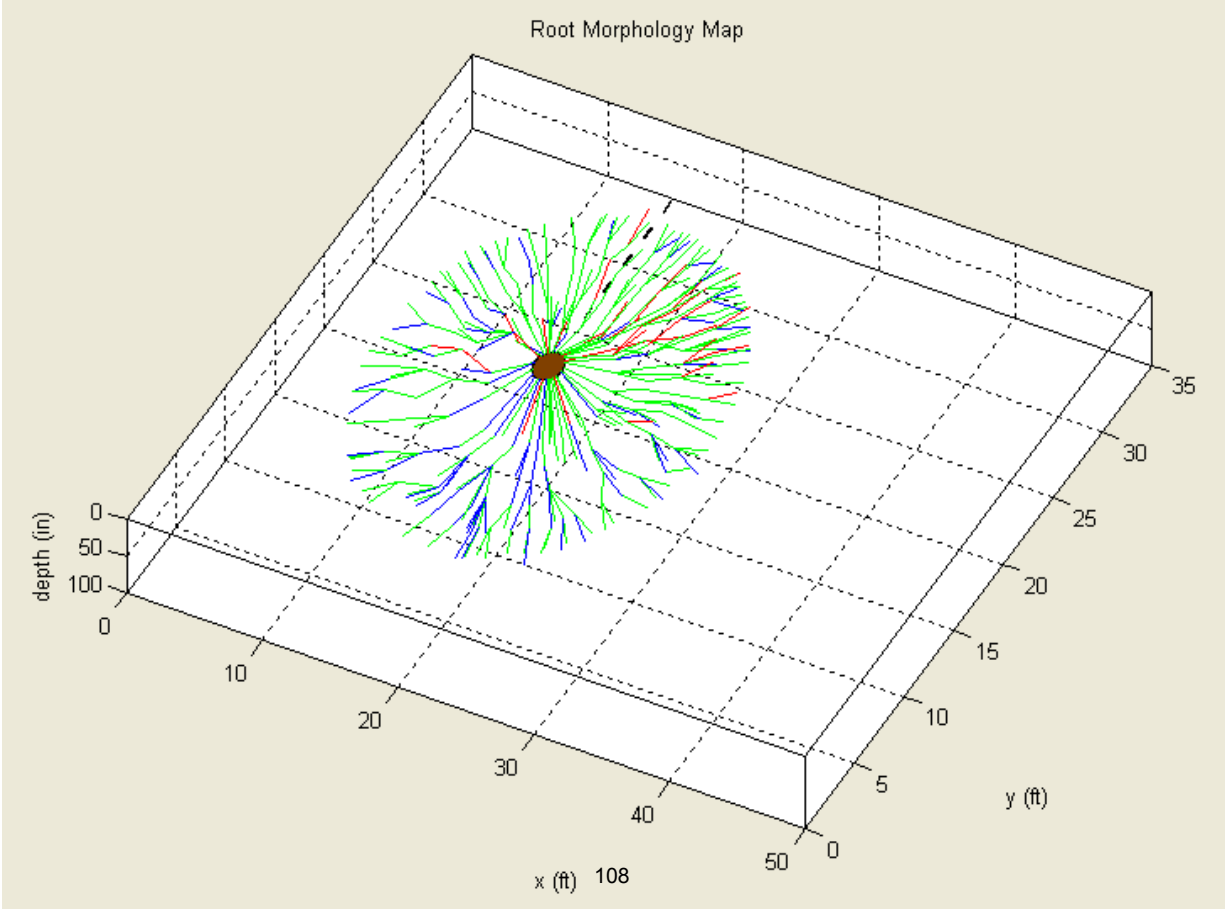
Four root morphology maps are attached. These are maps which are created by connecting the detected roots to approximate what the root system may look like from a top down or plan view. Two maps are monochrome and the others are color coded according to depth zone of roots. Note the north south line (dotted) on each scan.
